***Federal Railroad Administration
Office of Safety
Headquarters Assigned
Accident Investigation Report
HQ-2008-81***

***Union Pacific (UP)
Caney, OK
October 23, 2008***

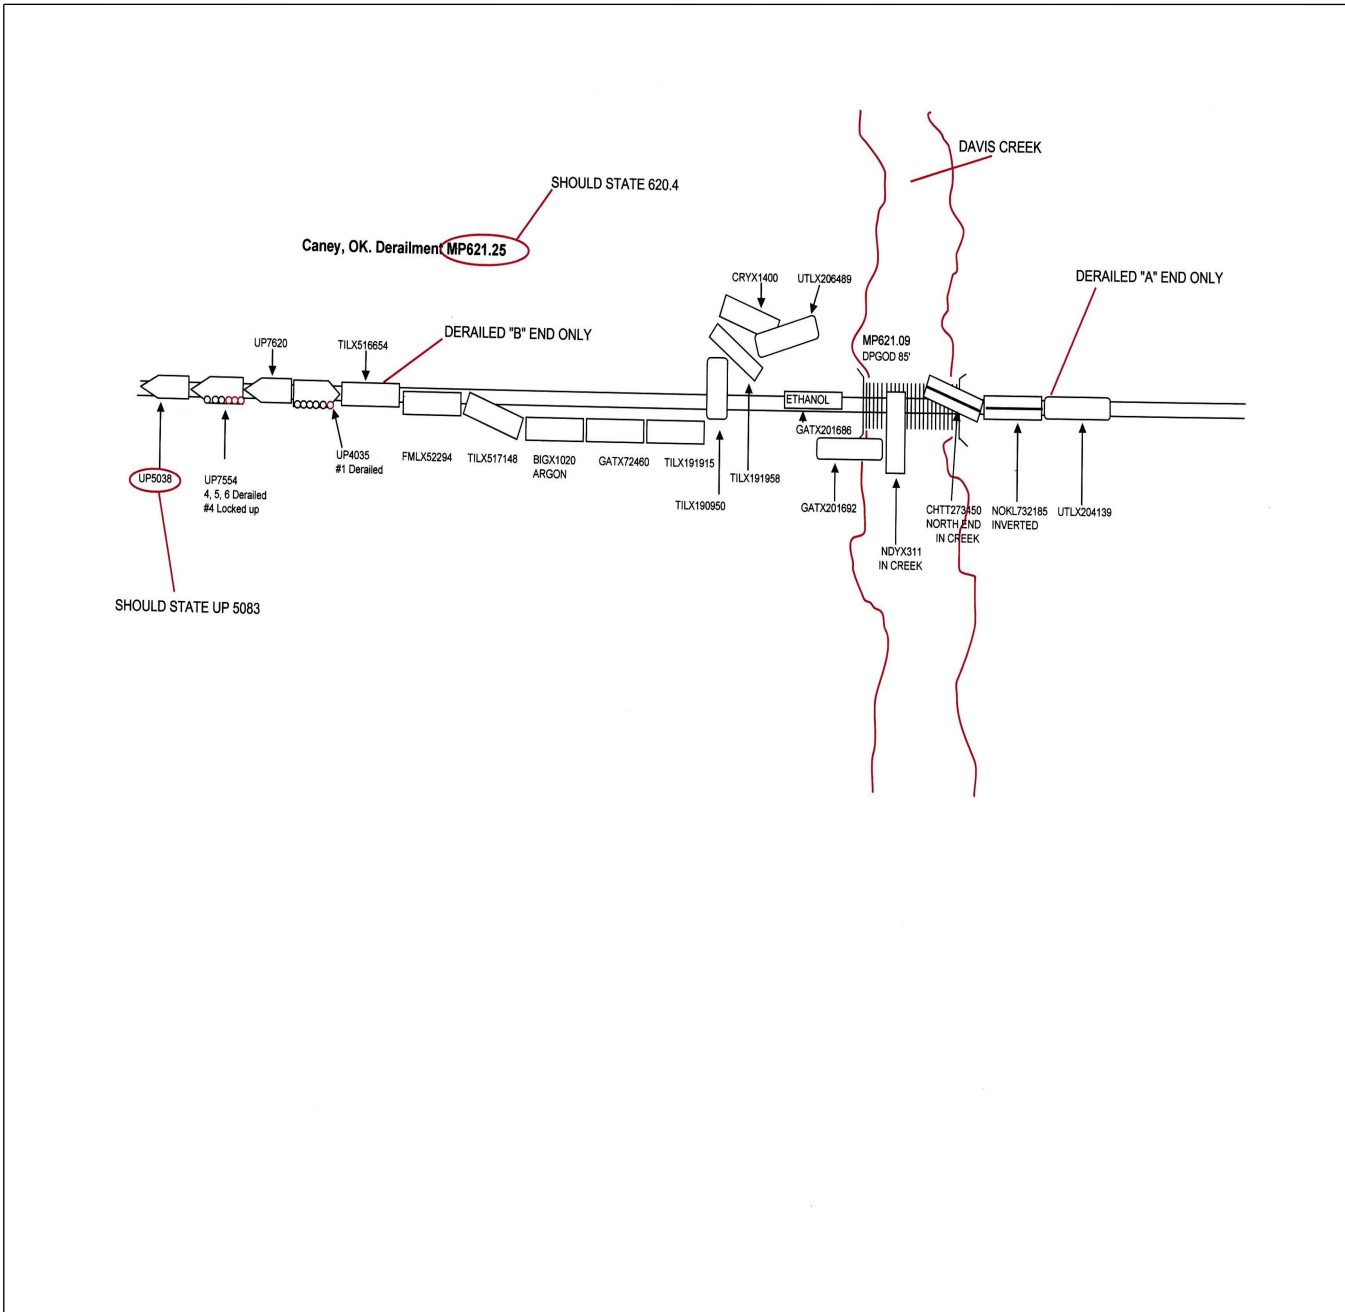
136. DRAW A SKETCH OF ACCIDENT AREA INCLUDING ALL TRACKS, SIGNALS, SWITCHES, STRUCTURES, OBJECTS, ETC., INVOLVED.

The point of derailment (POD) occurred at a frog portion of the stub track switch located at milepost 621.24. The stub track is used by the railroad to store maintenance of way equipment but was empty at the time of the derailment. The point where the lead locomotive stopped was at milepost 620.4.
