***Federal Railroad Administration
Office of Safety
Headquarters Assigned
Accident Investigation Report
HQ-2008-90***

***Long Island Railroad (LIRR)
Jamaica, NY
November 23, 2008***

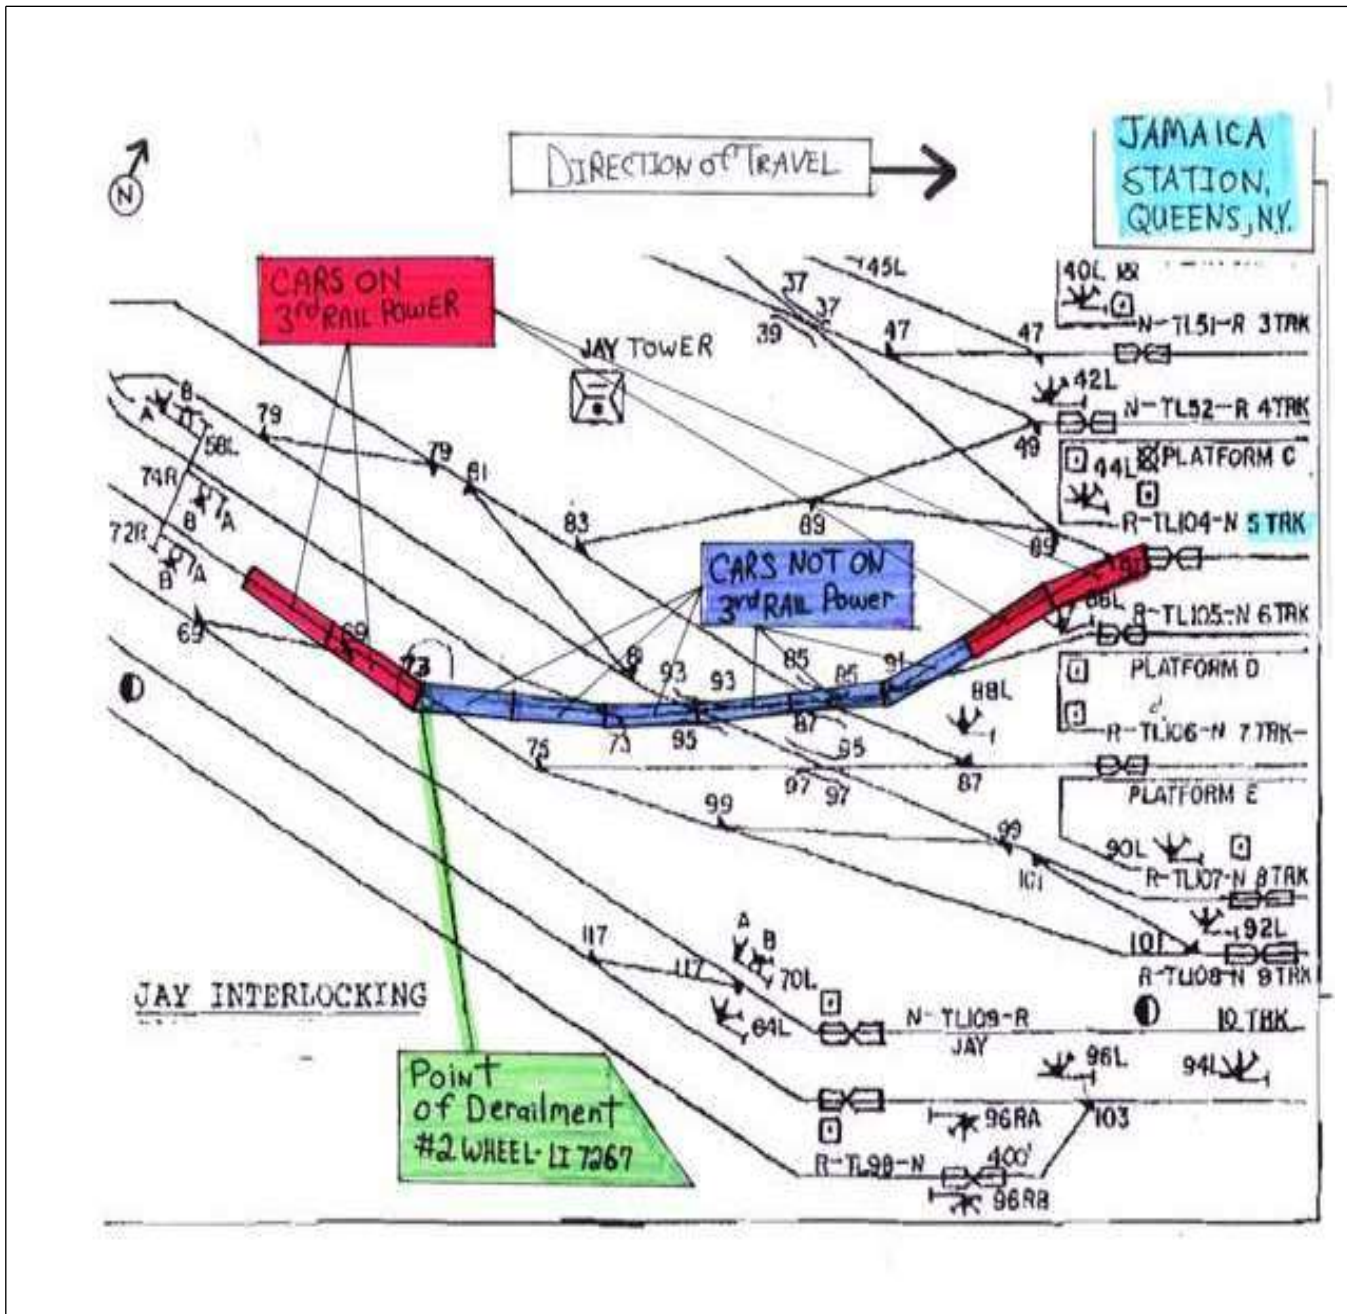
136. DRAW A SKETCH OF ACCIDENT AREA INCLUDING ALL TRACKS, SIGNALS, SWITCHES, STRUCTURES, OBJECTS, ETC., INVOLVED.

On November 23, 2008 at 12:18 p.m. EST eastbound Long Island Railroad (LIRR) Passenger Train No. 7700 operating from Penn Station, N.Y. to Huntington, N.Y. derailed the three west cars of a ten car train at milepost 9.7, west of Jamaica Train Station at the Jay Interlocking. LIRR Train # 7700 was operating on Main Track # Four into Jamaica station track five. There were no reported injuries to the crew members however one minor passenger injury was reported.

The cause of this derailment was a result of low speed wheel climb of the number two wheel on passenger coach car # 7267 positioned the eighth car in the consist. A low speed wheel climb derailment is not caused by a single factor, but a combination of multiple factors working together to create the potential for the derailment. Factors that contributed to the low speed wheel climb were a high ratio of lateral wheel force as it relates to the vertical wheel force (L/V ratio) and a high coefficient of friction (COF) between the wheel and the rail at the point of derailment. The point of derailment (POD) was at the # 73 switch. The way the switch was lined caused a tight radius crossover. Just prior to the derailment the number two wheel of the first derailed car was stopped on the heel block of the # 73 switch. This stop was due to an existing train on track five at Jamaica station. While the first derailed car was situated on the crossover it mirrored the angle of the crossover. The car behind the first derailed car was not on the crossover. The difference in how these two cars were situated caused significant coupler angularity. Additionally, as the train was stopped at this position, only the first two and the last two cars of the train were on third rail power. The middle six cars were not on third rail power. Third rail power is necessary for traction effort. Without third rail power the cars cannot move under their own power and must rely on neighboring powered cars to move them. The first derailed car was not on third rail power; however the two cars behind it were on third rail power. When the engineer began to move the train and called for full throttle, only the third rail powered cars began making traction effort. In effect, the two cars behind the first derailed car began pushing the train. This generated a significant longitudinal compressive (buff) force which converted to lateral force because of coupler angularity and the way the first derailed car was situated on the crossover. The lateral force from the coupler created an elevated lateral wheel force which increased the L/V ratio at the point of derailment which contributed to the low speed wheel climb.

Contributing to the high coefficient of friction was the fact that the rail lubricators had been turned off in this area due to the accelerated leaf accumulation. Another factor contributing to the high coefficient of friction was that traces of Sandite were present. Sandite is a wheel/rail adhesive additive used to prevent wheel slip. The Long Island Railroad has a Sandite train which travels throughout the system, cleans the rail, and applies Sandite where slippery conditions exist during the leaf and snow seasons. The high coefficient of friction did not allow the wheel to slide. The high COF, along with the high L/V ratio and the train starting from a stopped position, caused the number L-two wheel of LIRR coach car # 7267 to climb the number 73 switch and derail.

The Long Island Railroad has taken the following steps to assure derailments of this nature do not re-occur. LIRR has stopped all train movement through the number 73 switch in the reverse position. LIRR has developed policies to assure Sandite is not applied on any switches, turnouts, crossovers, or high degree curves. The LIRR will maintain rail lubrication on year round basis and refrain from discontinuing the process during the winter months and leaf season. Some of the Long Island Railroad's long term recommendations include revised operational changes that will reduce the risk of derailments in the Jay Interlocking area, review infrastructure changes that will reduce the risk of derailments, and review other locations to ascertain similar derailment risks.
