***Federal Railroad Administration  
Office of Safety  
Headquarters Assigned  
Accident Investigation Report  
HQ-2007-01***

***Massachusetts Bay Transit Authority  
Woburn, MA  
January 9, 2007***

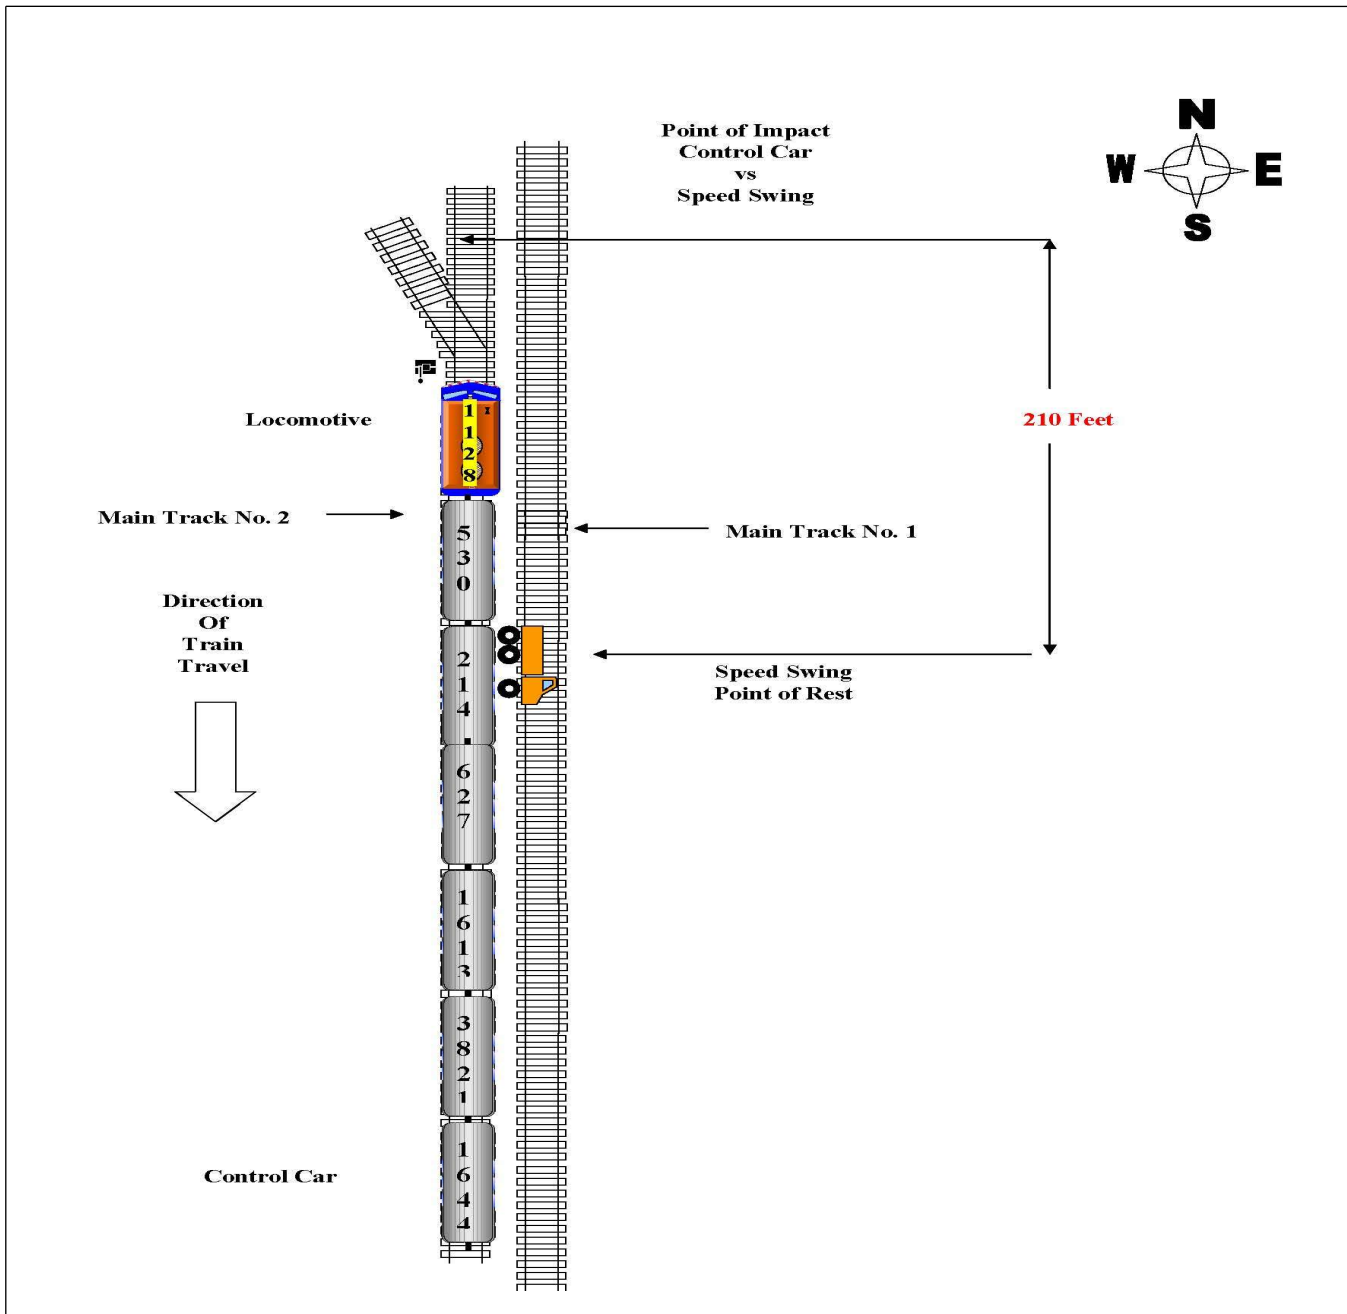
136. DRAW A SKETCH OF ACCIDENT AREA INCLUDING ALL TRACKS, SIGNALS, SWITCHES, STRUCTURES, OBJECTS, ETC., INVOLVED.

A southbound MBTA/MBAX commuter train collided with a roadway maintenance machine on January 9, 2007, at 1:38 p.m. EST. The collision occurred in Woburn, Massachusetts, at MBAX Milepost 10.38, on the New Hampshire Route Main Track No. 2.

At the time of the accident, six maintenance of way employees (MoW) were engaged in replacing switch ties at milepost 10.40. Two MoW employees were killed, one was seriously injured, and three others sustained minor injuries. There were no injuries to the train crew. Damages to the train equipment were estimated at \$450,000, damages to track structure were \$111,000, and the damage to the roadway maintenance machine was estimated at \$95,000. In addition, 43 passengers were evacuated from Train 322 South with 10 reportable injuries. There was no derailment.
