***Federal Railroad Administration
Office of Safety
Headquarters Assigned
Accident Investigation Report
HQ-2007-04***

***Union Pacific (UP)
Gore, Oklahoma
January 17, 2007***

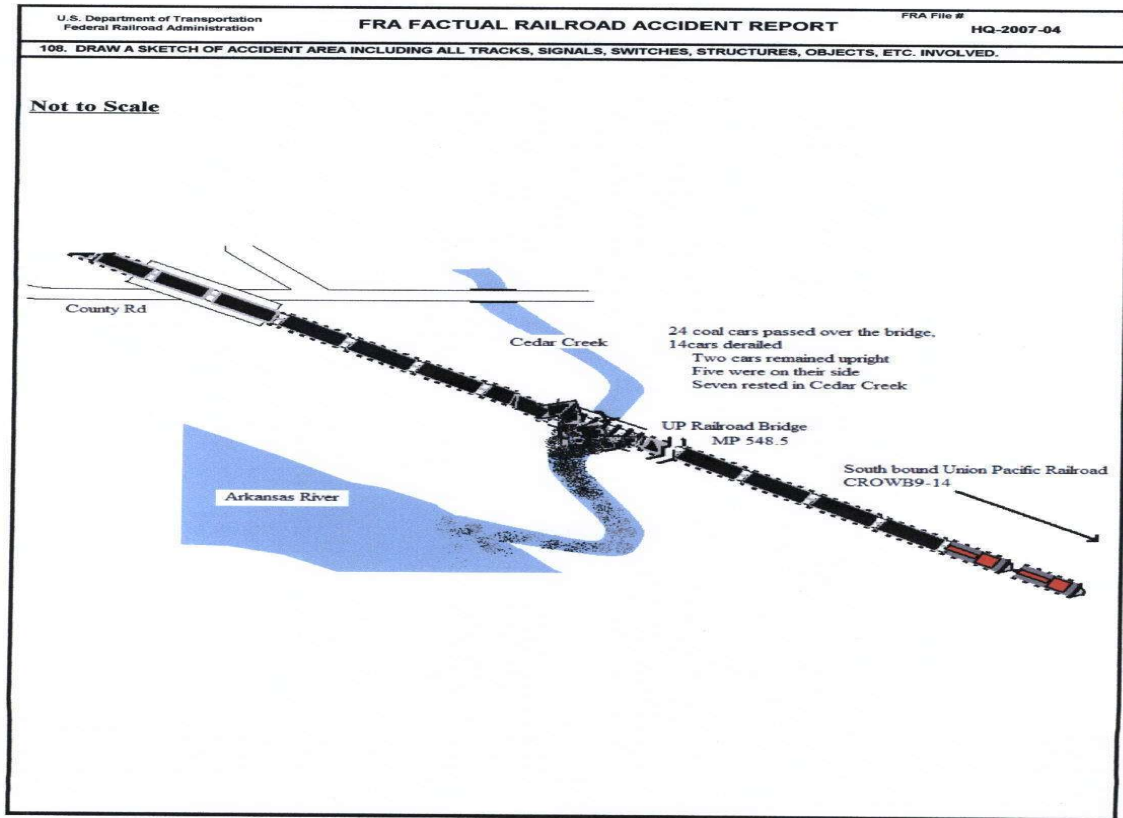
136. DRAW A SKETCH OF ACCIDENT AREA INCLUDING ALL TRACKS, SIGNALS, SWITCHES, STRUCTURES, OBJECTS, ETC., INVOLVED.

A southbound Union Pacific Railroad (UP) freight train derailed on January 17, 2007, at approximately 12:50 p.m. The accident occurred near Gore, Oklahoma, at UP Milepost 548.6, on the UP Wagoner Subdivision.

A bridge at that location was destroyed. A total of 14 cars derailed; two remained upright, five turned over on their side, and seven fell off the bridge into Cedar Creek. There were no injuries to the train crew. There was extensive damage to track, roadbed, bridge, and equipment totaling about \$1,328,000.

Further observation revealed a broken rail end on the east rail in approach to (north of) the bridge. As the MTM continued his investigation, he noted that the surface of the wheels on the leading locomotive and subsequent cars were marked on the east side, consistent with marks left by a fractured rail.
