***Federal Railroad Administration  
Office of Safety  
Headquarters Assigned  
Accident Investigation Report  
HQ-2007-09***

***Norfolk Southern (NS)  
Goshen, Indiana  
February 21, 2007***

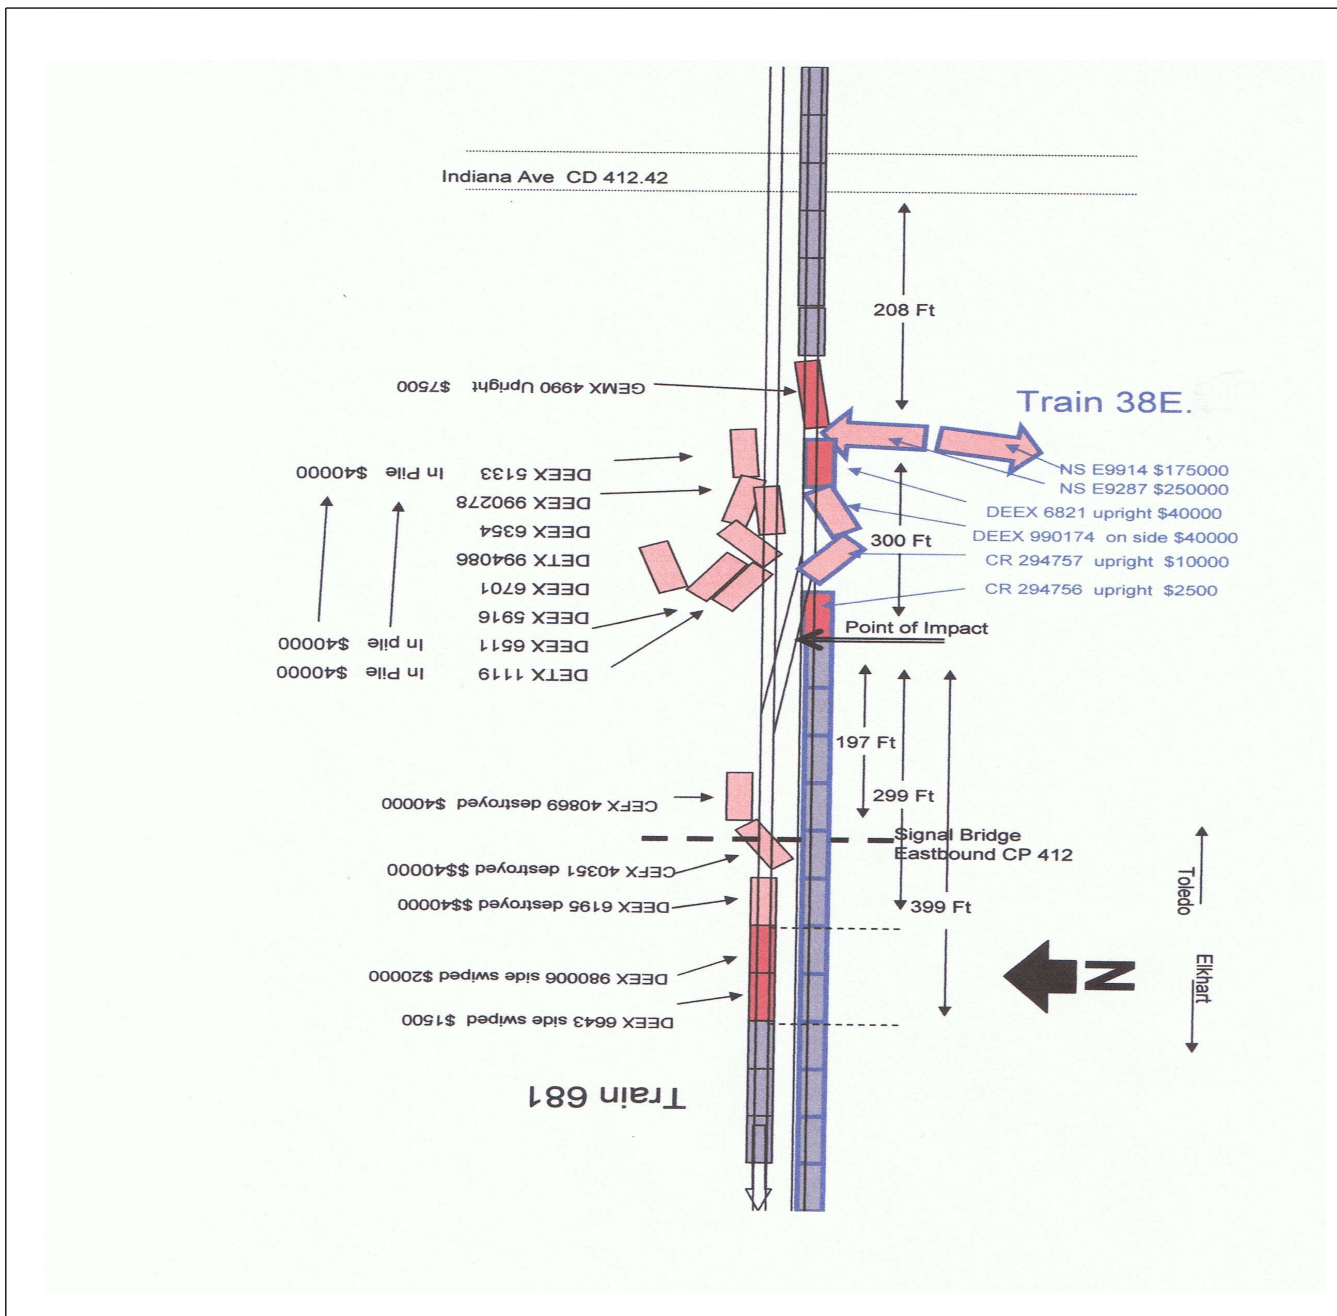
136. DRAW A SKETCH OF ACCIDENT AREA INCLUDING ALL TRACKS, SIGNALS, SWITCHES, STRUCTURES, OBJECTS, ETC., INVOLVED.

On February 21, 2007, at 12:35 p.m. e.s.t., a Norfolk Southern Railroad (NS) eastbound freight train collided with the side of a westbound NS freight train. The accident occurred in Goshen, Indiana, at NS Milepost 412, on the Chicago Line of the NS Dearborn Subdivision

The accident occurred because the locomotive engineer and the conductor failed to comply with rules and regulations regarding a stop signal indication when they allowed their train, NS 38EB-221, to pass an absolute signal displaying a stop indication at NS Milepost 412 on Main Track No. 2 without authority. Failure to comply with automatic block or interlocking signal displaying stop. Contributing was failure of the crew to comply with restricted speed in connection with the restrictive indication of a block or interlocking signal.
