***Federal Railroad Administration
Office of Safety
Headquarters Assigned
Accident Investigation Report
HQ-2007-11***

***Canadian National/Metra (CN/NIRC)
Chicago, Illinois
March 7, 2007***

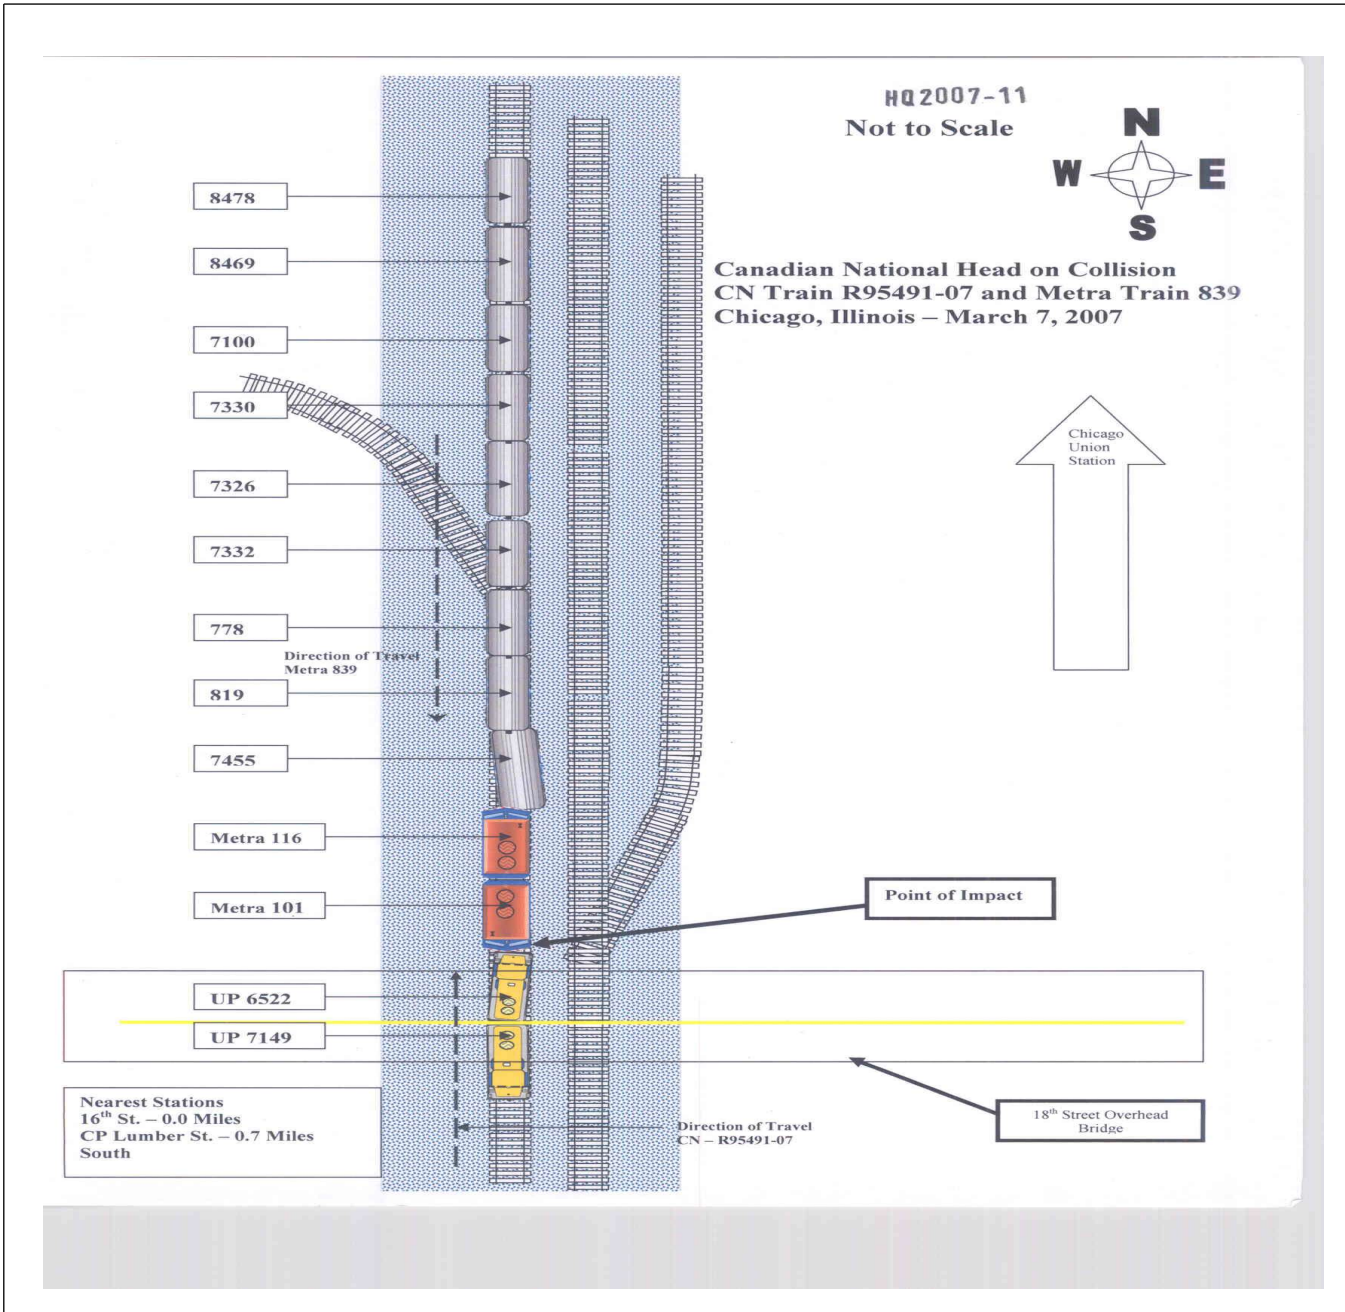
136. DRAW A SKETCH OF ACCIDENT AREA INCLUDING ALL TRACKS, SIGNALS, SWITCHES, STRUCTURES, OBJECTS, ETC., INVOLVED.

The route traversed by the unattended CN locomotive consist begins on a .59-percent descending grade in a left-hand curve, which runs northeast to a connection with ATK at CN Milepost 2.9, approximately 1,034 feet geographically south of the point where the collision occurred. Beyond the connection, ATK trackage is tangent, running in a geographically south-north direction. The track ascends briefly on the approach to a lift bridge spanning the south branch of the Chicago River. North of the bridge the .59-percent descending grade continues to the point of the collision.
