***Federal Railroad Administration  
Office of Safety  
Headquarters Assigned  
Accident Investigation Report  
HQ-2007-12***

***Kansas City Southern Railway Co. (KCS)  
Hattiesburg, Mississippi  
March 8, 2007***

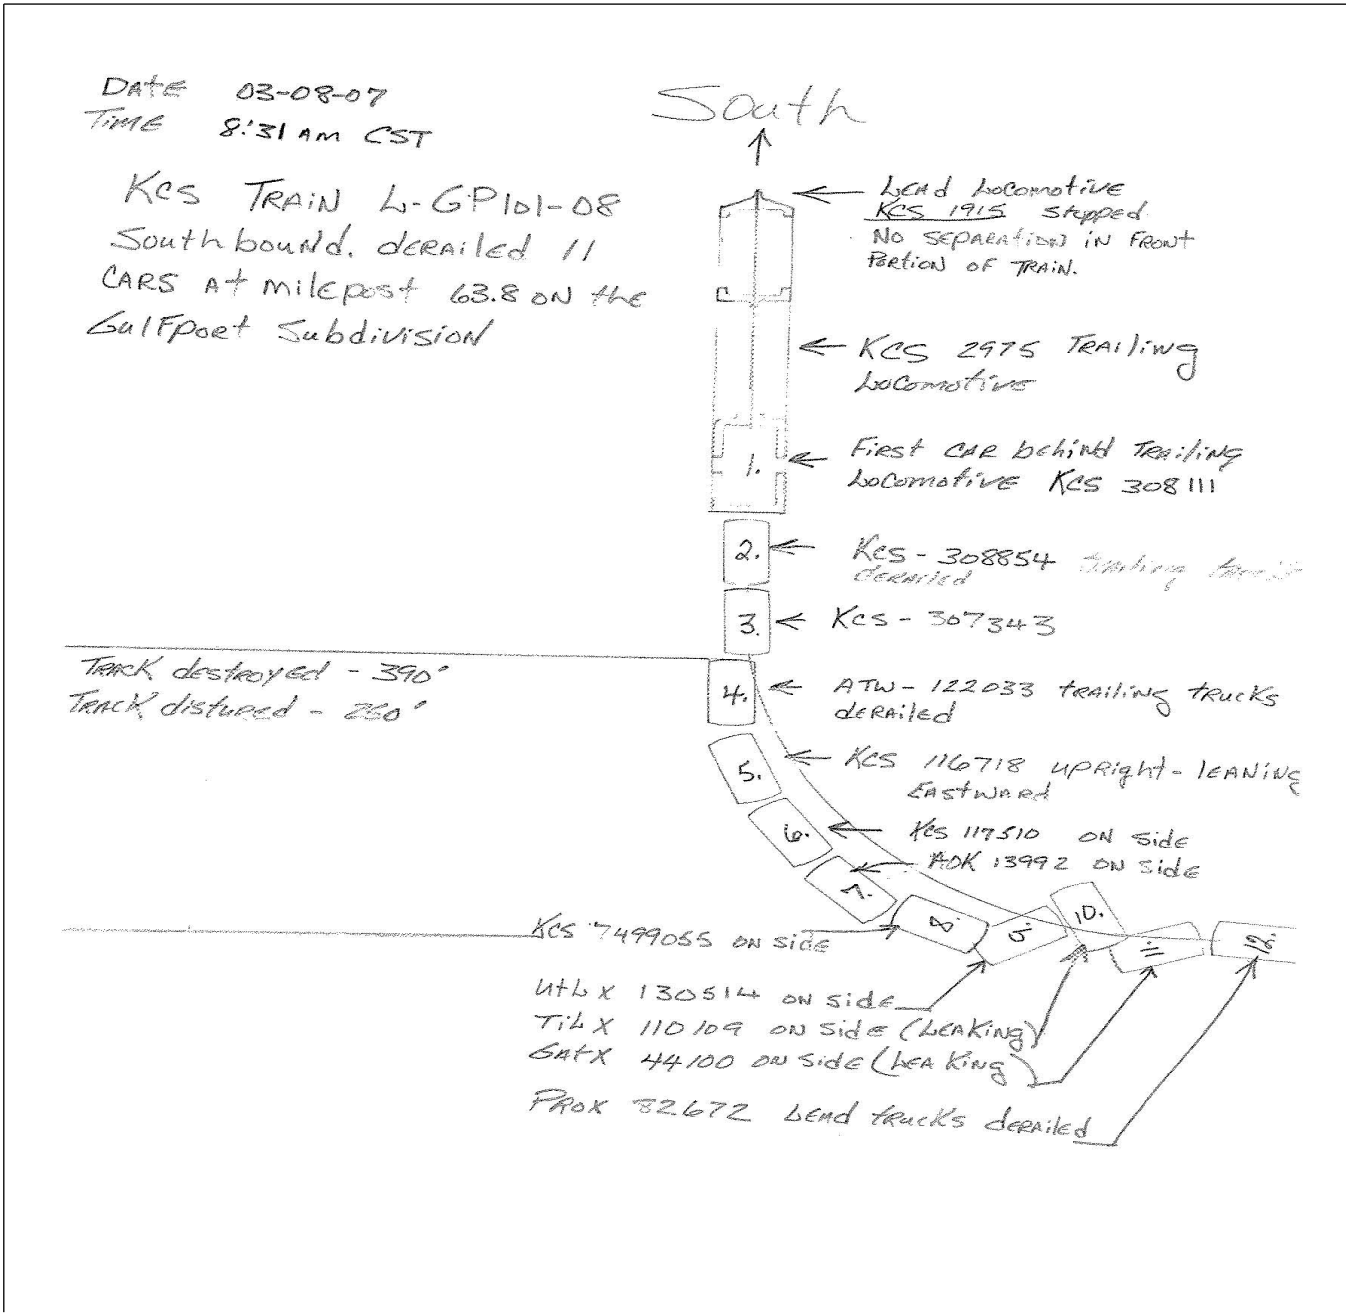
136. DRAW A SKETCH OF ACCIDENT AREA INCLUDING ALL TRACKS, SIGNALS, SWITCHES, STRUCTURES, OBJECTS, ETC., INVOLVED.

At the accident scene the KCS Engineering Department recovered a section of rail from the high side, east side of the curve, with two breaks 33 inches apart. The two breaks were identified as an 80% Detail Fractures (DF) about one inch in diameter, and another 20% DF about three-eighths inch in diameter. Both breaks were on the gage side of the east rail head. The 80% break was the northern most break, the 20% break 33" south of it.

Rail-end batter existed on the north side of the 80% DF with a slight discoloration in the break, which shows this rail broke under the previous northbound train the night before the accident. The continuous vertical induced train forces of Train LGP10108 over the rail, which caused the 20% DF to break completely through. The 33" section of rail rolled out from the track causing the train to derail.
