***Federal Railroad Administration
Office of Safety
Headquarters Assigned
Accident Investigation Report
HQ-2007-14***

***Missouri & Northern Arkansas RR Co Inc. (MNA)
Bergman, Arkansas
April 6, 2007***

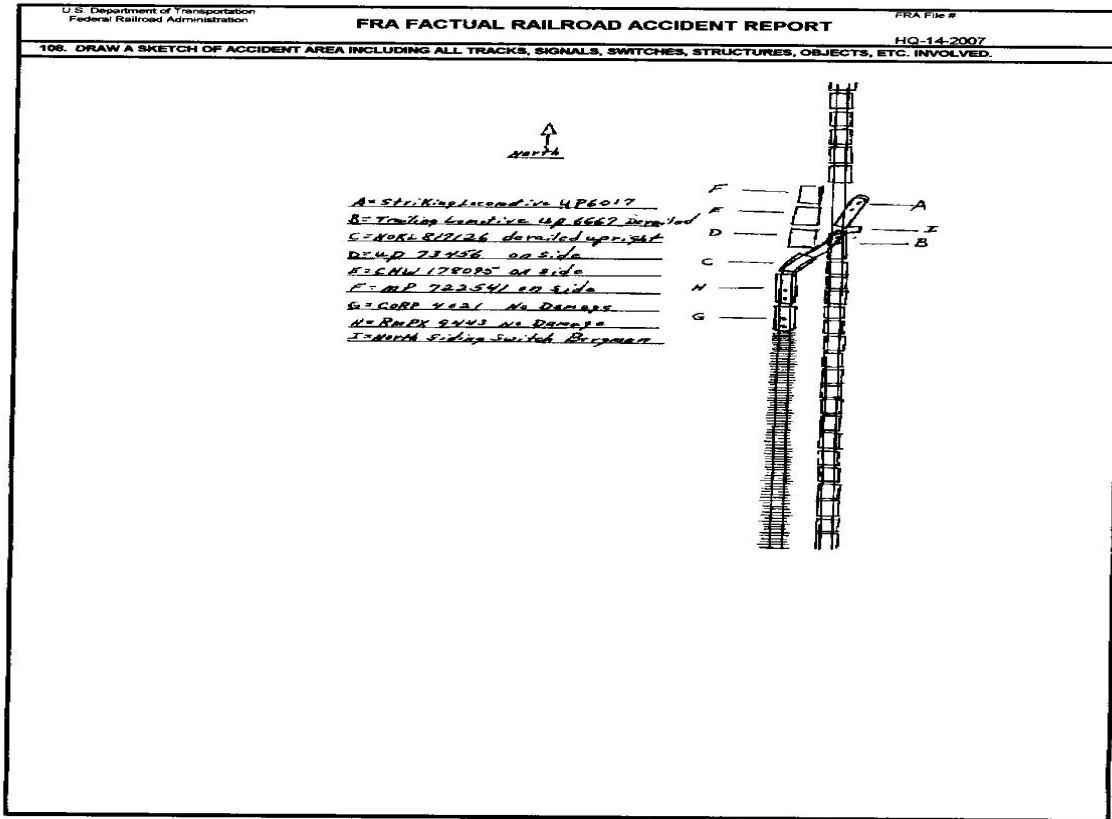
136. DRAW A SKETCH OF ACCIDENT AREA INCLUDING ALL TRACKS, SIGNALS, SWITCHES, STRUCTURES, OBJECTS, ETC., INVOLVED.

A northbound MNA freight train collided with a standing southbound MNA freight train at the north switch of Bergman siding on April 6, 2007 at 4:02 a.m. The accident occurred at Bergman, AR at MNA Milepost 416.85 on the MNA Aurora subdivision.

The striking train struck the 2nd head car behind the two unit locomotive consist. The impact caused the trailing trucks of the lead car to derail. The 2nd, 3rd, and 4th cars of the struck train were knocked onto their sides.
