***Federal Railroad Administration  
Office of Safety  
Headquarters Assigned  
Accident Investigation Report  
HQ-2007-51***

***New Mexico Rail Runner Express (NMRX)  
Los Chavez, New Mexico  
September 18, 2007***

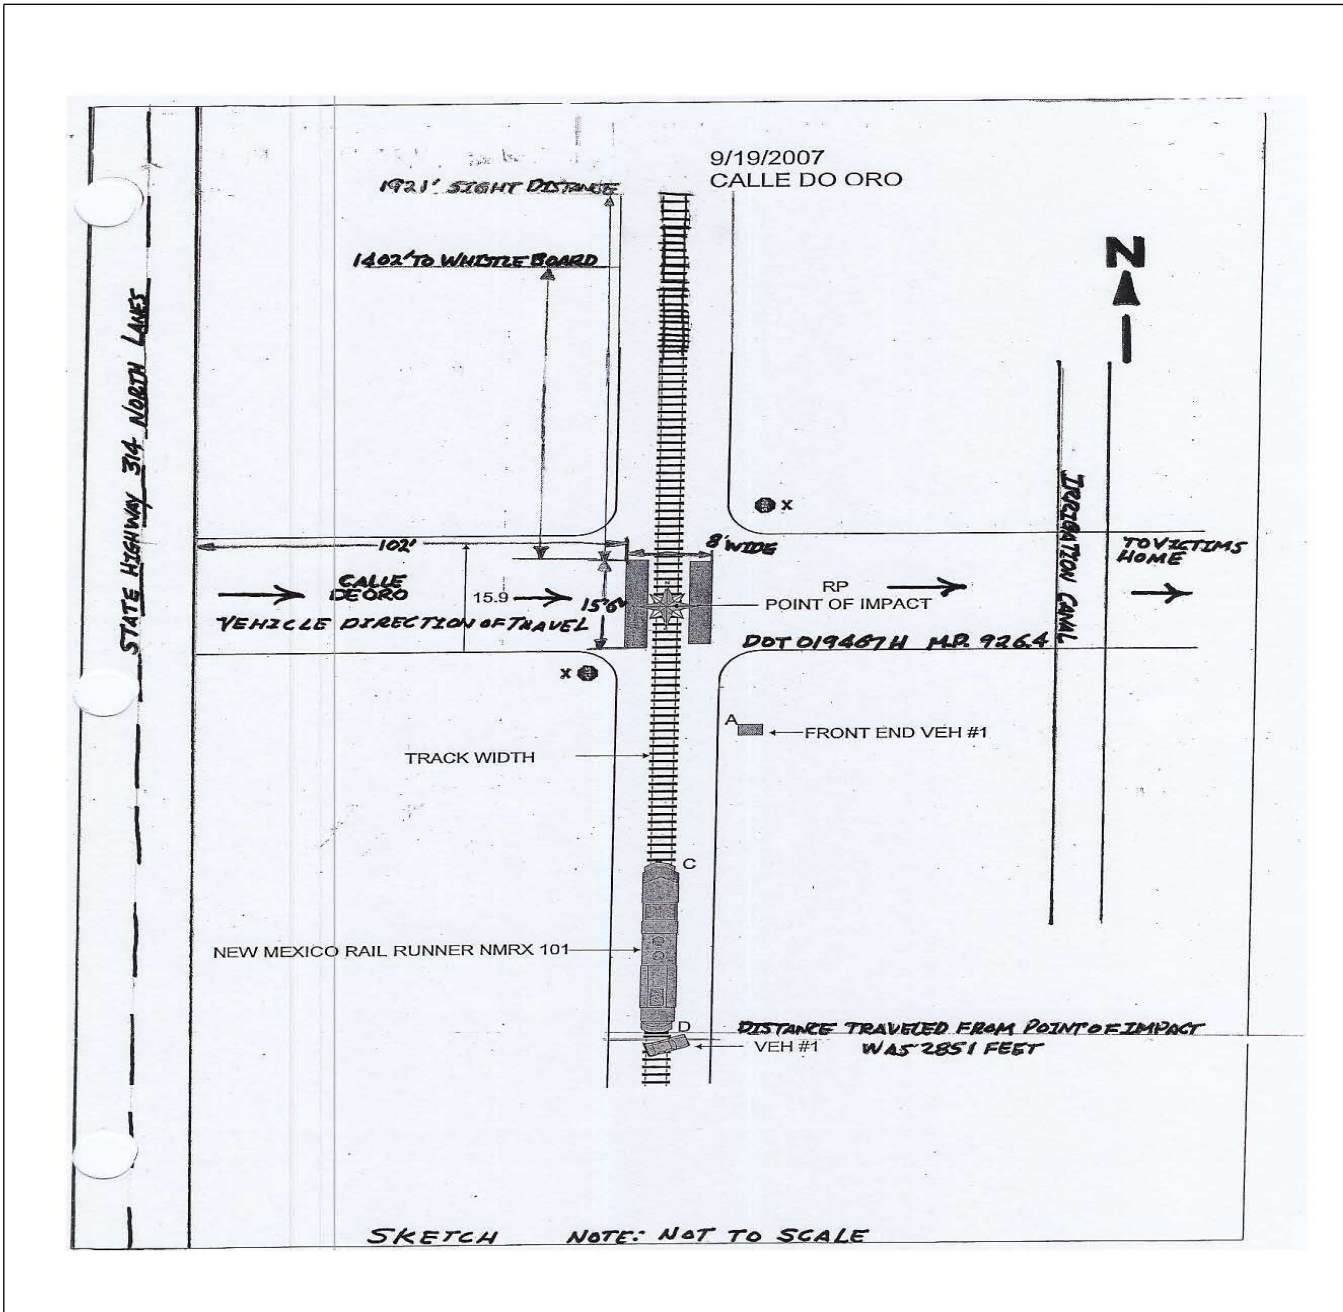
136. DRAW A SKETCH OF ACCIDENT AREA INCLUDING ALL TRACKS, SIGNALS, SWITCHES, STRUCTURES, OBJECTS, ETC., INVOLVED.

The sketch contained in this report indicates that a motor vehicle operator making the required stop at the outer edge of the private crossing has 1,920 feet of visibility. This is the recommended sight distance needed for a motorist to be able to cross the tracks from a stopped position prior to the arrival of a train moving 79-80 mph according to the Federal Highway Administration (FHWA).
