***Federal Railroad Administration
Office of Safety
Headquarters Assigned
Accident Investigation Report
HQ-2007-54***

***Norfolk Southern (NS)
Columbus, Ohio
September 26, 2007***

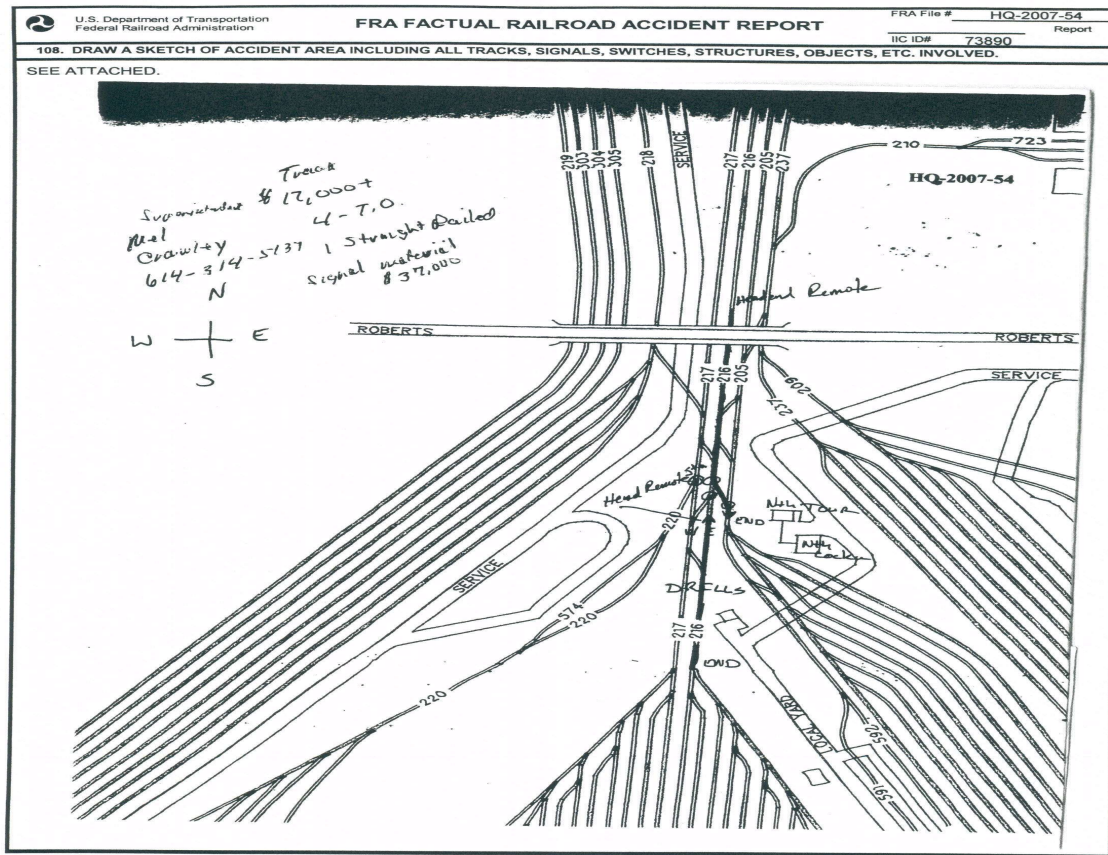
136. DRAW A SKETCH OF ACCIDENT AREA INCLUDING ALL TRACKS, SIGNALS, SWITCHES, STRUCTURES, OBJECTS, ETC., INVOLVED.

In the area of the accident there are two tangent tracks known as the east drill track and the west drill track. Moving north from the classification yard along the east drill track and west drill track, there is a remotely controlled crossover left-handed switch connecting the east drill track and west drill track, known as number eight crossover, a second remotely controlled crossover switch connecting the west drill track to the east drill track known as number five crossover and a remotely controlled switch for reverse movement from the east drill track to the departure yard lead, known as number five crossover. The grade in the area is practically level

At approximately 4:30 p.m. Train LY35 collided into the side of Train LY34 on the east drill track at the number three crossover switch derailing one locomotive and four rail cars in both movements. The Yardmaster observed the collision and immediately made a radio transmission to stop all movements stating "that will do, that will do, damn."
