***Federal Railroad Administration
Office of Safety
Headquarters Assigned
Accident Investigation Report
HQ-2007-56***

***Norfolk Southern/Alabama & Gulf Coast Rwy LLC (NS/AGR)
Boligee, Alabama
October 1, 2007***

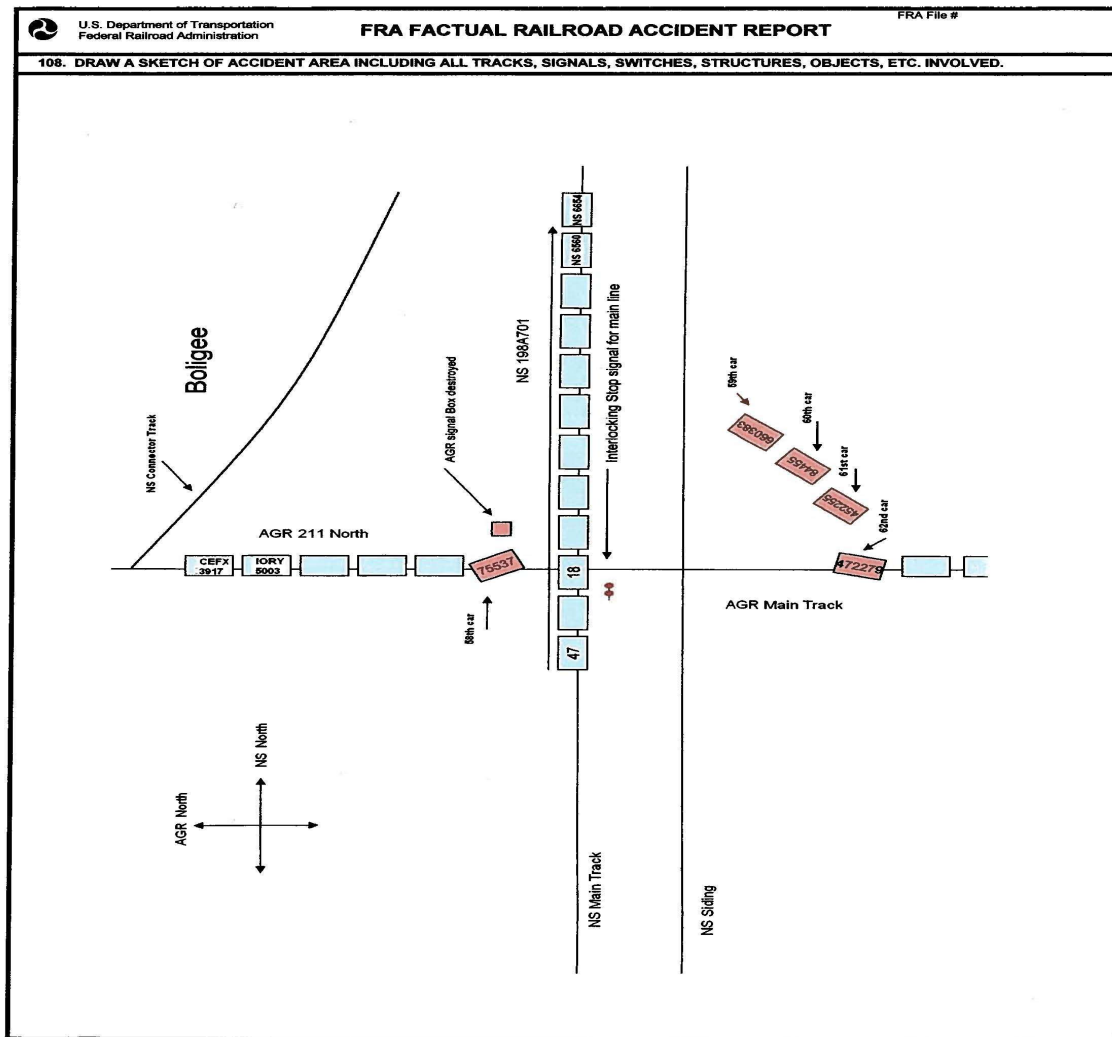
136. DRAW A SKETCH OF ACCIDENT AREA INCLUDING ALL TRACKS, SIGNALS, SWITCHES, STRUCTURES, OBJECTS, ETC., INVOLVED.

On October 1, 2007, at 11:20 p.m. CDT, northbound Norfolk Southern (NS) Train 198A701 consisting of two locomotives, NS 6654 and NS 6560, and 47 cars struck the side of standing Alabama Gulf Coast (AGR) Train 211 North consisting of two locomotives, CEFX 3917 and IORY 5003, and 75 cars. The accident occurred on the AGR interlocking at Boligee, Alabama (AL), NS milepost (MP) 242.5 on the NS AGS South Subdivision of the Alabama Division. The collision resulted in the derailment of five freight cars in AGR Train 211 North. No freight cars or locomotives on NS Train 198A701 were derailed.
