***Federal Railroad Administration
Office of Safety
Headquarters Assigned
Accident Investigation Report
HQ-2007-57***

***CSX Transportation
Painesville, OH
October 10, 2007***

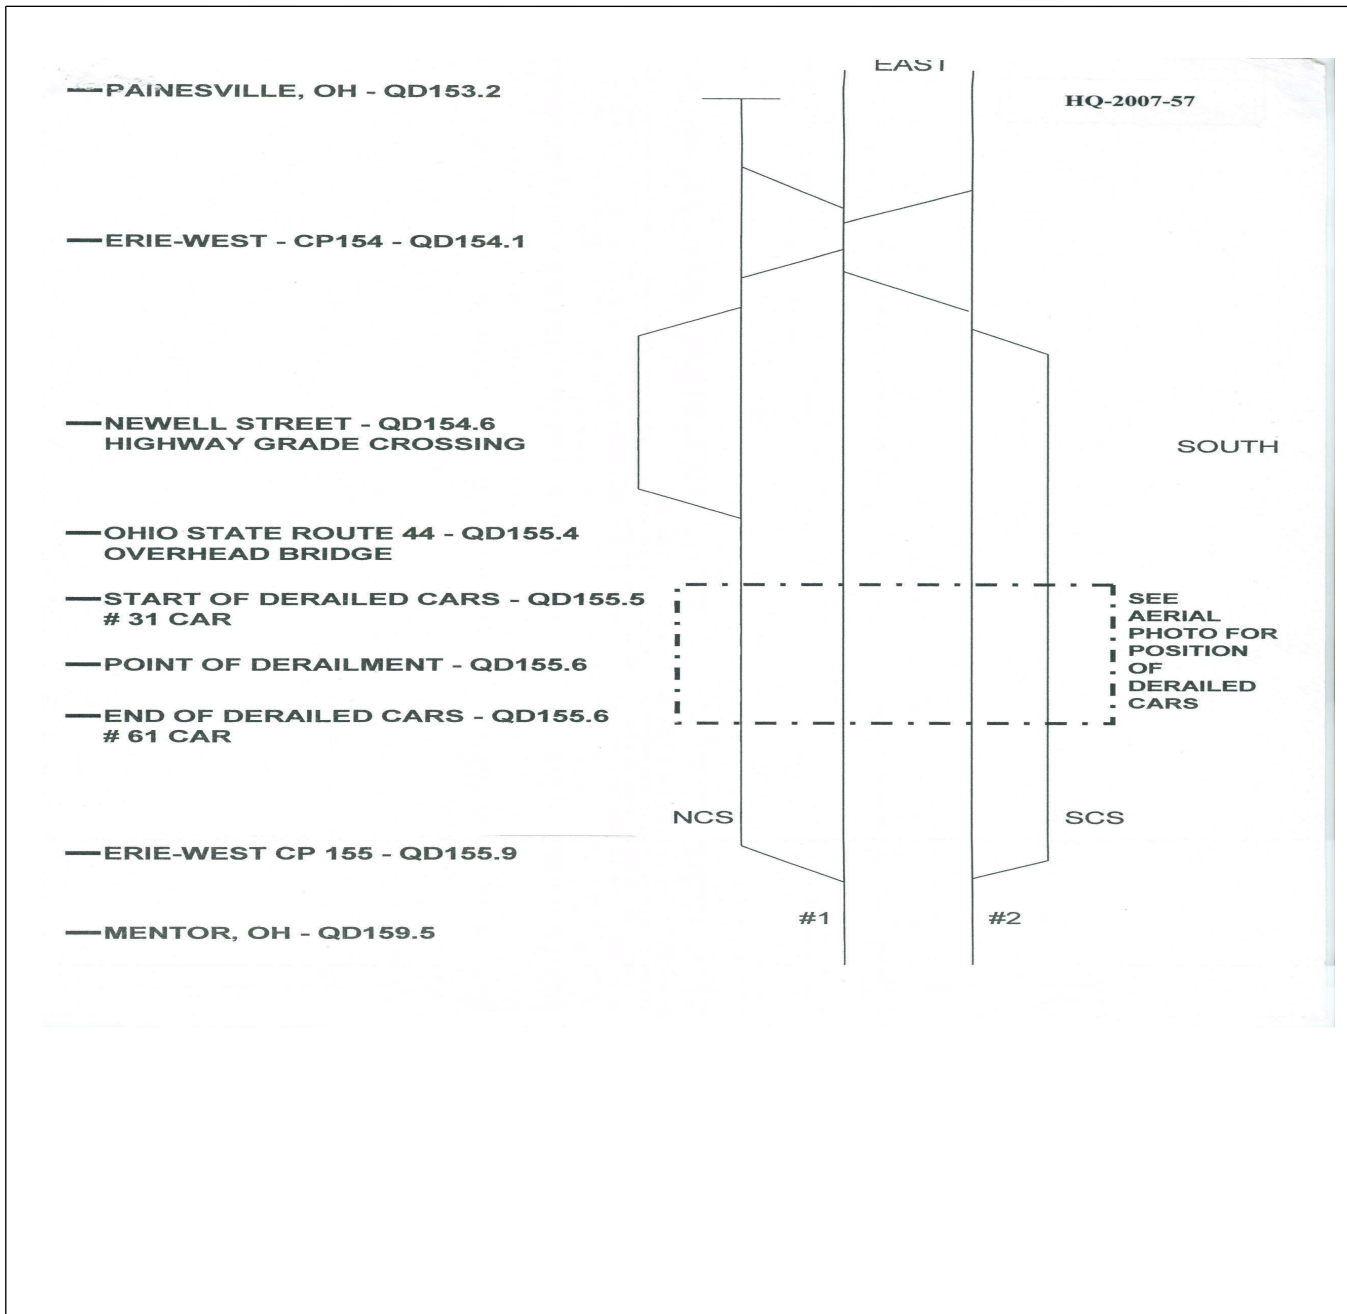
136. DRAW A SKETCH OF ACCIDENT AREA INCLUDING ALL TRACKS, SIGNALS, SWITCHES, STRUCTURES, OBJECTS, ETC., INVOLVED.

The probable cause of the derailment is a broken rail that occurred in a 20' 5" long "plug" rail installed in the continuous welded rail (CWR), following a rail defect detected on December 15, 2006, on the south rail of Number 1 Main Track. There was also evidence of multiple fractures and rail end batter at the west end joint of the plug rail.
