***Federal Railroad Administration  
Office of Safety  
Headquarters Assigned  
Accident Investigation Report  
HQ-2007-58***

***Burlington Northern Santa Fe (BNSF)  
Motley, Minnesota  
October 12, 2007***

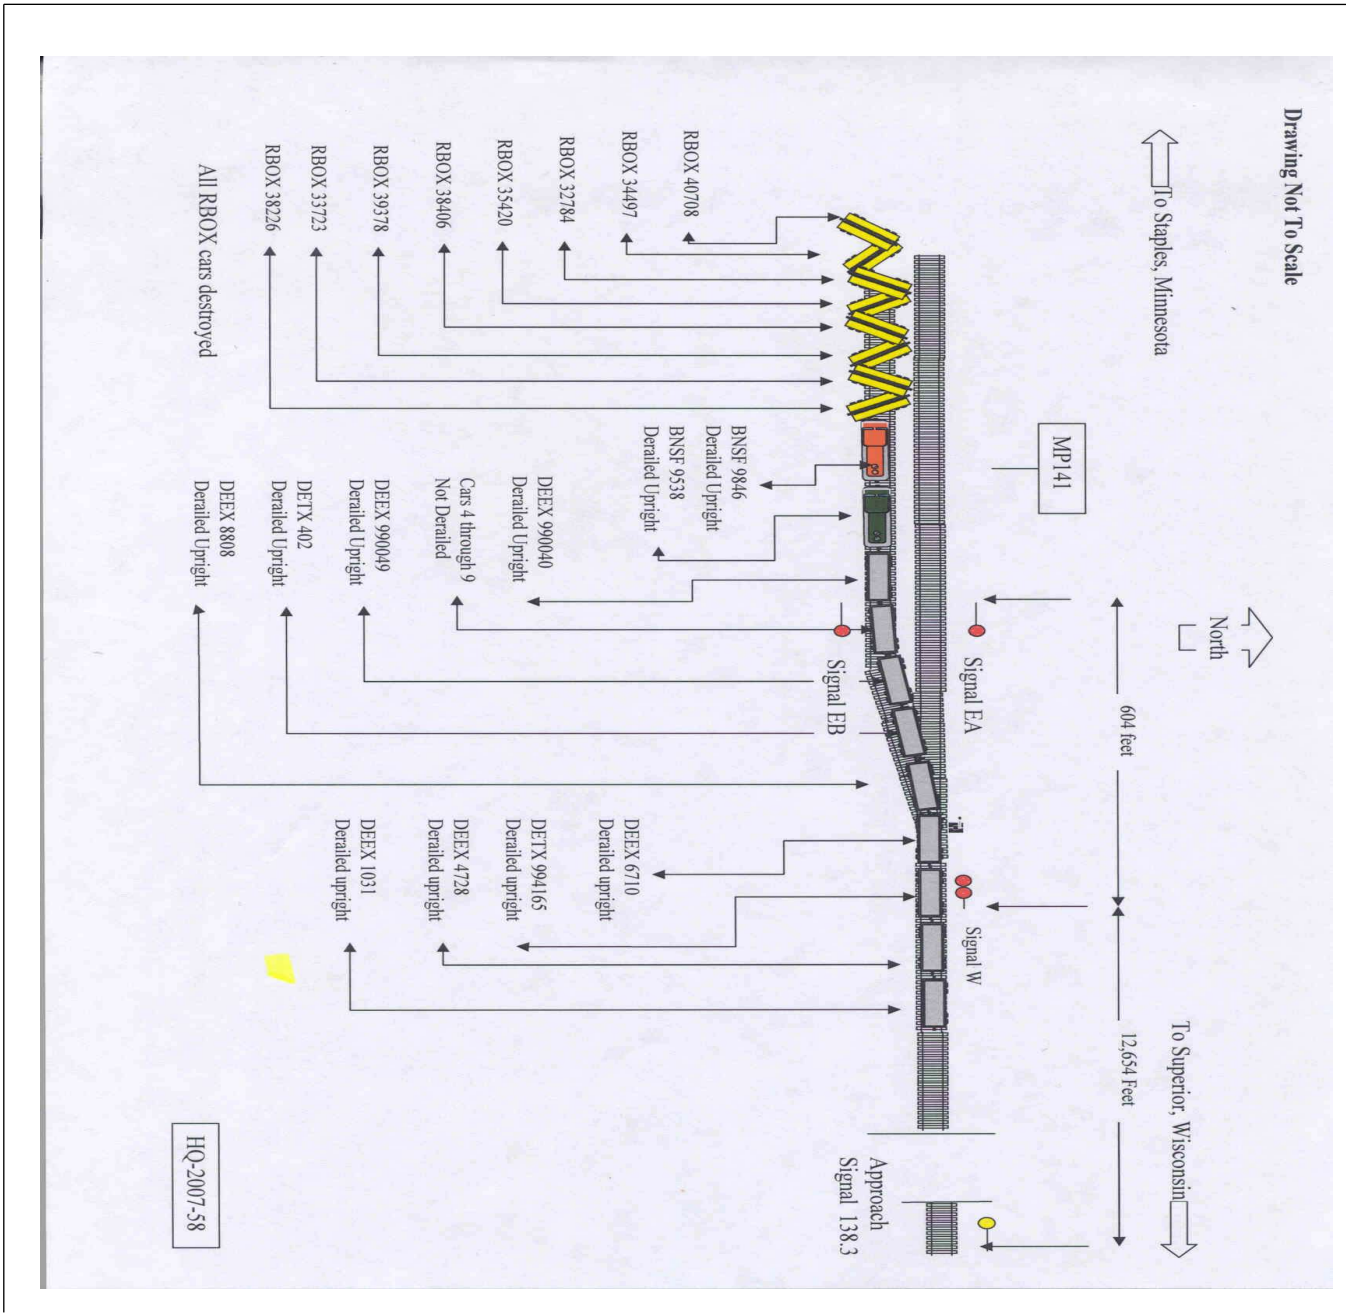
136. DRAW A SKETCH OF ACCIDENT AREA INCLUDING ALL TRACKS, SIGNALS, SWITCHES, STRUCTURES, OBJECTS, ETC., INVOLVED.

On October 12, 2007, at 2:45 a.m., CDT., westward Burlington Northern Santa Fe Railway Company (BNSF) empty unit coal train E-SUDBTM2-11 (E-SUDBTM2-11) operating west, collided with a standing cut of 103 empty cars stored on the siding track at East Motley, MN. The accident occurred in Motley, Minnesota, at BNSF Milepost (MP) 140.9 on the Brainerd Subdivision of the Twin Cities Division.

The conductor and locomotive engineer of E-SUDBTM2-11 suffered minor injuries. The two locomotives at the head end of the train both derailed but remained upright. Eight of the empty coal hopper cars derailed, with four destroyed and four damaged. The total damage to the westbound train was estimated at \$322,486. Eight of the stored empty boxcars were derailed and destroyed. Total damages for the stored empty boxcars were \$147,683. Neither the westbound train, nor the standing cut of cars, contained hazardous materials and there was no fire or evacuation.
