***Federal Railroad Administration
Office of Safety
Headquarters Assigned
Accident Investigation Report
HQ-2007-63***

***Burlington Northern Santa Fe (BNSF)
Imboden, Arkansas
October 20, 2007***

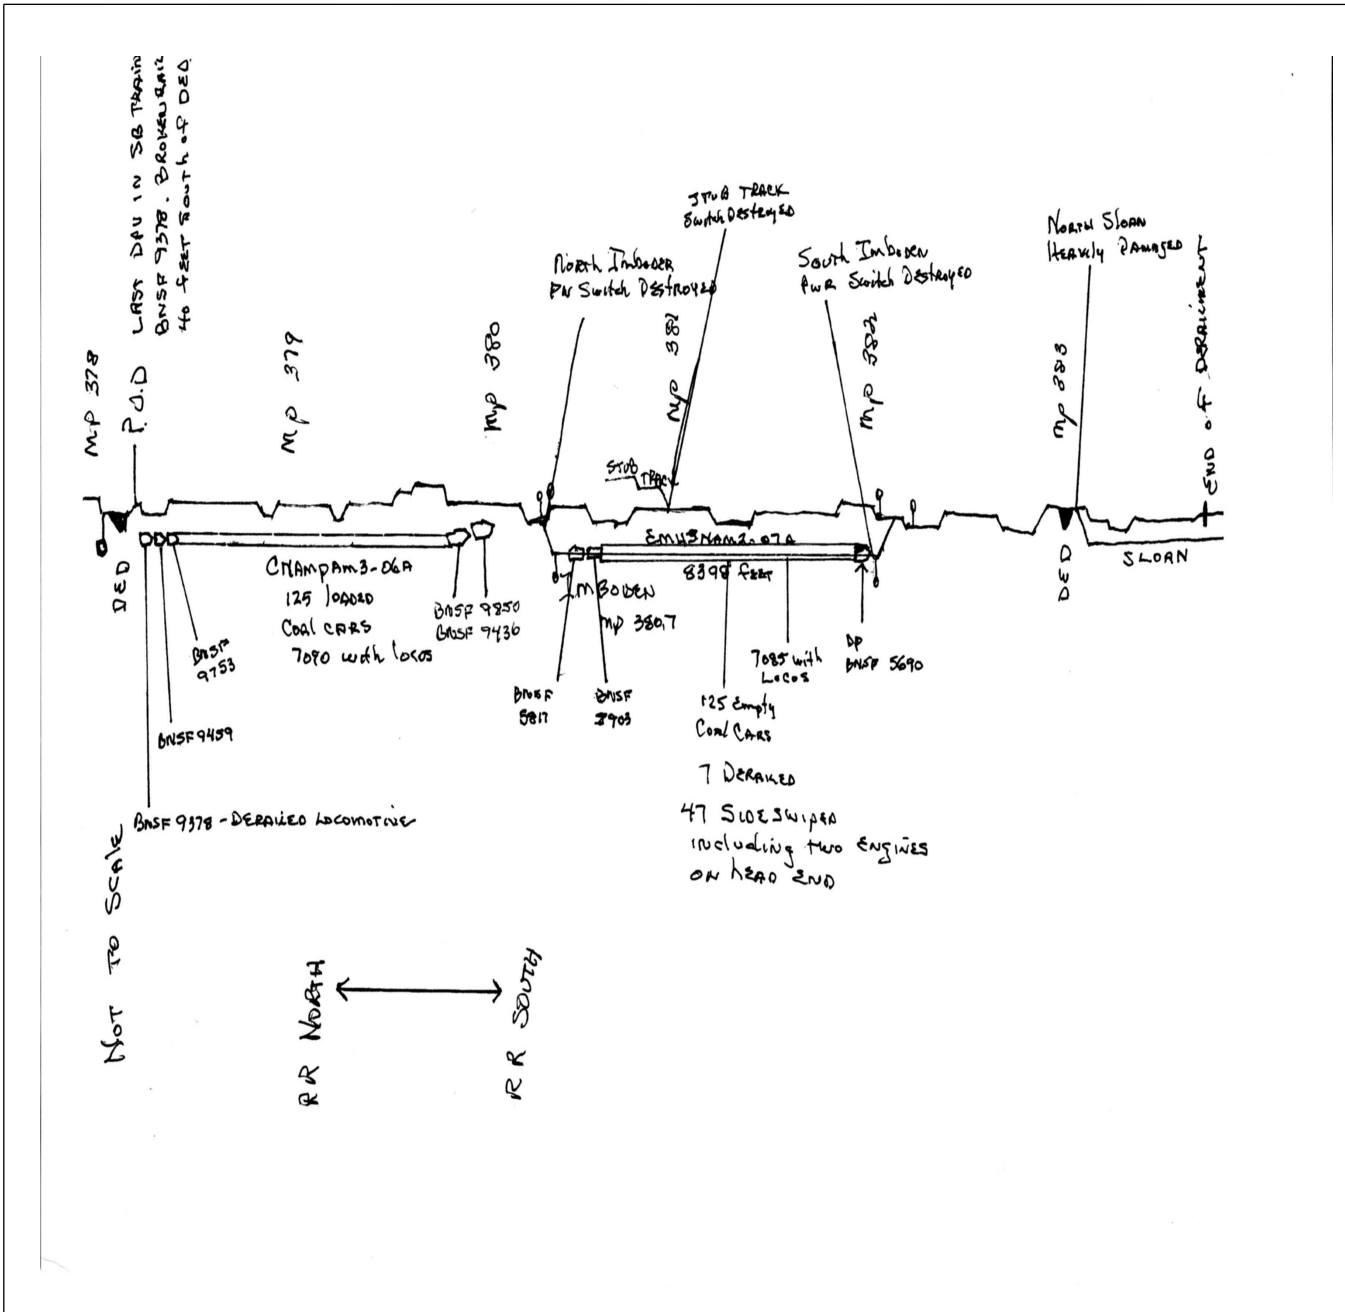
136. DRAW A SKETCH OF ACCIDENT AREA INCLUDING ALL TRACKS, SIGNALS, SWITCHES, STRUCTURES, OBJECTS, ETC., INVOLVED.

At approximately 8:05 a.m. CDT, October 20, 2007, on the BNSF's Springfield Division, Thayer South Subdivision, at Imboden, Arkansas in Lawrence County, Arkansas, southbound C-NAMPAM-3-06, derailed at Mile Post 378.1 account of a broken rail.

The rail was Tennessee USA, manufactured in 1981. The rail section was 132# standard carbon with a 40% detail fracture from head check. The derailment occurred 2.6 miles north of Imboden, Arkansas. This train consisted of 125 cars and 5 locomotives, with 3 of the locomotives being used as distributive power on the rear end of the train. The rear DP of C-NAMPAM-3-06, the BNSF 9378, derailed but stayed upright. The initial derailment occurred 40 feet south of the dragging equipment detector located at milepost 378.075. This has the derailed locomotive on the ground on concrete ties until the train was stopped by another detector, coming to a stop at Mile Post 383.5. This has the derailed locomotive traveling approximately 5.4 miles. It was dragged through the north siding switch at Imboden, Arkansas where it is believed all six axles may have derailed. The C-NAMPAM-3-06 sideswiped the front two locomotives of the E-MHSNAM-2-07, the BNSF 5817 and the BNSF 8903, which were stopped with no crew on board in the siding at Imboden, AR.

The measurements of the track centers at this location were 15 feet center to center. The southbound derailed locomotive struck the E-MHSNAM-2-07 again as it went into a right hand curve, sideswiping lines 1-11, including the engines, derailing lines 12 thru 18, and sideswiping lines 19 thru 47. The E-MHSNAM-2-07 consisted of 120 empty coal cars, was not crewed and was to travel northward. It consisted of 2 locomotives on the head end and one distributive power locomotive on the rear end. The C-NAMPAM-3-06 was stopped just south of the north Sloan Switch by another dragging equipment detector, located at milepost 383.4.
