***Federal Railroad Administration  
Office of Safety  
Headquarters Assigned  
Accident Investigation Report  
HQ-2007-65***

***Burlington Northern Santa Fe  
Clara City, MN  
October 29, 2007***

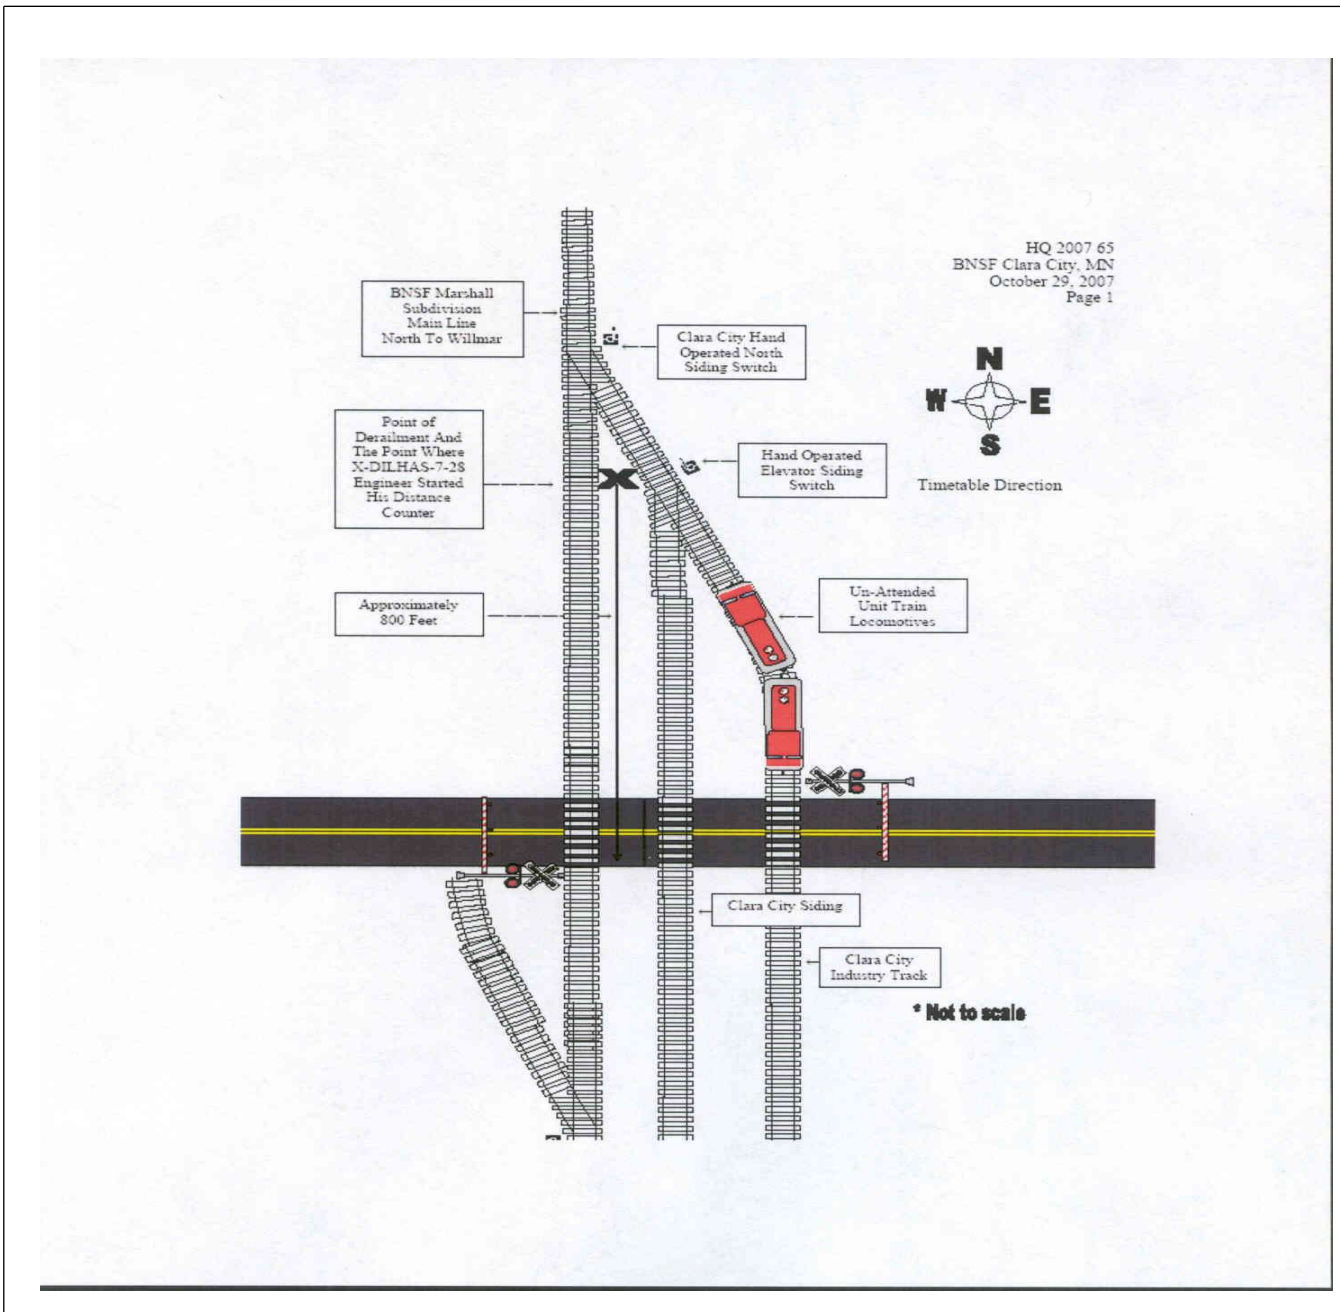
136. DRAW A SKETCH OF ACCIDENT AREA INCLUDING ALL TRACKS, SIGNALS, SWITCHES, STRUCTURES, OBJECTS, ETC., INVOLVED.

The accident was caused by the failure of the BNSF train crew of X-DILHAS7-28 to protect the rear of their train while making a shoving movement on the siding, resulting in the rear car passing through the improperly aligned Main Track switch and onto the Main Track without proper authority. Subsequently the forward movement caused the rear car to derail, along with four other cars, and foul the Main Track where they were struck by northward BNSF H-KCKNTW1-27.
