*Federal Railroad Administration
Office of Safety
Headquarters Assigned
Accident Investigation Report
HQ-2007-75*

*Amtrak/Norfolk Southern
Chicago, IL
November 30, 2007*

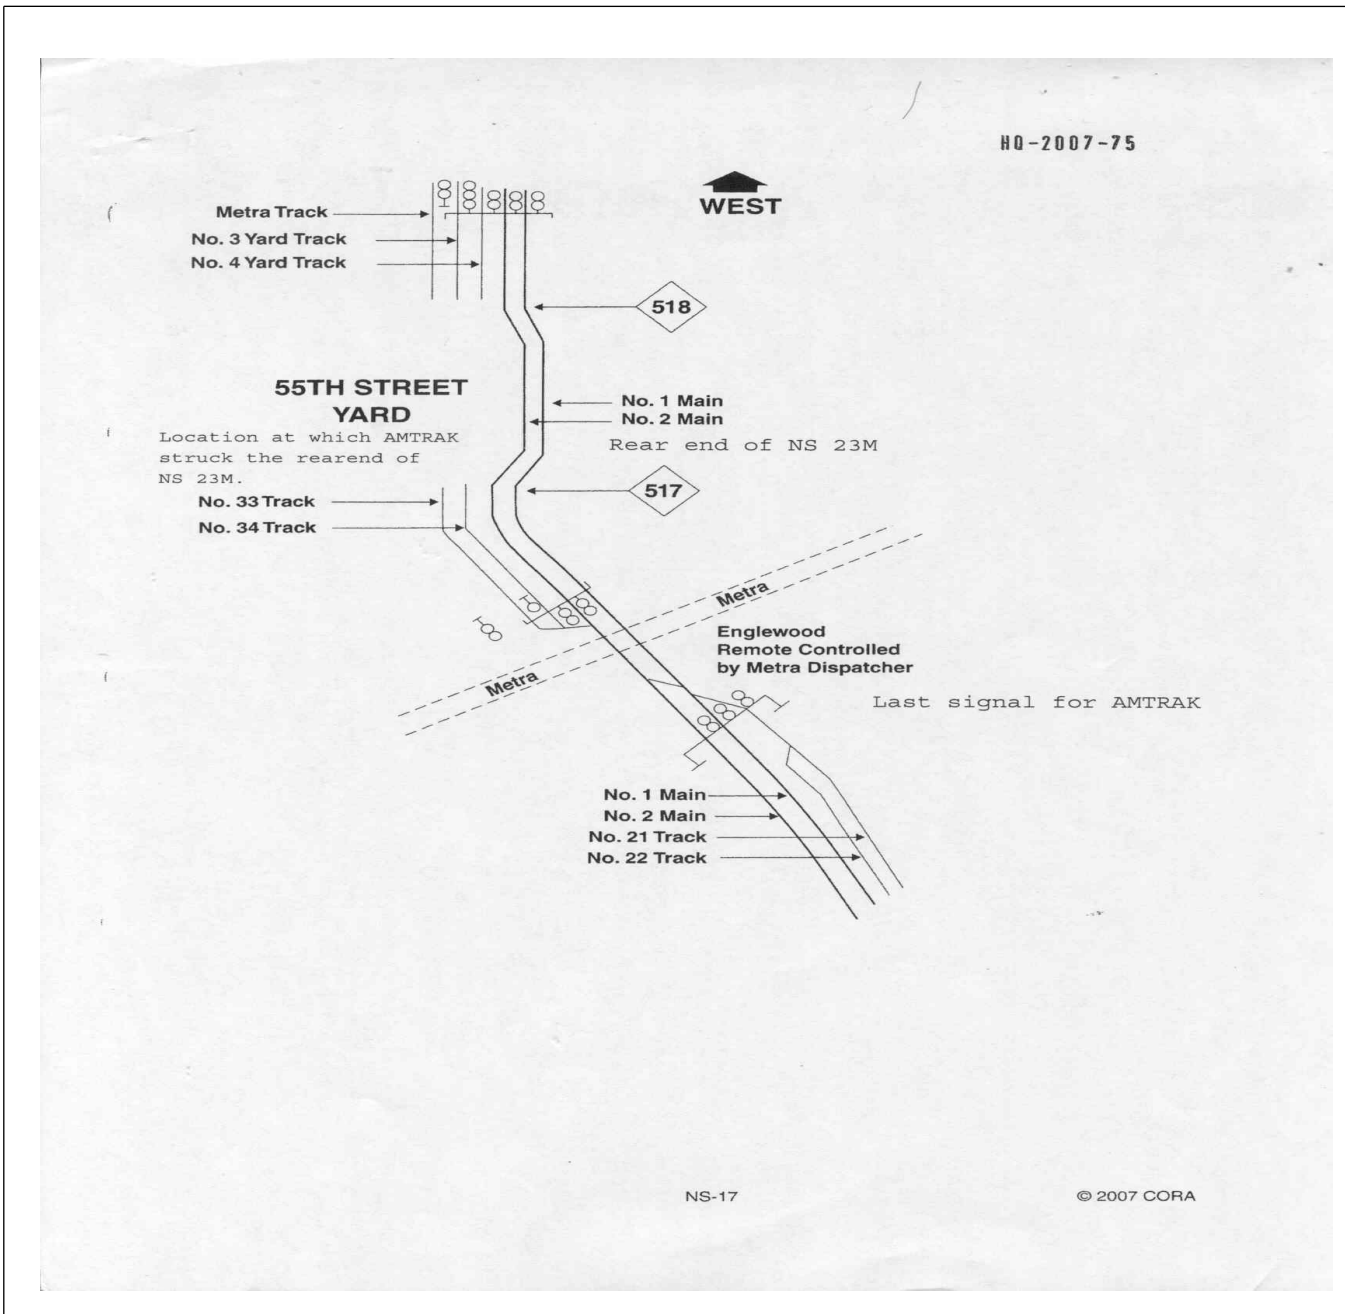
136. DRAW A SKETCH OF ACCIDENT AREA INCLUDING ALL TRACKS, SIGNALS, SWITCHES, STRUCTURES, OBJECTS, ETC., INVOLVED.

On November 30, 2007, at 11:23 a.m. CST, westbound Amtrak (ATK) Passenger Train 371 struck the rear of standing Norfolk Southern Corporation (NS) Intermodal Train 23MB.

The accident occurred on NS Main Track No. 2, Dearborn Division, Chicago District, at milepost 517.32, approximately five miles from Union Station in Chicago, Illinois. There were 187 passengers and six crew members, including one Amtrak lead service attendant onboard ATK 371. The Chicago Fire Department (CFD) responded to the accident.
