***Federal Railroad Administration
Office of Safety
Headquarters Assigned
Accident Investigation Report
HQ-2007-76***

***CSX Transportation (CSX)
Brookwood, Alabama
December 6, 2007***

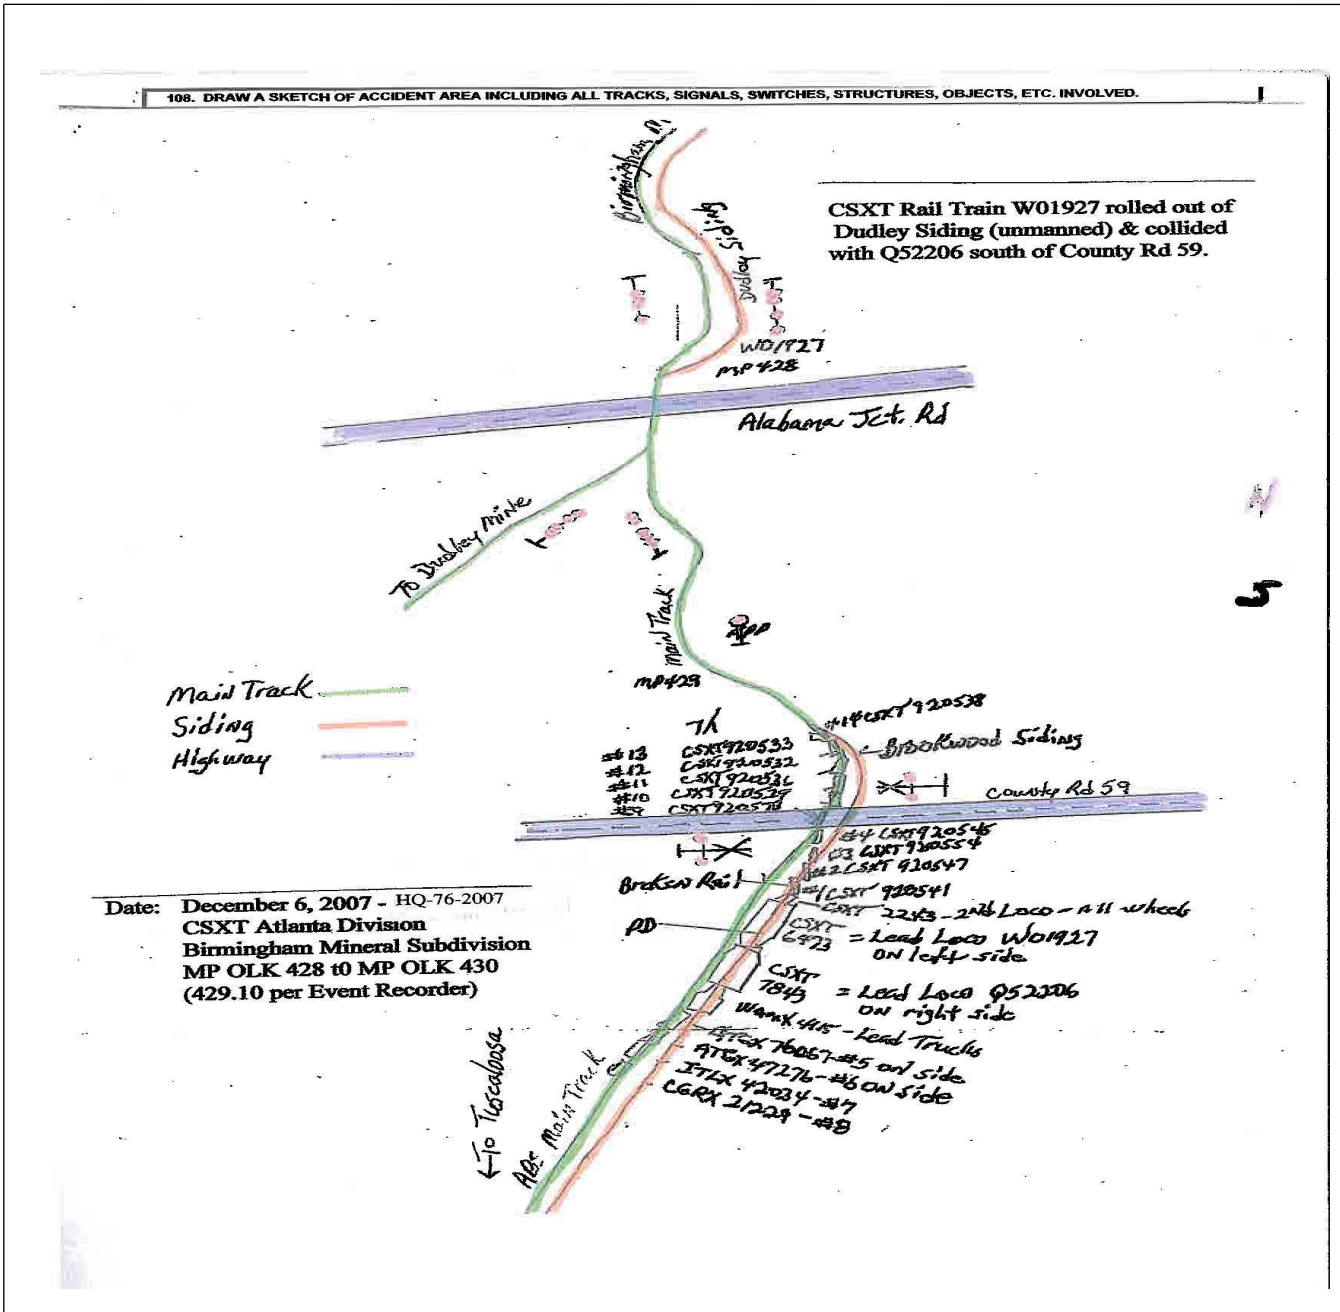
136. DRAW A SKETCH OF ACCIDENT AREA INCLUDING ALL TRACKS, SIGNALS, SWITCHES, STRUCTURES, OBJECTS, ETC., INVOLVED.

Dudley Siding has a 1.21-percent descending grade and beginning at the south switch, MP OLK 428, in the direction of travel southward, the grade descends at 1.33 percent to the point of impact, MP OLK 430.0. In that track segment there are three consecutive left hand curves, then a right hand curve, and then two more left hand curves. These six curves are separated by short segments of tangent track. The impact occurred on tangent track at the south end of the last left hand curve.

The collision occurred at MP OLK 430.0 about five car lengths south of Country Road 59. After running to safety, the train crew used their cell phones to call and explain the situation to the train dispatcher. Emergency response teams were immediately dispatched to the scene. The Brookwood Fire Department was the first to arrive. Brookwood Fire Department received a call about 1:15 a.m. on December 6th, 2007 and arrived on the scene at 1:20 a.m. Minutes later the Tuscaloosa County Rescue Squad arrived and provided comfort to the CSX train crew members. Both employees declined medical attention at the time of the accident.
