*Federal Railroad Administration
Office of Safety
Headquarters Assigned
Accident Investigation Report
HQ-2007-77*

*Union Pacific
Spring, TX
December 6, 2007*

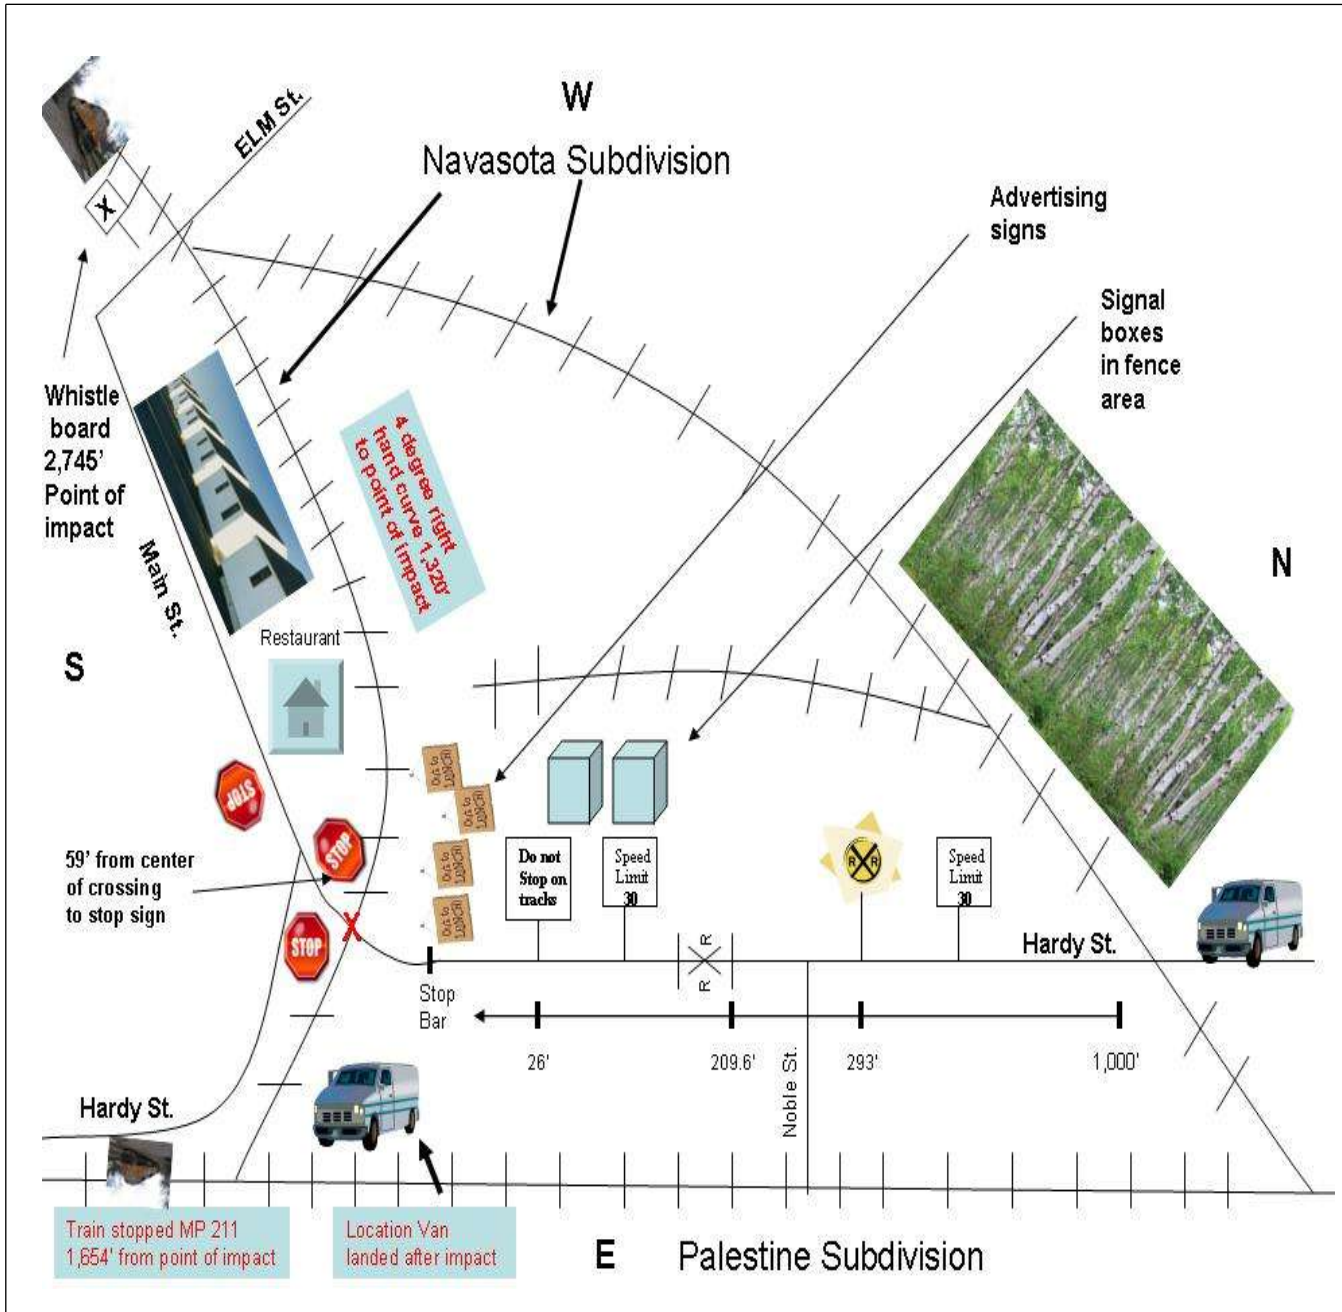
136. DRAW A SKETCH OF ACCIDENT AREA INCLUDING ALL TRACKS, SIGNALS, SWITCHES, STRUCTURES, OBJECTS, ETC., INVOLVED.

Southward Union Pacific Railroad (UP) Freight Train MSAHO-05 struck an SUV van traveling westbound on Hardy Street at a highway-rail grade crossing, DOT 430 064 X on December 6, 2007, at 5:20 p.m. The accident occurred in Spring, Texas at UP Milepost (MP) 0.10, on the UP Navasota Subdivision.

The train struck the passenger side of the van about center of passenger door. The van was projected about 200 feet between the east side of the Navasota Main Line and the west side of the Palestine Main Track clear of the right away on both subdivisions. The train came to a stop about 1,654 feet from point of impact on the Palestine Subdivision as indicated by the event recorder data and the report of interview of the train crew.
