***Federal Railroad Administration  
Office of Safety  
Headquarters Assigned  
Accident Investigation Report  
HQ-2007-80***

***Union Pacific/Regional Transportation District  
Littleton, CO  
December 11, 2007***

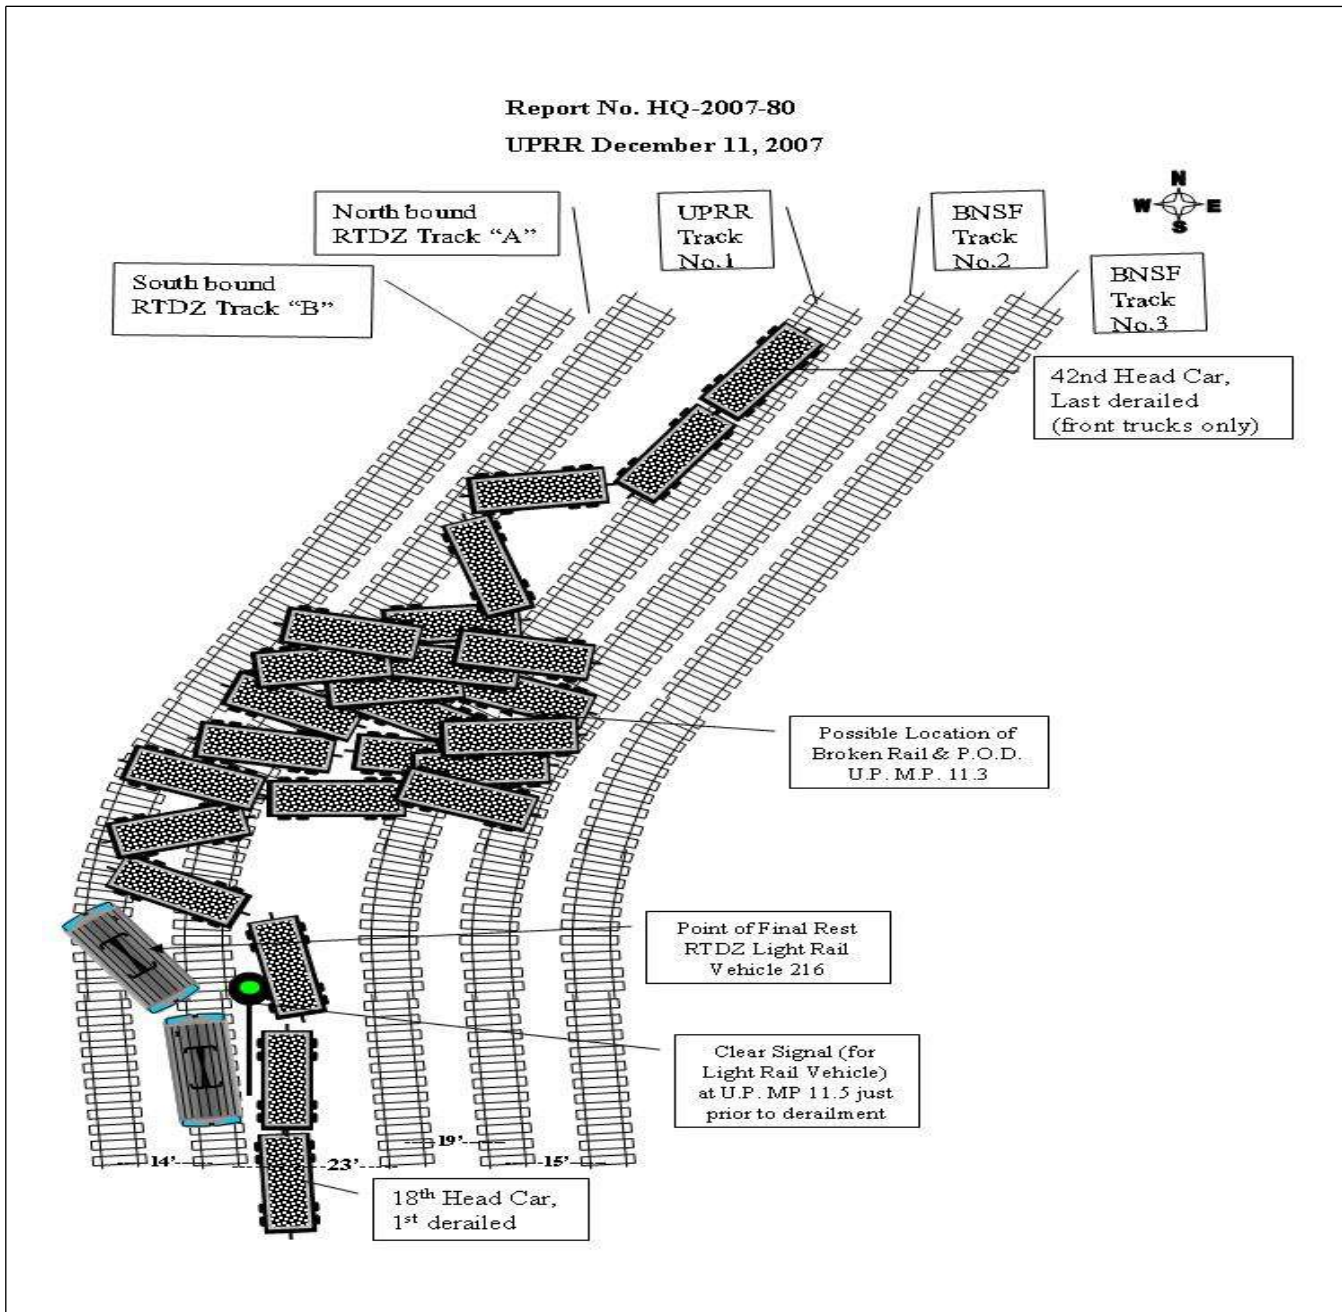
136. DRAW A SKETCH OF ACCIDENT AREA INCLUDING ALL TRACKS, SIGNALS, SWITCHES, STRUCTURES, OBJECTS, ETC., INVOLVED.

Southbound Union Pacific Railroad Company (UP) loaded coal train, Symbol CAIKM-08, derailed on the UP Colorado Springs Subdivision about 1 mile south of Littleton, Colorado, in Arapahoe County. The accident occurred on the UP Main Track No.1 at milepost (MP) 11.3, on December 11, 2007, at 7 a.m., MST. The UP train was being operated under Centralized Traffic Control (CTC), at a recorded speed of 39 mph at the time which was recorded by the event recorder of controlling Locomotive No. UP 7330. The maximum authorized operating speed for a loaded coal train on the UP Main Track No. 1 is 45 mph, as designated by the current Burlington Northern Santa Fe Railway Company (BNSF) Timetable. The 18th through 42nd head cars derailed fouling BNSF Main Tracks No.2 and No.3, and Denver Regional Transportation District (RTDZ) Main Tracks A and B.

RTDZ Light Rail Vehicle (LRV) Symbol RTDZ32-1 with two occupied units, was traveling northward on their Main Track A. The operator noticed the UP coal train begin to derail in front of the LRV, spilling coal on the RTDZ tracks. The RTDZ LRV hit the spilled coal and derailed cars and as a result derailed both LRV units.
