*Federal Railroad Administration
Office of Safety
Headquarters Assigned
Accident Investigation Report
HQ-2007-82*

*Burlington Northern Santa Fe
Mulvane, KS
December 17, 2007*

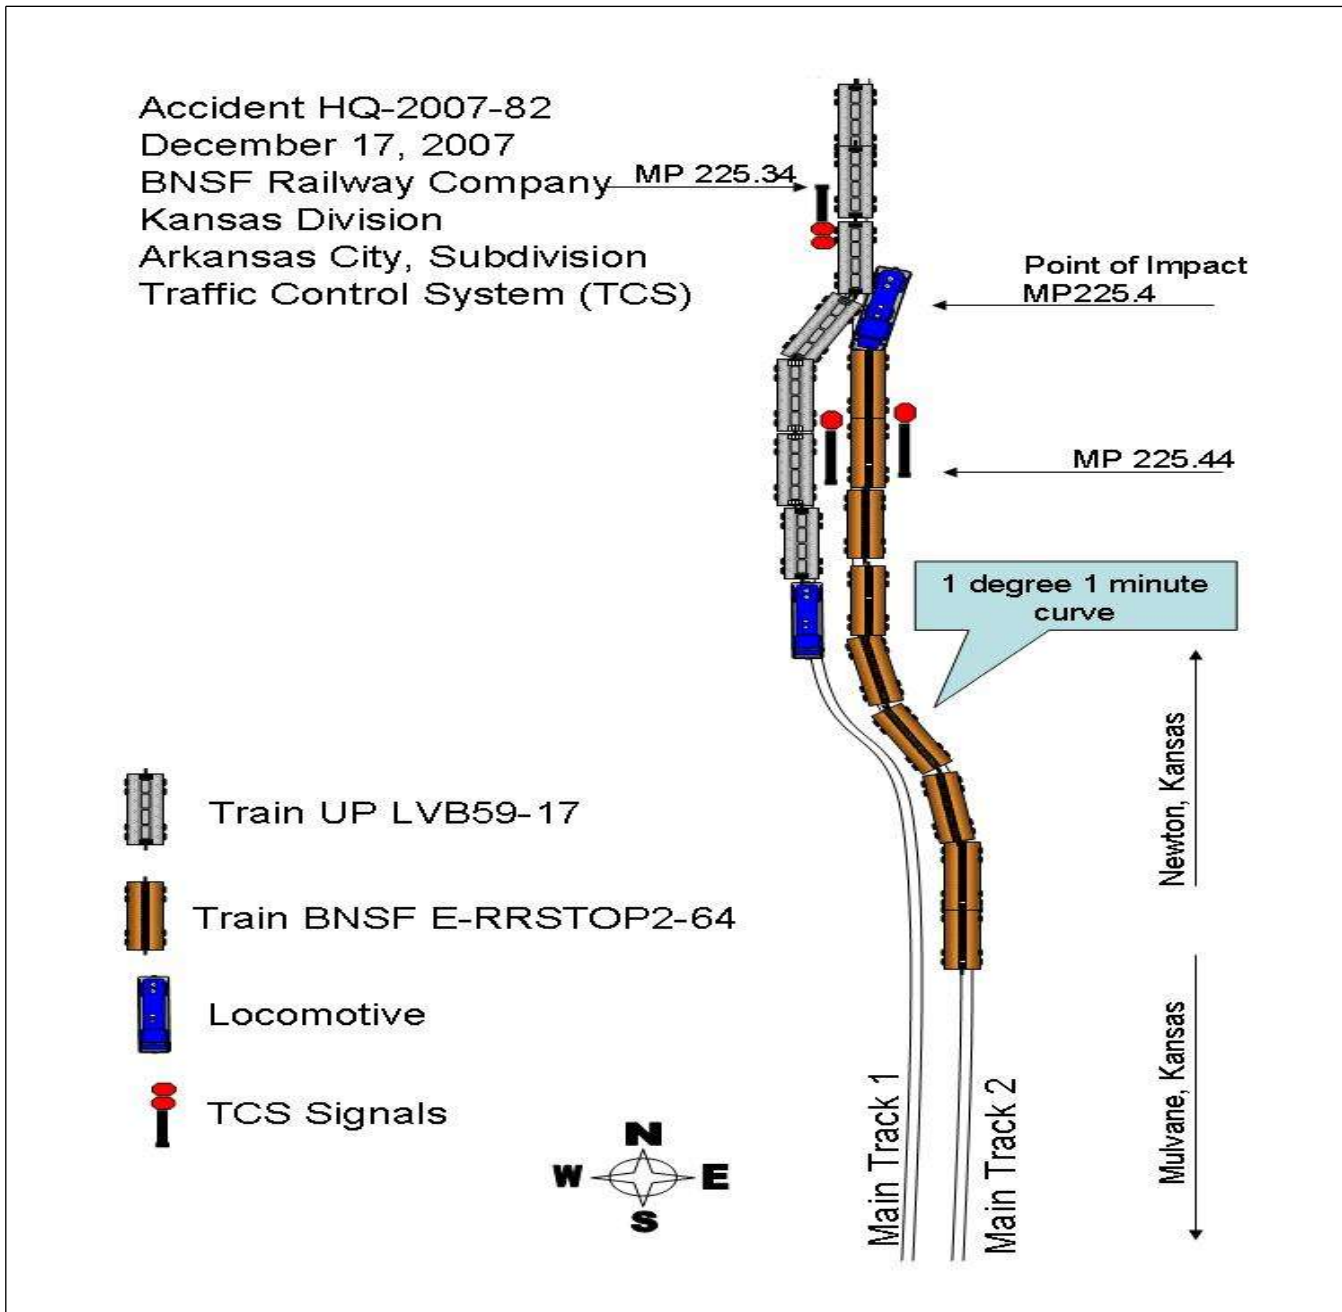
136. DRAW A SKETCH OF ACCIDENT AREA INCLUDING ALL TRACKS, SIGNALS, SWITCHES, STRUCTURES, OBJECTS, ETC., INVOLVED.

At 9:55 a.m. CST, December 17, 2007, Burlington Northern Santa Fe Railway Company (BNSF) eastbound (geographic direction north) empty coal Train Symbol E-RRSTOP2-64 (Train No. 1) collided with Union Pacific Railroad Company (UP) westbound (geographic direction south) local Train Symbol LVB59-17 (Train No. 2). The side collision occurred at milepost 225.4 on the BNSF Arkansas City Subdivision of the Kansas Division, approximately 2 miles north of Mulvane, Kansas. BNSF Unit Coal Train E-RRSTOP2-64 struck the 47th car of UP Freight Train LVB59-17.
