*Federal Railroad Administration
Office of Safety
Headquarters Assigned
Accident Investigation Report
HQ-2007-85*

*Norfolk Southern
Centerville, PA
December 28, 2007*

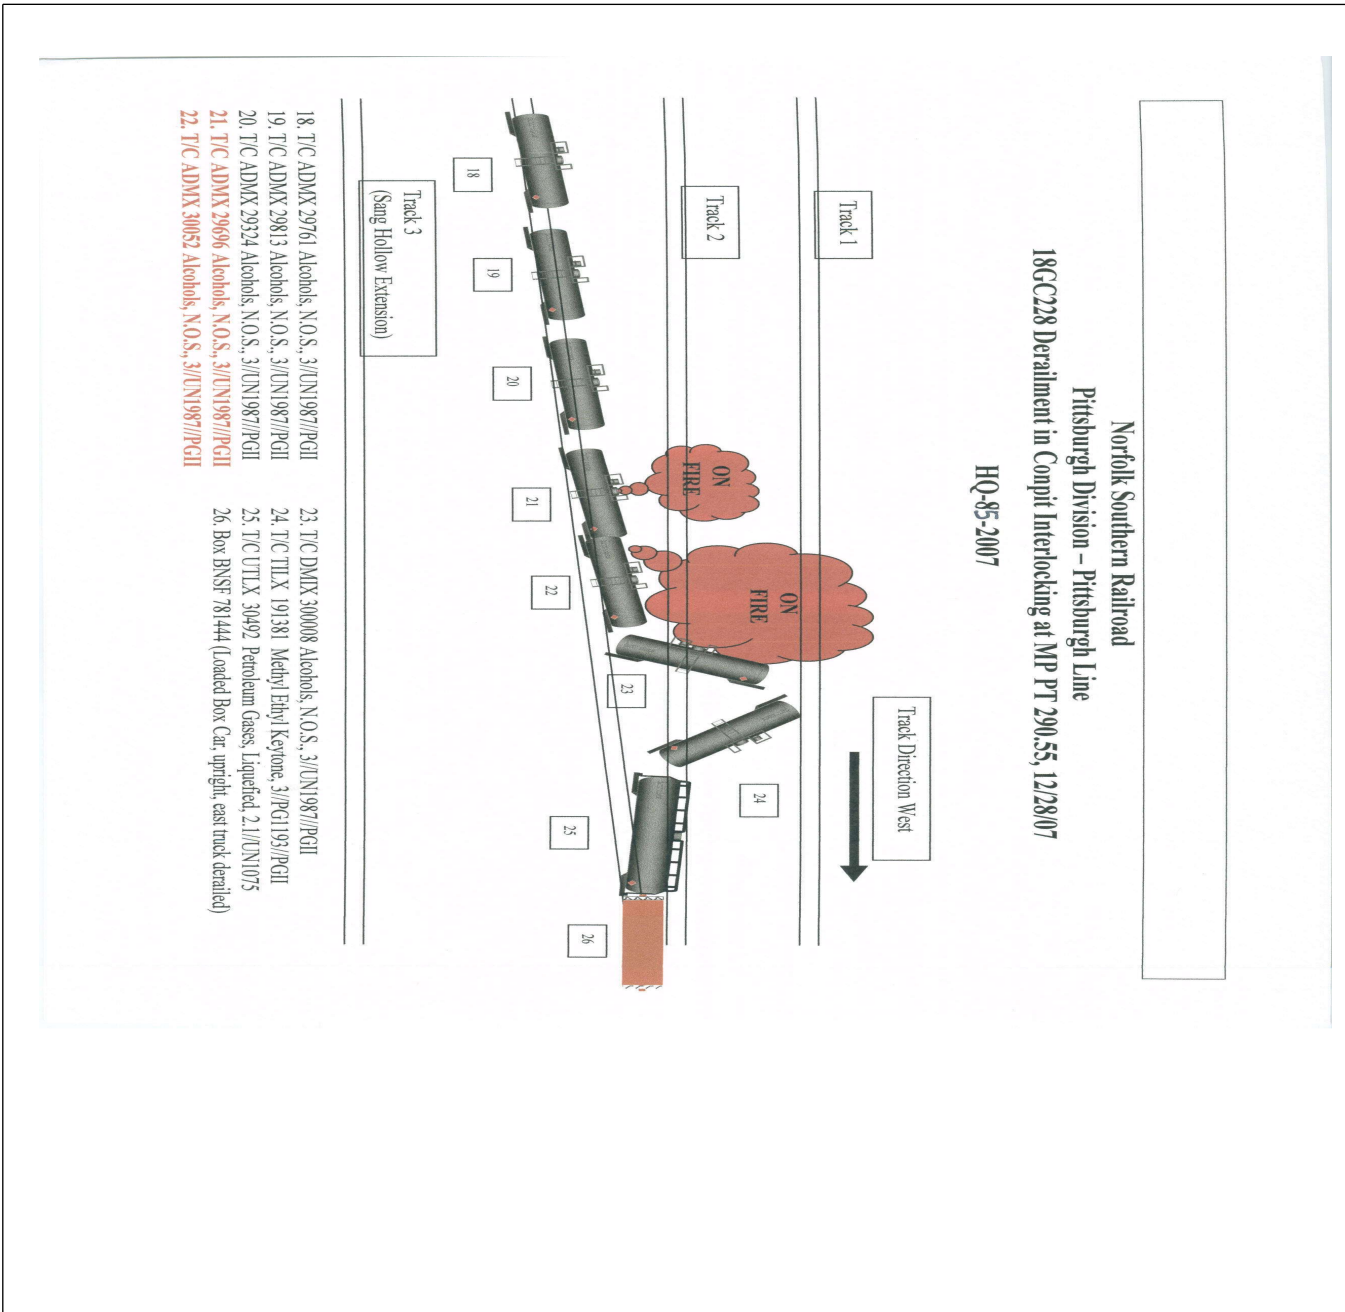
136. DRAW A SKETCH OF ACCIDENT AREA INCLUDING ALL TRACKS, SIGNALS, SWITCHES, STRUCTURES, OBJECTS, ETC., INVOLVED.

The point of derailment (POD) was determined to be at the point section of a number 15 left hand turnout located within the CP Conpiti interlocking. This particular switch is identified as switch 15 located on Main Track #2 and positioned to divert rail traffic from Main Track # 2 track to Main Track # 3 track in an east direction. This switch is Samson Electro-Pneumatic powered and is remotely controlled by a dispatcher.

An impact mark was present on the right-hand facing switch point. This mark would indicate the switch point was struck by a wheel flange, which had either got behind the point (picked) or climbed the point.

Inspection showed the right hand closed switch point was found to be gapping approximately 7/16 inch and failed the 3/8 inch obstruction test. The right hand switch point was worn and measured 5/16 inch below the top of the stock rail for approximately 14 inches. The number four switch clip on the left switch point, approximately 18 feet east of the point was found to be broken.

The probable cause of the accident is determined to be a gapping switch point, cause code T-319. Testing confirmed the improper fit between the right hand switch point and the right hand stock rail at number 15 switch, in the Conpit Interlocking.

As a result of these findings FRA personnel recommended the imposition of a Civil Penalty against Norfolk Southern Rwy. Co. for violation of 49 CFR §213.135.03 for improper fit between the right-hand switch point and the right hand stock rail of number 15 switch at Conpit Interlocking.
