***Federal Railroad Administration
Office of Safety
Headquarters Assigned
Accident Investigation Report
HQ-2006-03***

***CSX Transportation (CSX)
Bieber, California
January 17, 2006***

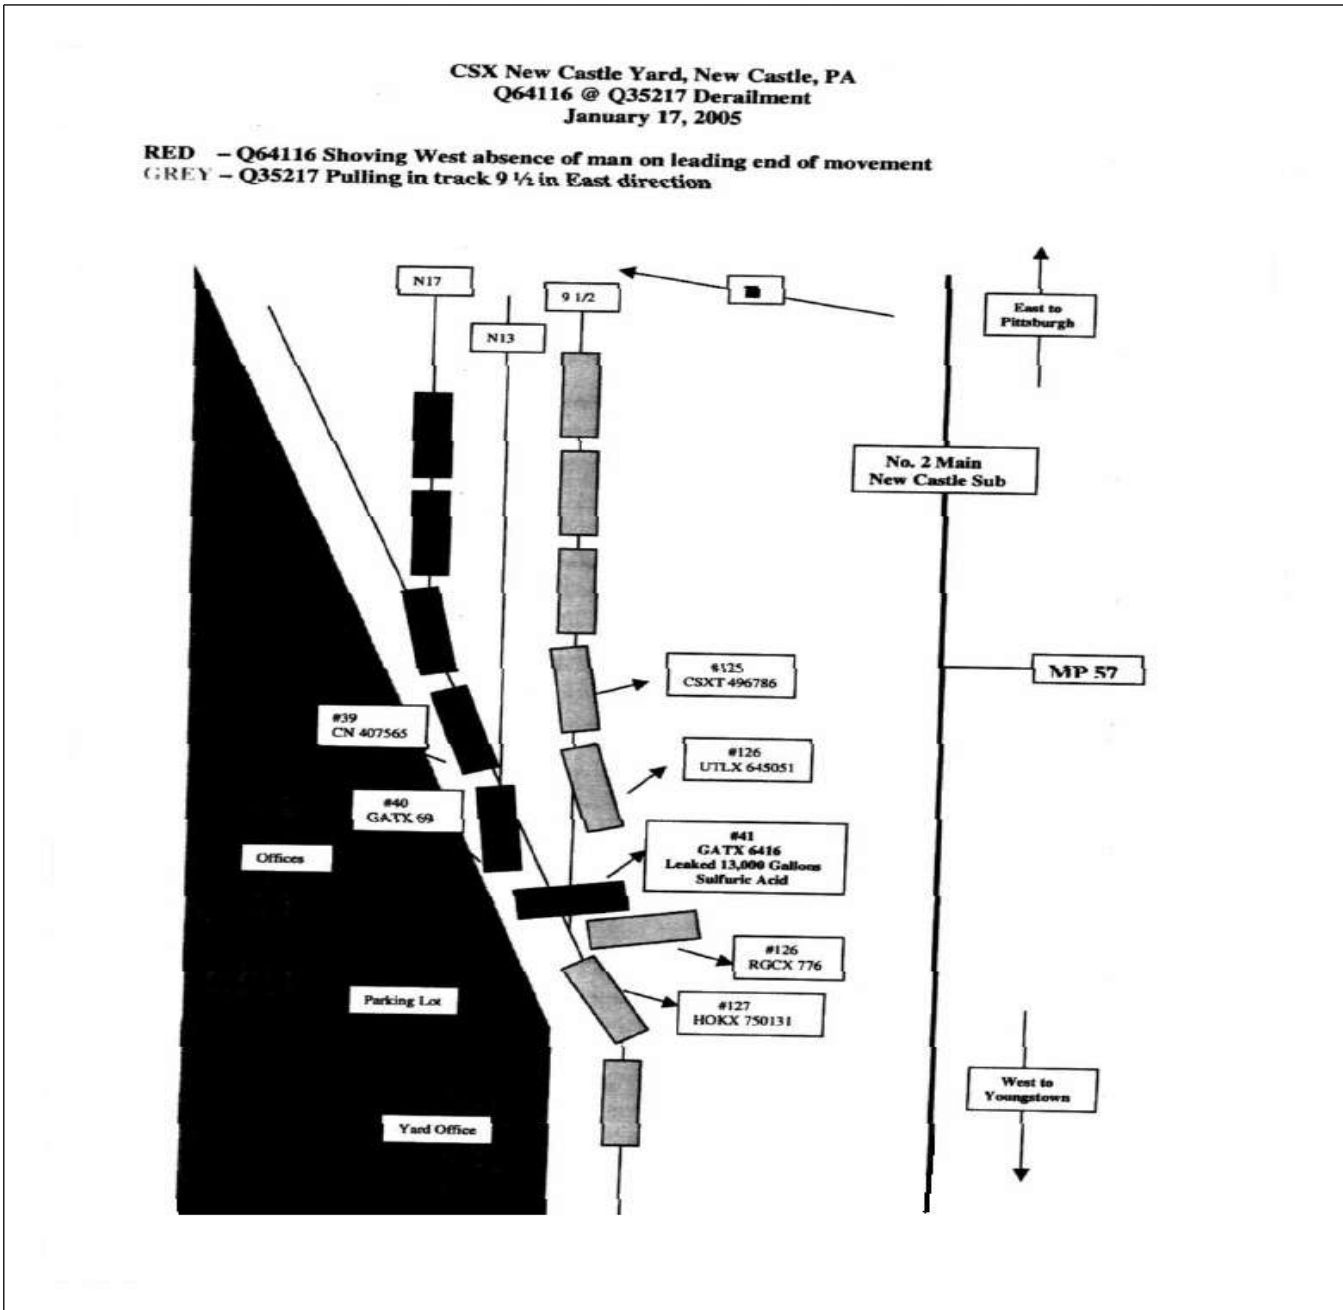
108. DRAW A SKETCH OF ACCIDENT AREA INCLUDING ALL TRACKS, SIGNALS, SWITCHES, STRUCTURES, OBJECTS, ETC., INVOLVED.
 HQ-2006-3.bmp

The point of impact was at the west end of New Castle Yard where 17 track extension and 9½ track meet (also called N17 Lead and N95) Approximately MP BG 57.2.

Train Q641 crew did not stop at the east end of 17 extension; the Q641 continued to shove the 41 cars west the entire length of 17 track, onto 17 extension west into track 9 1/2 striking the side of the 125th through 128th cars of the second train, Q352, which was moving east.
