***Federal Railroad Administration
Office of Safety
Headquarters Assigned
Accident Investigation Report
HQ-2006-04***

***Norfolk Southern (NS)
Lincoln, Alabama
January 18, 2006***

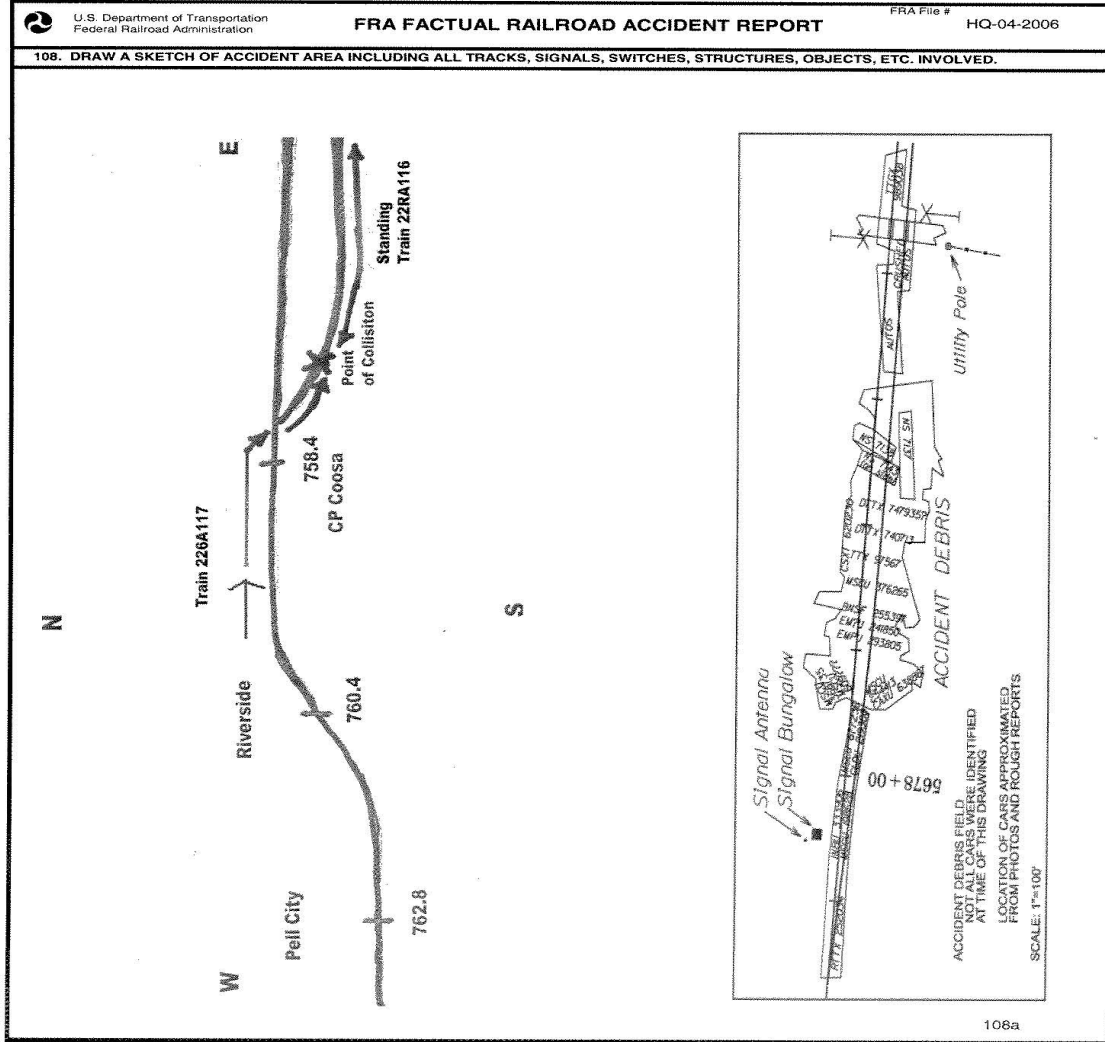
HQ-04-
2006
sketch.jpg

108. DRAW A SKETCH OF ACCIDENT AREA INCLUDING ALL TRACKS, SIGNALS, SWITCHES, STRUCTURES, OBJECTS, ETC., INVOLVED.
