***Federal Railroad Administration
Office of Safety
Headquarters Assigned
Accident Investigation Report
HQ-2006-08***

***Amtrak (ATK)
Sprague, Washington
January 28, 2006***

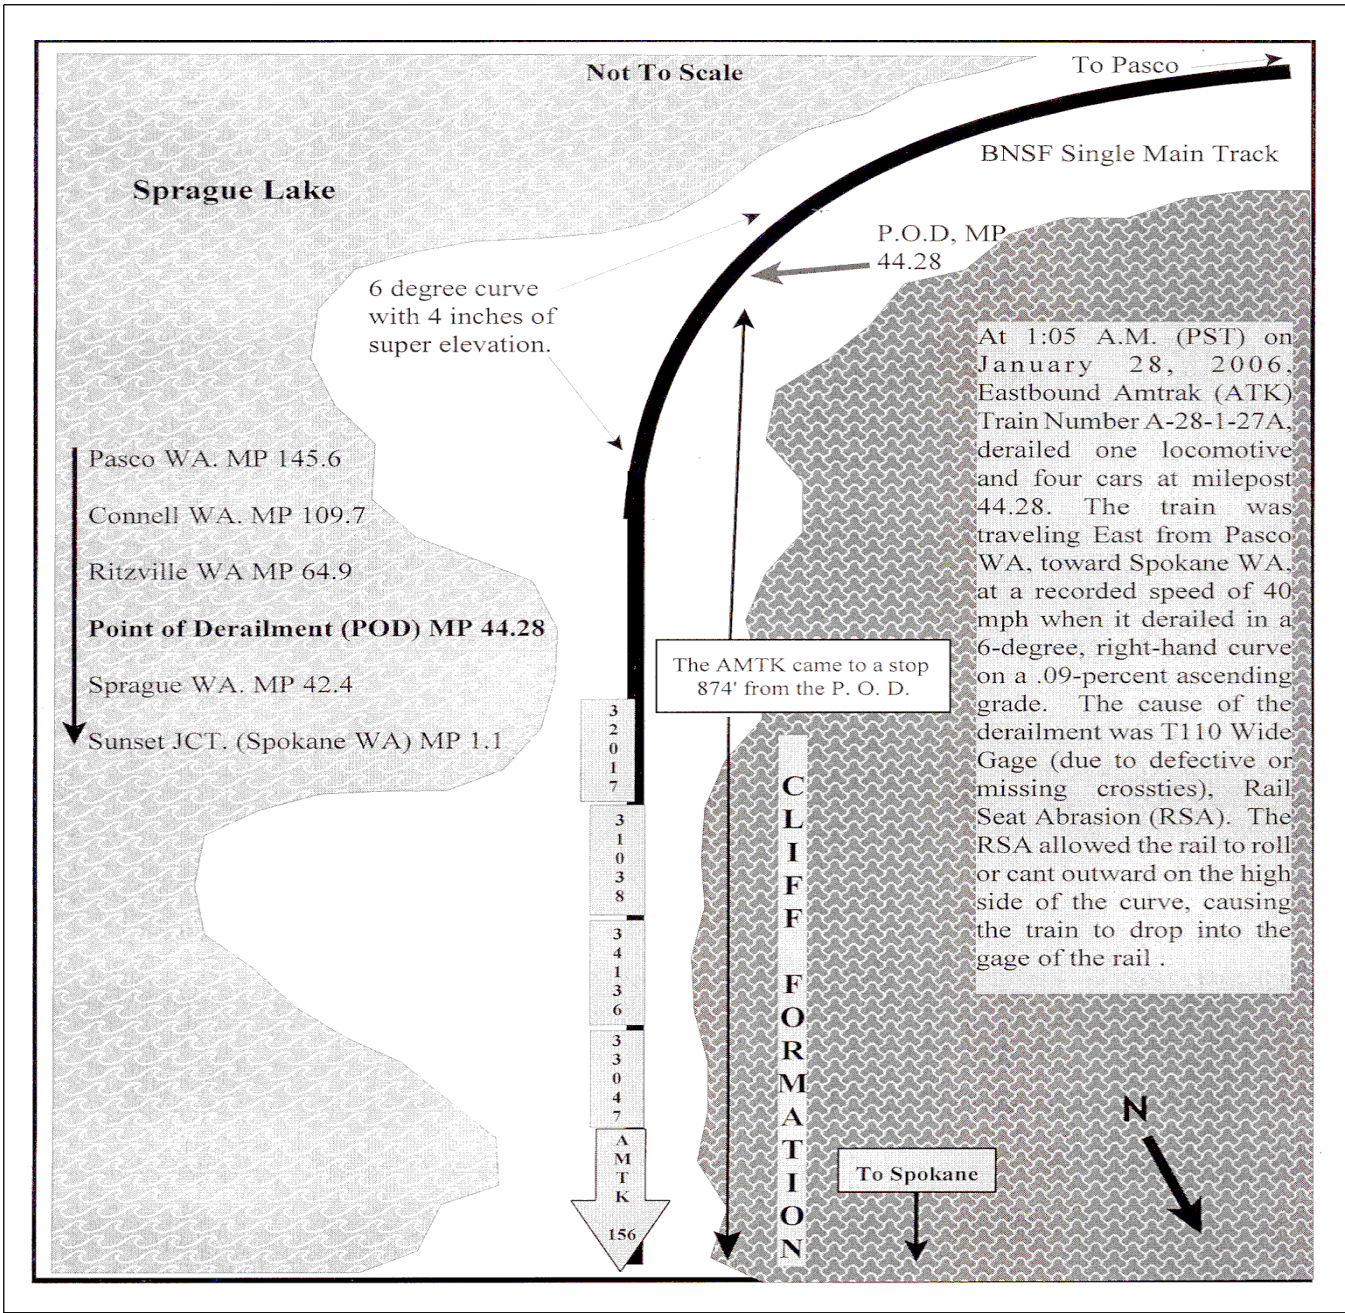
HQ-08-
 2006
 Sketch.
 bmp

Evidence found during the accident investigation indicates the rail on the high side of the curve canted outward under the train, due to rail seat abrasion on concrete crossties, creating wide gage.

Evidence found during the accident investigation indicates the rail on the high side of the curve canted outward under the train, causing the gage to be out of compliance with the FRA maximum allowable gage of 57-3/4 inches for FRA Class 3 Track. The rail on the high side of the curve showed 1/2 inch of gage side wear. The concrete ties at the (POD) showed as much as 1-inch of rail seat abrasion on the field side of the rail, allowing the rail to cant outward when loaded.

Field observations of the undamaged portion of the curve prior to the POD showed a static gage measurement of 57-1/2 inches in several places. This measurement, combined with the one inch rail seat abrasion would have caused the gage to be at least 58-1/2 inches at the POD. Investigators all agreed that the probable cause of the derailment was wide gage caused by rail seat abrasion on concrete crossties.
