Federal Railroad Administration Office of Safety Headquarters Assigned Accident Investigation Report HQ-2006-09

> Union Pacific (UP) Timpson, Texas January 31, 2006

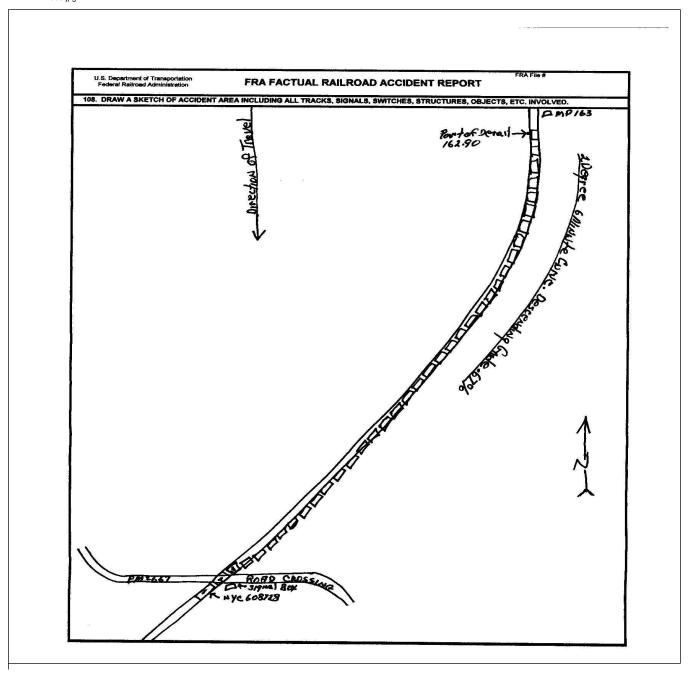
108. DRAW A SKETCH OF ACCIDENT AREA INCLUDING ALL TRACKS, SIGNALS, SWITCHES, STRUCTURES, OBJECTS, ETC., INVOLVED. HQ-09-2006.jpg

A Southbound Union Pacific Freight Train traveling at a recorded speed of 28 mph, derailed 37 cars, all remaining upright, on January 31, 2006, at 11:45 am. The accident occurred 2.1 miles South of Timpson, TX at UP milepost 162.9 on the UP's Southern Region, Livonia Service Unit, Lufkin Subdivision. The train had been operating on a 25 mph speed restriction for the previous 4 miles. The reason for the speed restriction was defective tie conditions.
