***Federal Railroad Administration
Office of Safety
Headquarters Assigned
Accident Investigation Report
HQ-2006-17***

***Union Pacific (UP)
Longview, Texas
March 20, 2006***

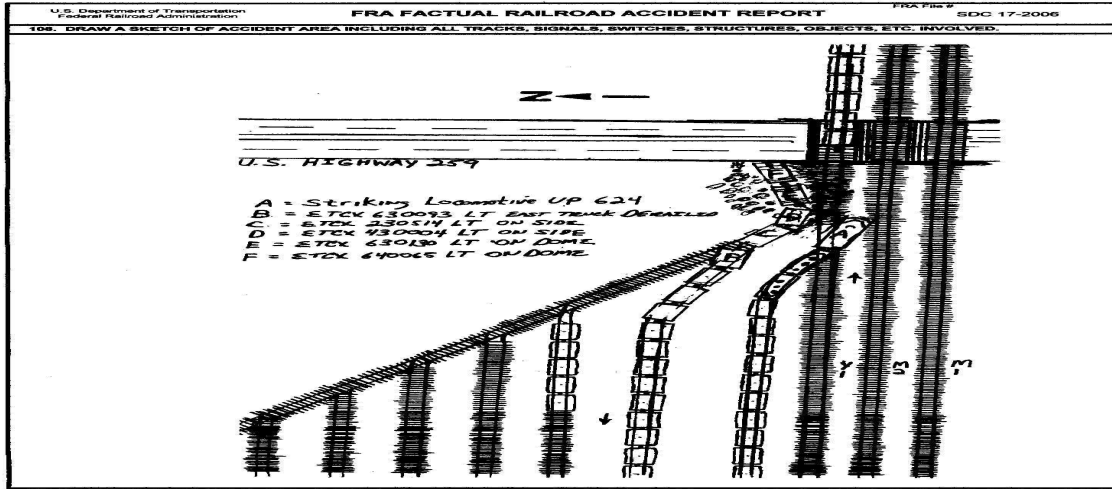
108. DRAW A SKETCH OF ACCIDENT AREA INCLUDING ALL TRACKS, SIGNALS, SWITCHES, STRUCTURES, OBJECTS, ETC., INVOLVED.
HQ-17-
2006.jpg

At 10:39 p.m. (CST) on Monday, March 20, 2006, a side collision occurred between Union Pacific Remote Control Yard Switching Job YLT 25R-20 and Union Pacific Manual Yard Switching Job YLT 67-20.

The point of collision was about 192 feet beyond the departure end of zone one. This point is about 77 feet into Zone Two.
