***Federal Railroad Administration
Office of Safety
Headquarters Assigned
Accident Investigation Report
HQ-2006-21***

***Burlington Northern Santa Fe (BNSF)
Berea, Nebraska
April 8, 2006***

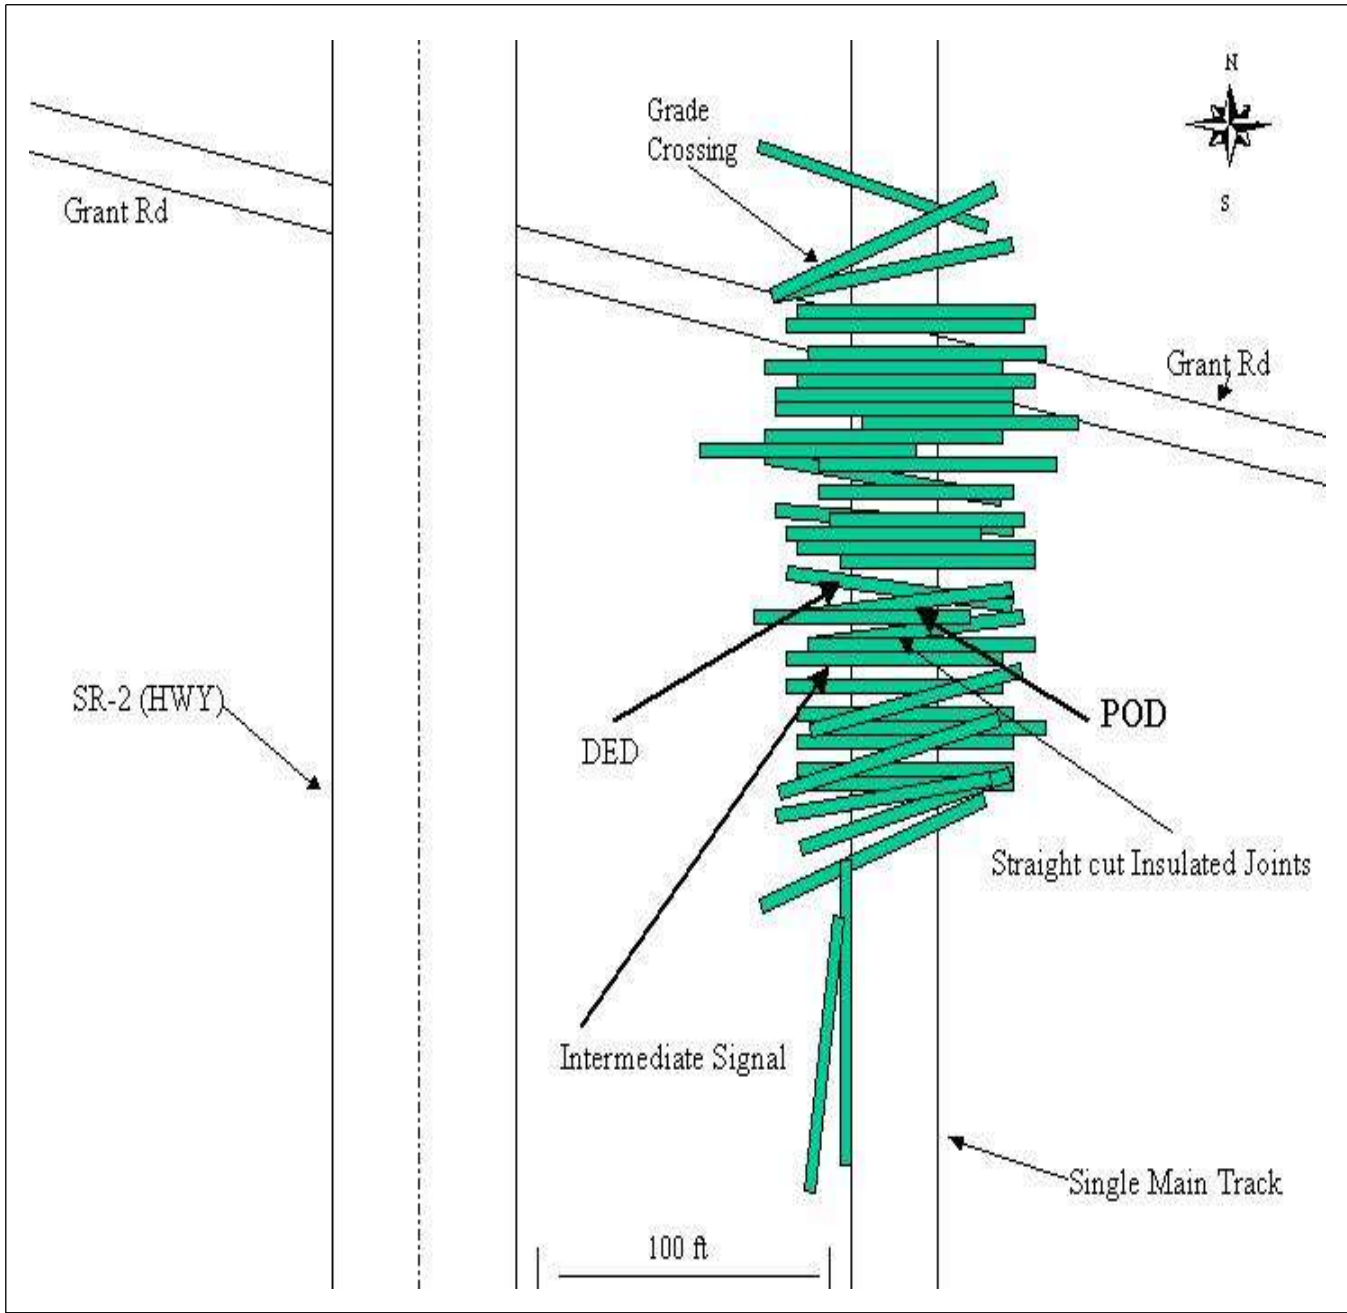
HQ-2006-
21
Sketch.
JPG

Upon inspection, the conductor reported to the engineer that he thought there were approximately 38 cars derailed accordion-style. The 34th head car from the locomotive consist was the first car derailed. Two cars lay adjacent to the track and the remaining 36 cars were piled up accordion-style in the area of the intermediate signal, dragging equipment detector, and public grade crossing.

Approximately 300 feet of concrete track panels and the grade crossing were destroyed on the single main track. The track was back in service by 10 p.m., on April 8, with an approximate cost of \$110,000 in track damage. The intermediate signal and dragging equipment detector were destroyed at a cost of \$60,000. There was \$1,400,000 in equipment damages. The total monetary damages were \$1,570,000.
