***Federal Railroad Administration
Office of Safety
Headquarters Assigned
Accident Investigation Report
HQ-2006-22***

***Burlington Northern Santa Fe (BNSF)
Granada, Colorado
April 13, 2006***

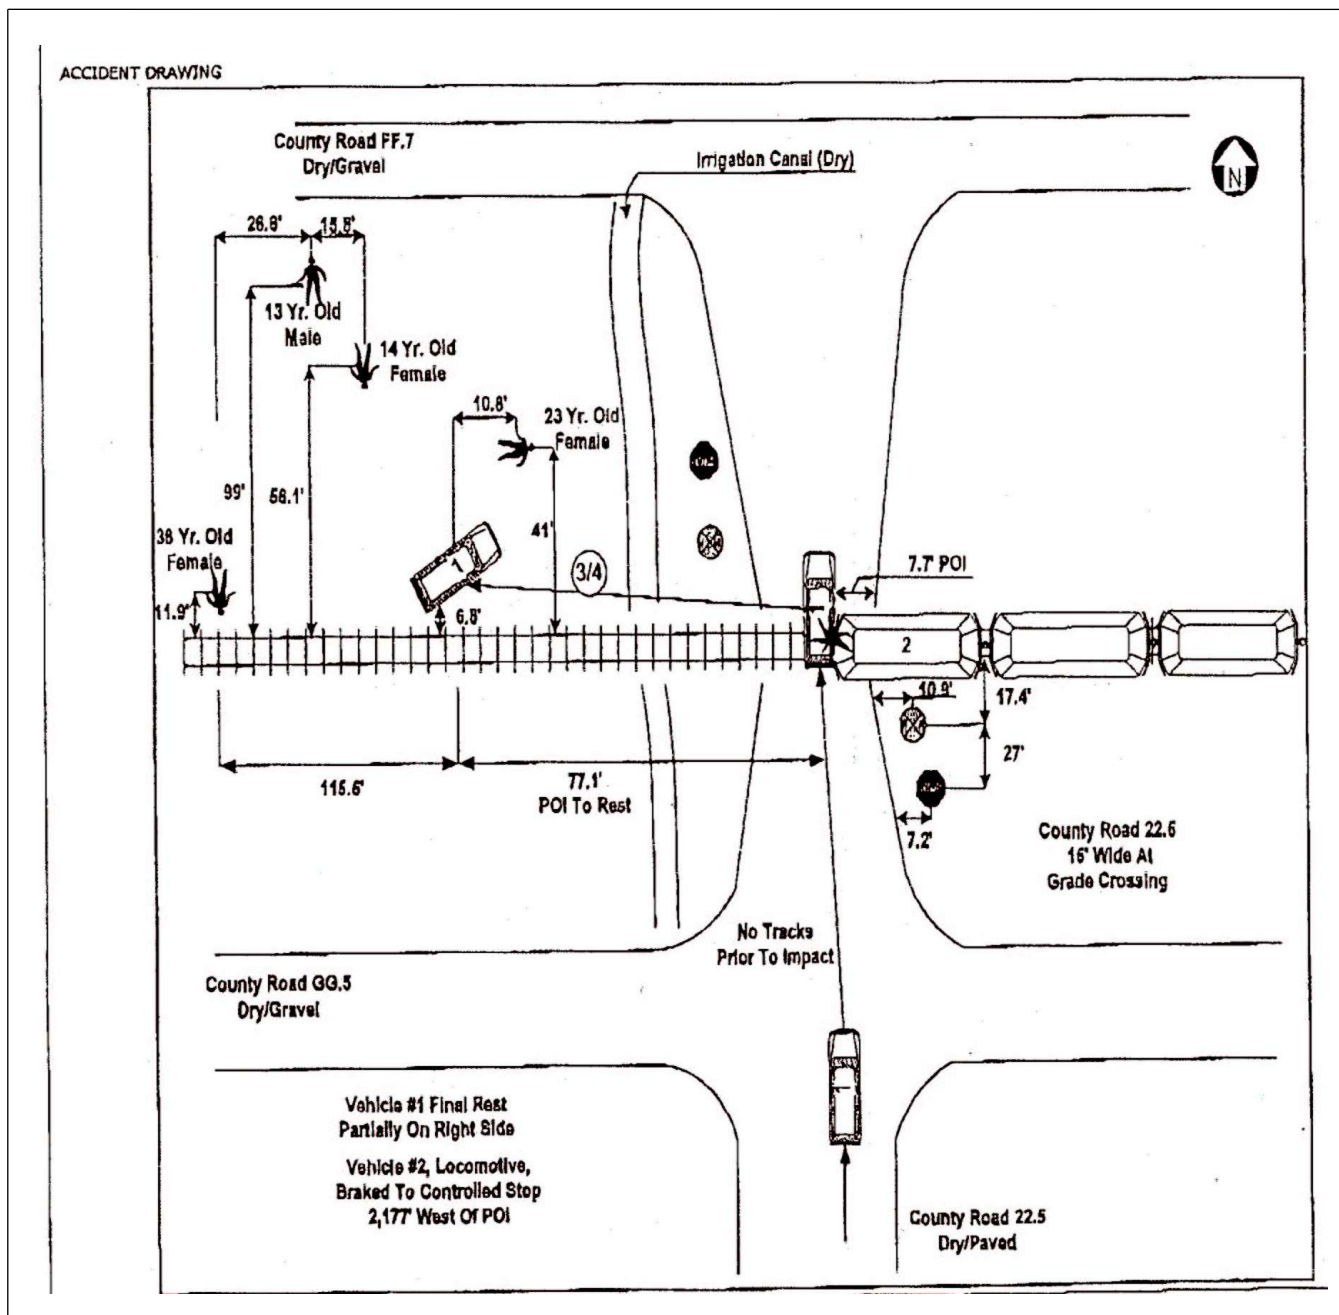
HQ-2006-
 22
 Sketch.jpg

The train struck the right side of the SUV at the rear wheel and door. The SUV was pushed off to the northwest side of the track. It traveled for about 40 feet where it hit a ditch and was flung up into the air, traveling an additional 37.1 feet, coming to rest on the roof. The train came to a stop about 2,000 feet west of the point of impact at MP 487.82.
