***Federal Railroad Administration  
Office of Safety  
Headquarters Assigned  
Accident Investigation Report  
HQ-2006-24***

***CSX Transportation (CSX)  
Richmond, Virginia  
April 22, 2006***

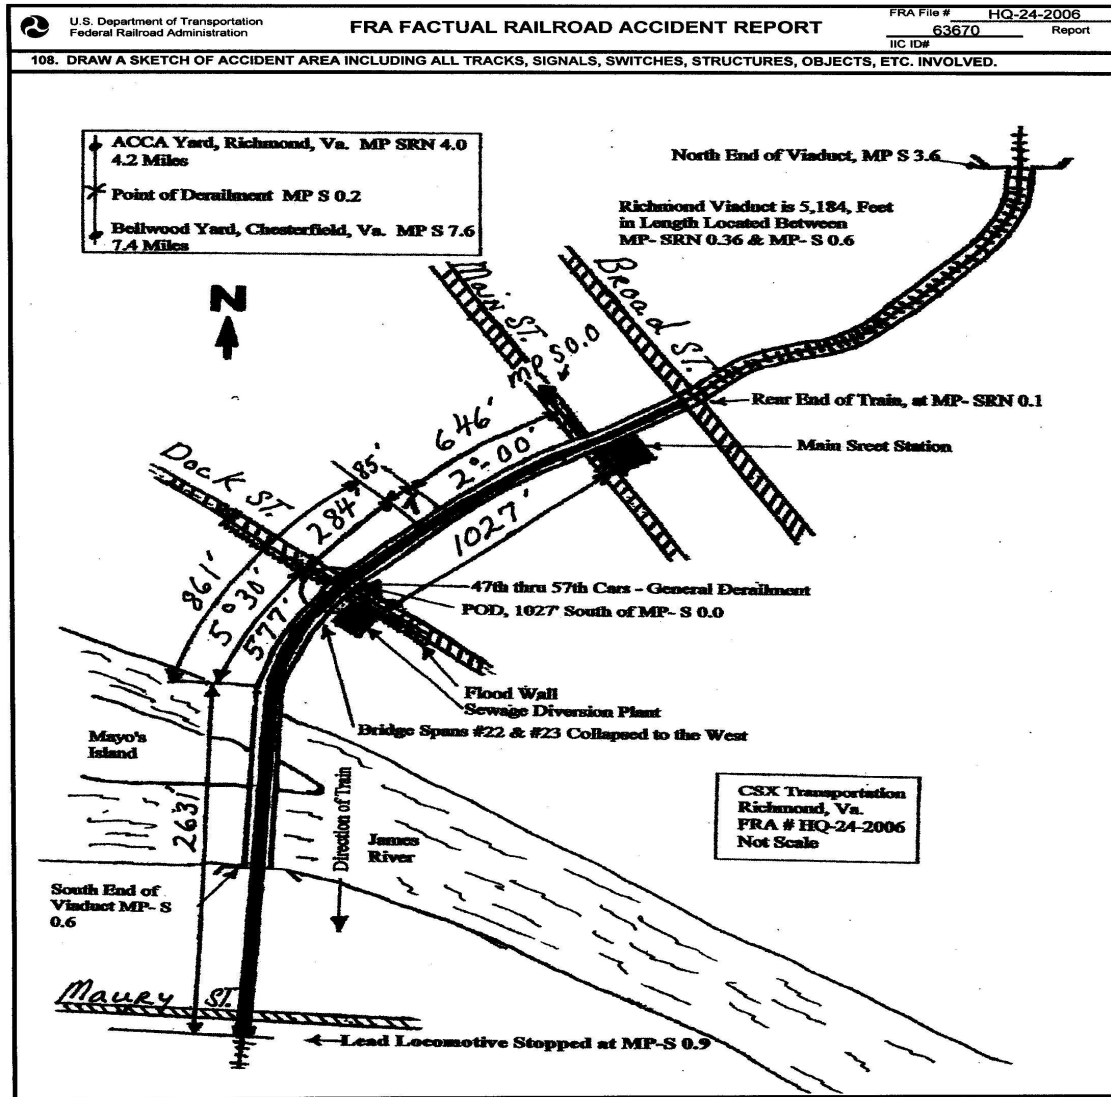
HQ-2006-  
24  
SKETCH.  
jpg

The accident investigation found that the POD was 19 feet north of the Richmond City Flood Wall where the CSX single main track crosses through the flood wall on the Richmond Viaduct, and 1,027 feet south of CSX milepost S 0.0. The track structure at the POD is in a 5-degree 30-minute left hand curve with 2 ½ inches of elevation. The bridge structure was through plate girder bridges. The rail through this area was 115-pound jointed rail manufactured by US Steel Tennessee in 1963. The rail was seated on flat plates with pandrol clip housings welded on to hold the pandrol rail fasteners. The flat plates were bolted through the deck and lateral I beams.

After the cars and coal were removed from the POD, it was discovered that the welds applied to the inside of the pandrol housing were cracked or had completely broken. Further investigation of the housing revealed very poor welding in the area with little adhesion to the flat plates. The welds broke against the field side base of the low rail, allowing the base of the rail under load, to push under the housing creating wide gage. Wheel marks on the gage side of the low rail followed by flange marks in the web of the low rail is evidence of gage widening which would have allowed car wheels to slip off the head of the rail between the gage. The plates did not show any wear beyond the housing clips indicating that this was a sudden failure. As one clip failed it put additional lateral forces on the adjacent clips causing them to fail which allowed the rail to push under the clip housing.

CSX has temporarily reinstalled the pandrol rail fastening system back on the flat rail plates with an emphasis on the welding adhesion of pandrol clip housing. To help support this system against lateral forces steel blocks have been welded on the flat rail plates on the field side of the rail base. CSX has ordered new milled pandrol plates and fasteners to replace all the existing flat plates and fasteners on the through plate girder bridges in the area of the derailment.
