***Federal Railroad Administration
Office of Safety
Headquarters Assigned
Accident Investigation Report
HQ-2006-25***

***Union Pacific (UP)
Elm Creek, Nebraska
April 27, 2006***

UP Derailment Near Elm Creek, Nebraska at Milepost (MP) 208.2

April 27, 2006

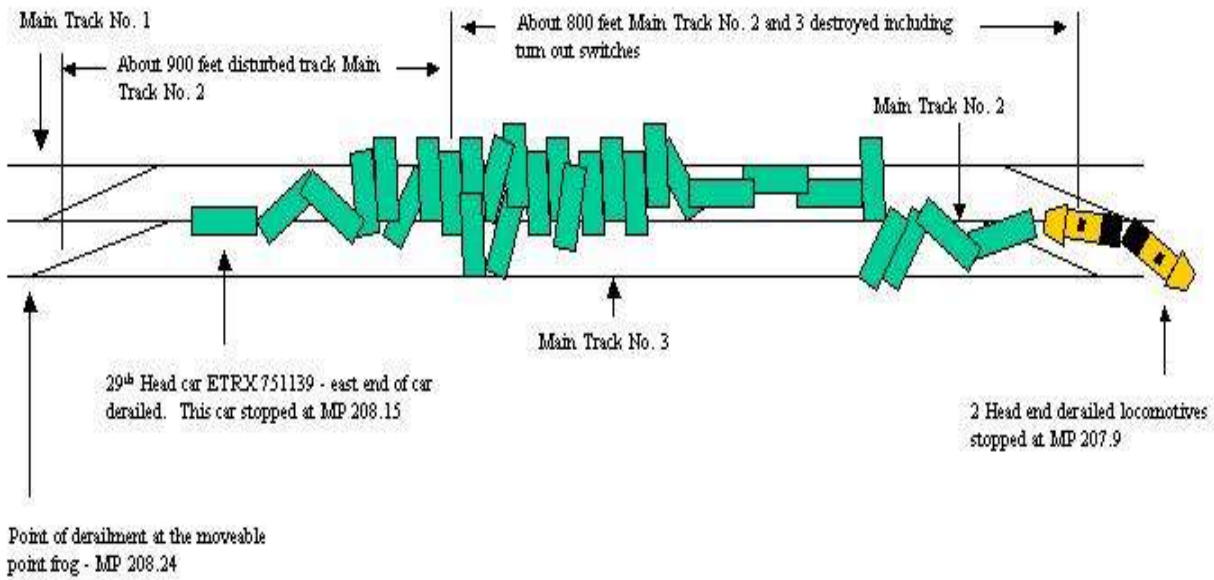
HQ-2006-
25
sketch.jpg

DIRECTION OF TRAVEL - EAST →

At approximately 4:45 a.m., as Train Symbol 3 CNANW 25 was traveling eastward through the west-end turnout switch from Main Track No. 3 to Main Track No. 2, the engineer noticed a rough spot at or near the moveable point frog at the west-end turnout, at milepost 208.2. The point of the derailment was identified at the location of the short point of the moveable point frog at the west control point turnout, controlling movement from Main Track No. 3 to Main Track No. 2, at milepost 208.2.
