***Federal Railroad Administration  
Office of Safety  
Headquarters Assigned  
Accident Investigation Report  
HQ-2006-26***

***Alabama & Gulf Coast Railway LLC (AGR)  
Linden, Alabama  
April 28, 2006***

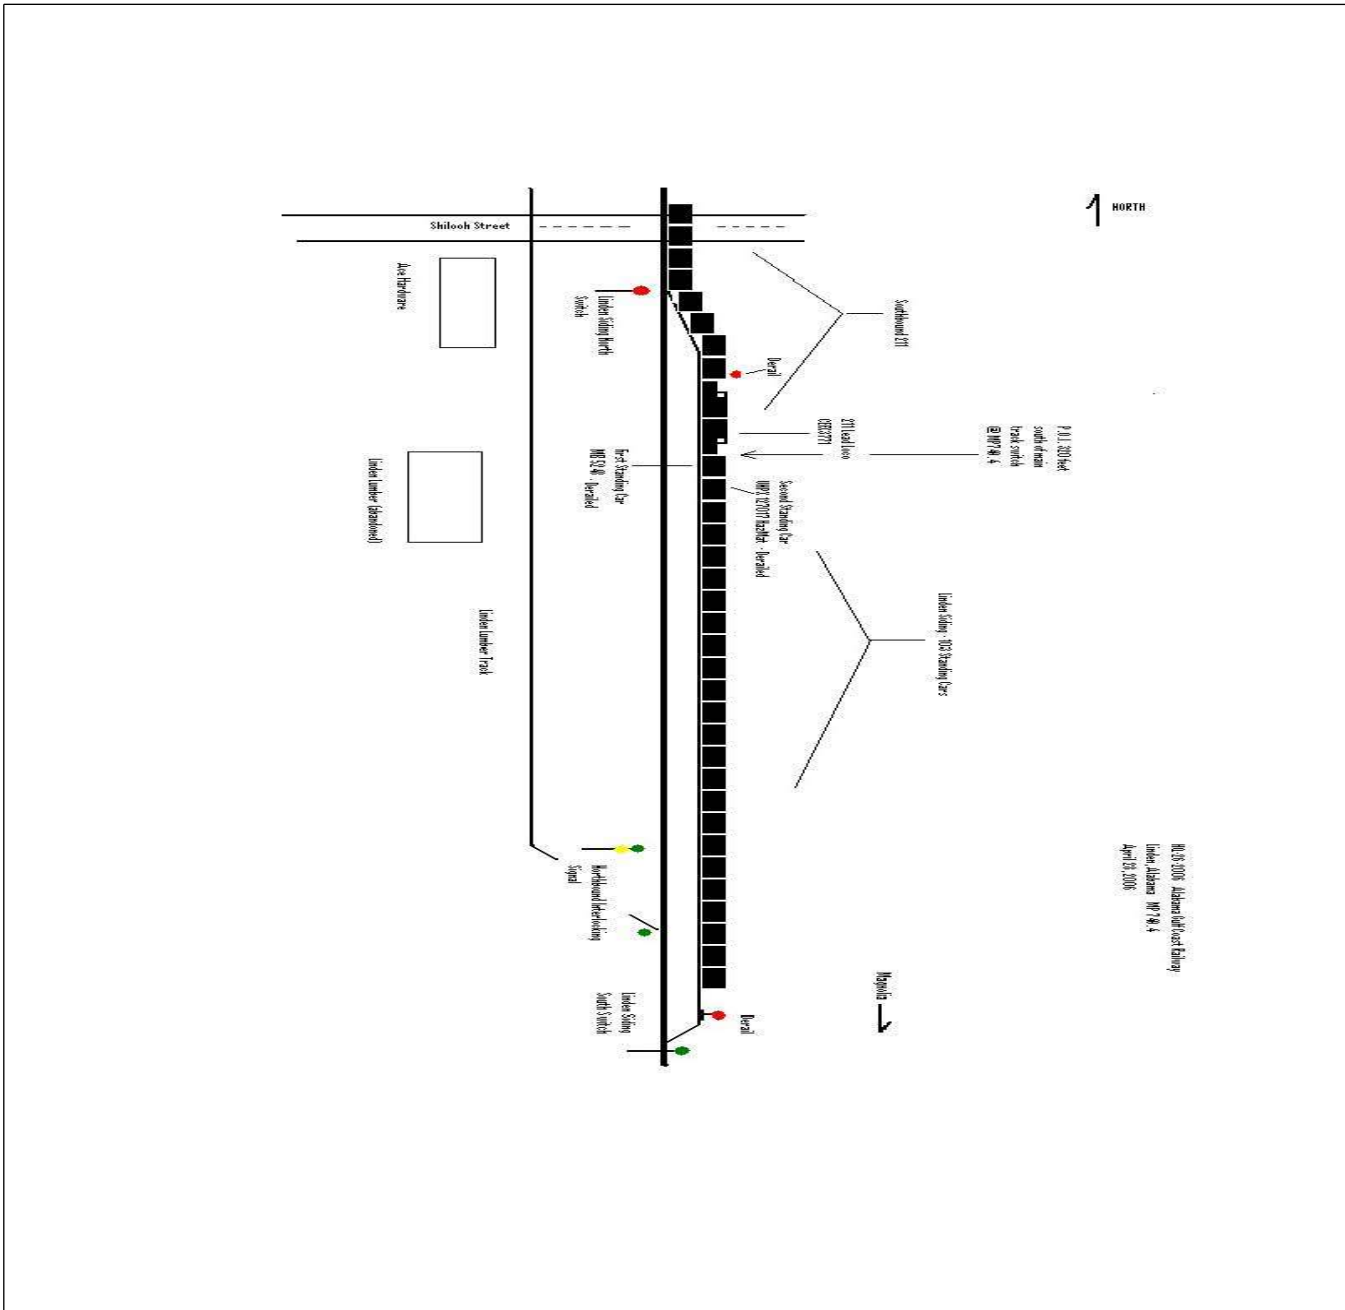
HQ-26-  
2006  
sketch.jpg

HQ-26-2006 - Alabama Railroad Company  
Lumber Shop, April 13, 2006
