***Federal Railroad Administration  
Office of Safety  
Headquarters Assigned  
Accident Investigation Report  
HQ-2006-27***

***Norfolk Southern (NS)  
Radebaugh, Pennsylvania  
May 3, 2006***

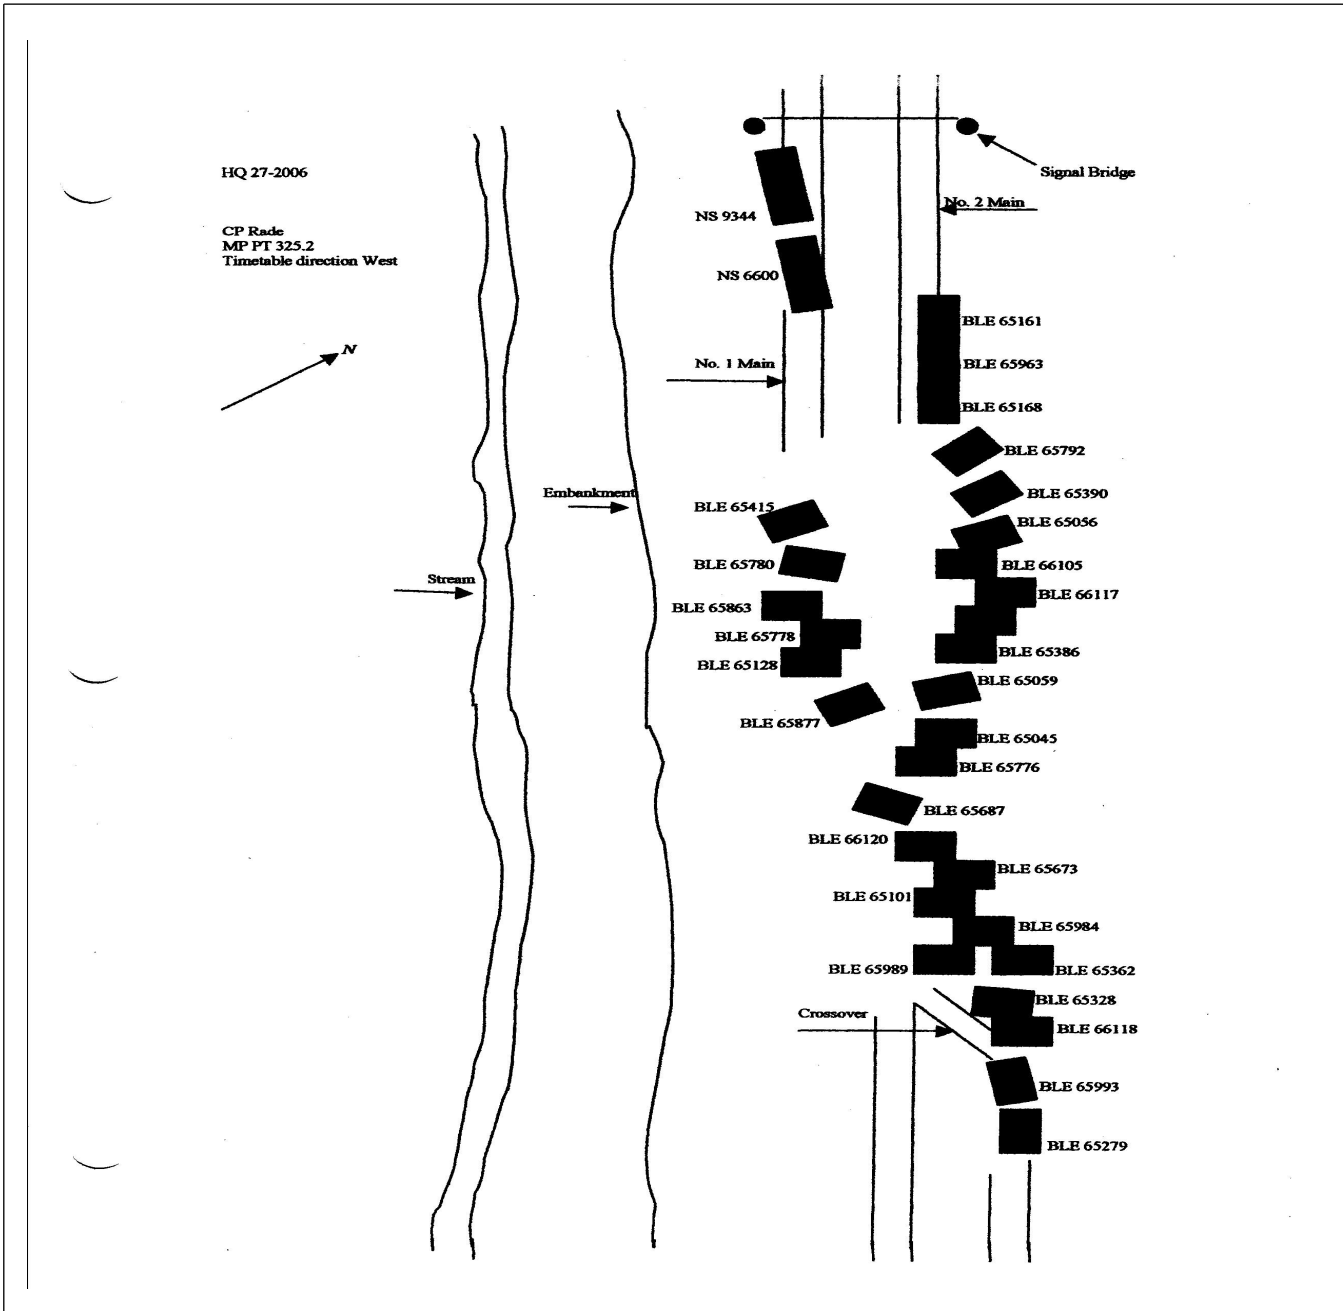
SKETCHES  
S  
HQ-27-  
2006  
(2).jpg

The lead axle (#6) on the right side of the trailing unit hit the switch point of the facing point on a No. 20 crossover switch. This caused the right #6 wheel to lift and jump the rail.
