***Federal Railroad Administration
Office of Safety
Headquarters Assigned
Accident Investigation Report
HQ-2006-30***

***Burlington Northern Santa Fe (BNSF)
Lake Side, Nebraska
May 17, 2006***

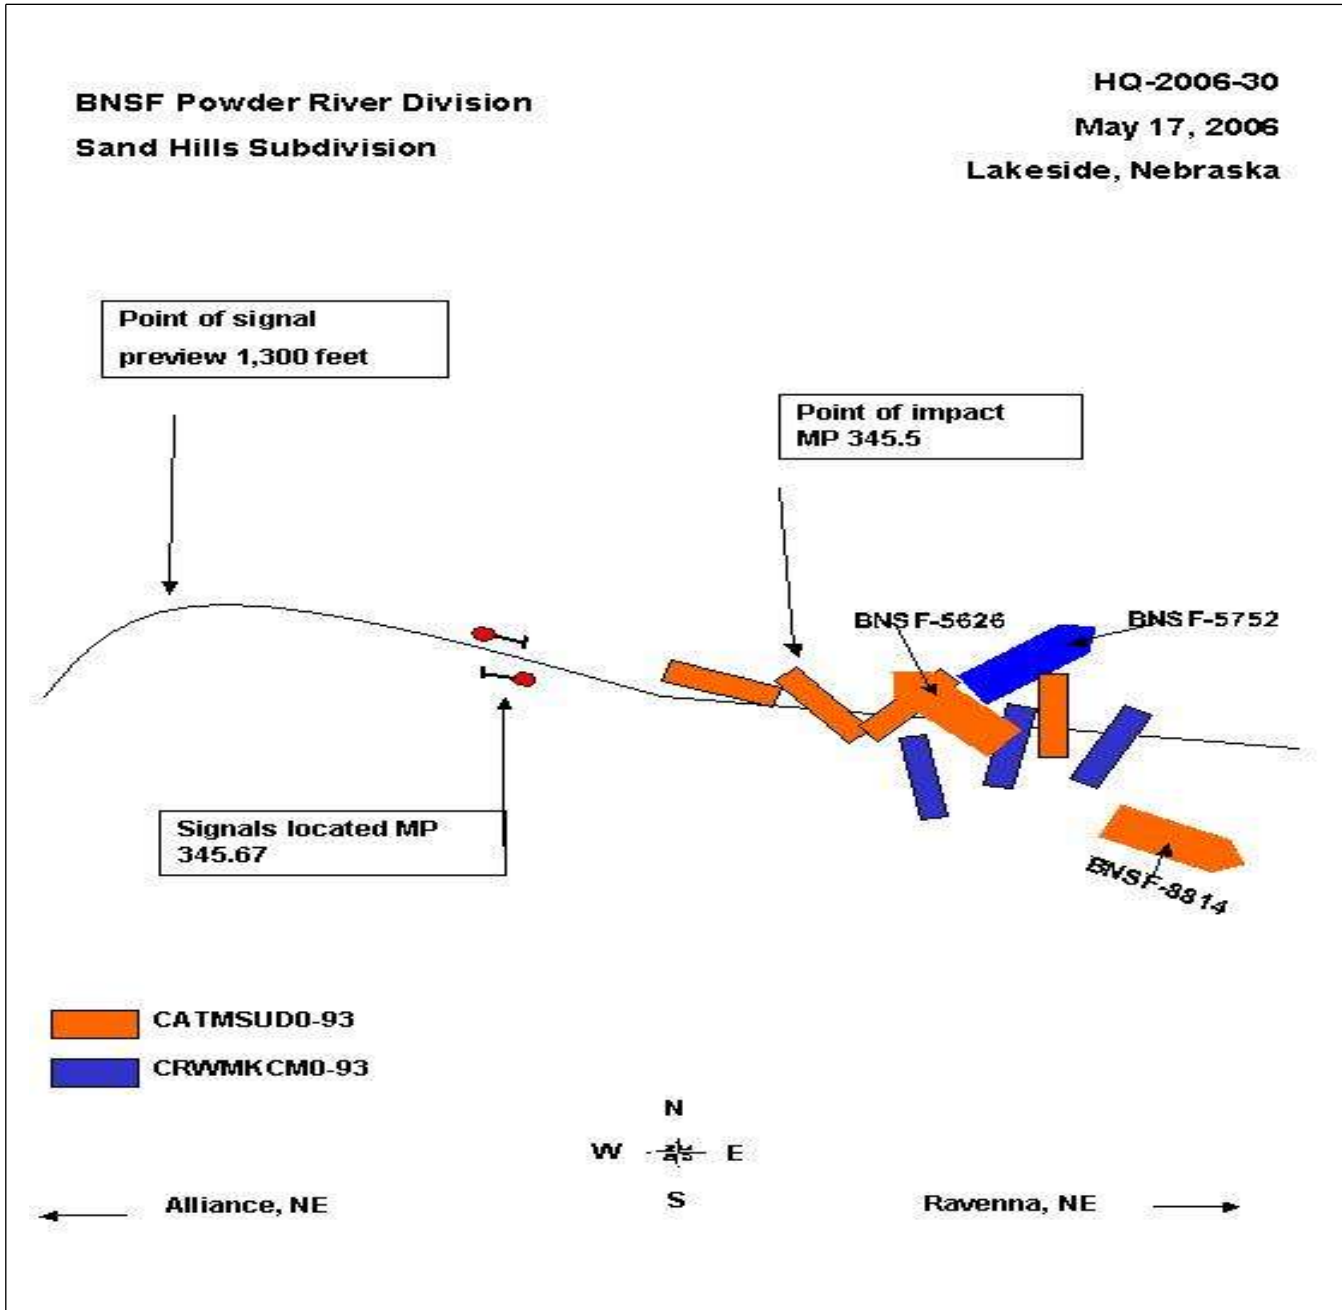
HQ-2006-30_Sketch.jpg

108. DRAW A SKETCH OF ACCIDENT AREA INCLUDING ALL TRACKS, SIGNALS, SWITCHES, STRUCTURES, OBJECTS, ETC., INVOLVED.
