***Federal Railroad Administration  
Office of Safety  
Headquarters Assigned  
Accident Investigation Report  
HQ-2006-34***

***Norfolk Southern (NS)  
Loudon, Tennessee  
May 22, 2006***

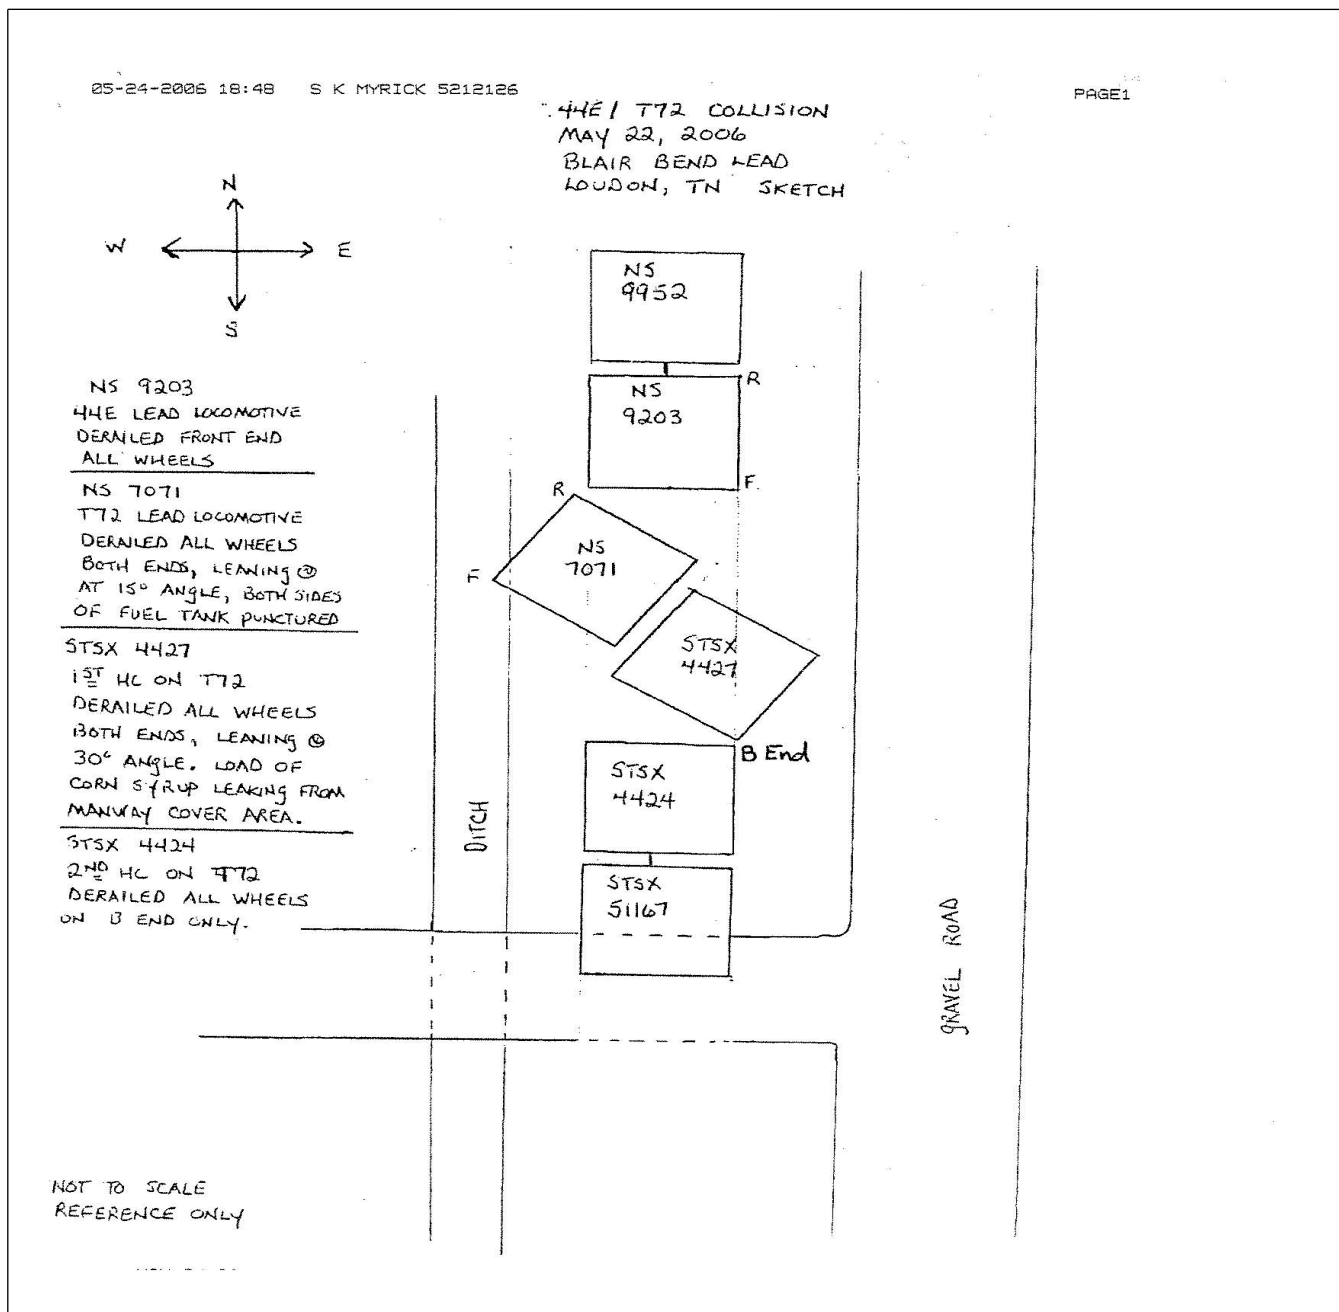
HQ-34-  
2006  
sketch.jpg

108. DRAW A SKETCH OF ACCIDENT AREA INCLUDING ALL TRACKS, SIGNALS, SWITCHES, STRUCTURES, OBJECTS, ETC., INVOLVED.
