***Federal Railroad Administration
Office of Safety
Headquarters Assigned
Accident Investigation Report
HQ-2006-35***

***Allegheny Valley Railroad Company (AVR)/Amtrak (ATK)
Pittsburgh, Pennsylvania
May 25, 2006***

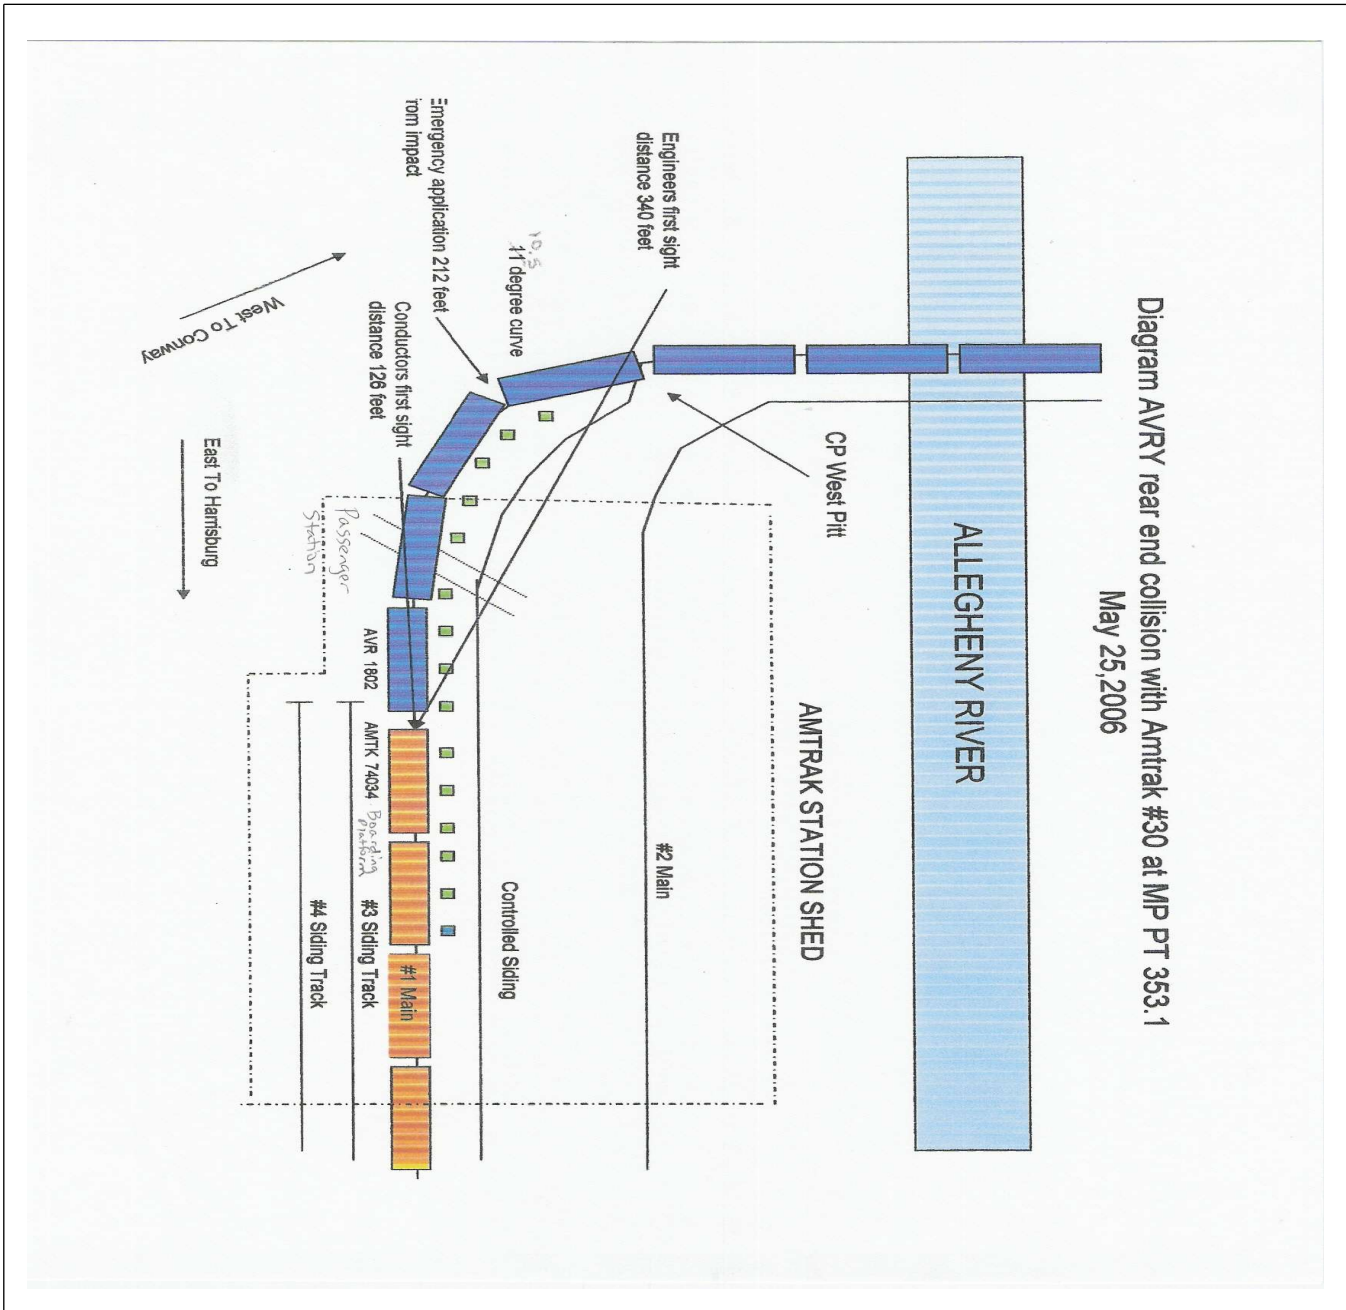
HQ-35-
2006
sketch.jpg

108. DRAW A SKETCH OF ACCIDENT AREA INCLUDING ALL TRACKS, SIGNALS, SWITCHES, STRUCTURES, OBJECTS, ETC., INVOLVED.
