***Federal Railroad Administration  
Office of Safety  
Headquarters Assigned  
Accident Investigation Report  
HQ-2006-42***

***Norfolk Southern  
Lemoyne, AL  
June 1, 2006***

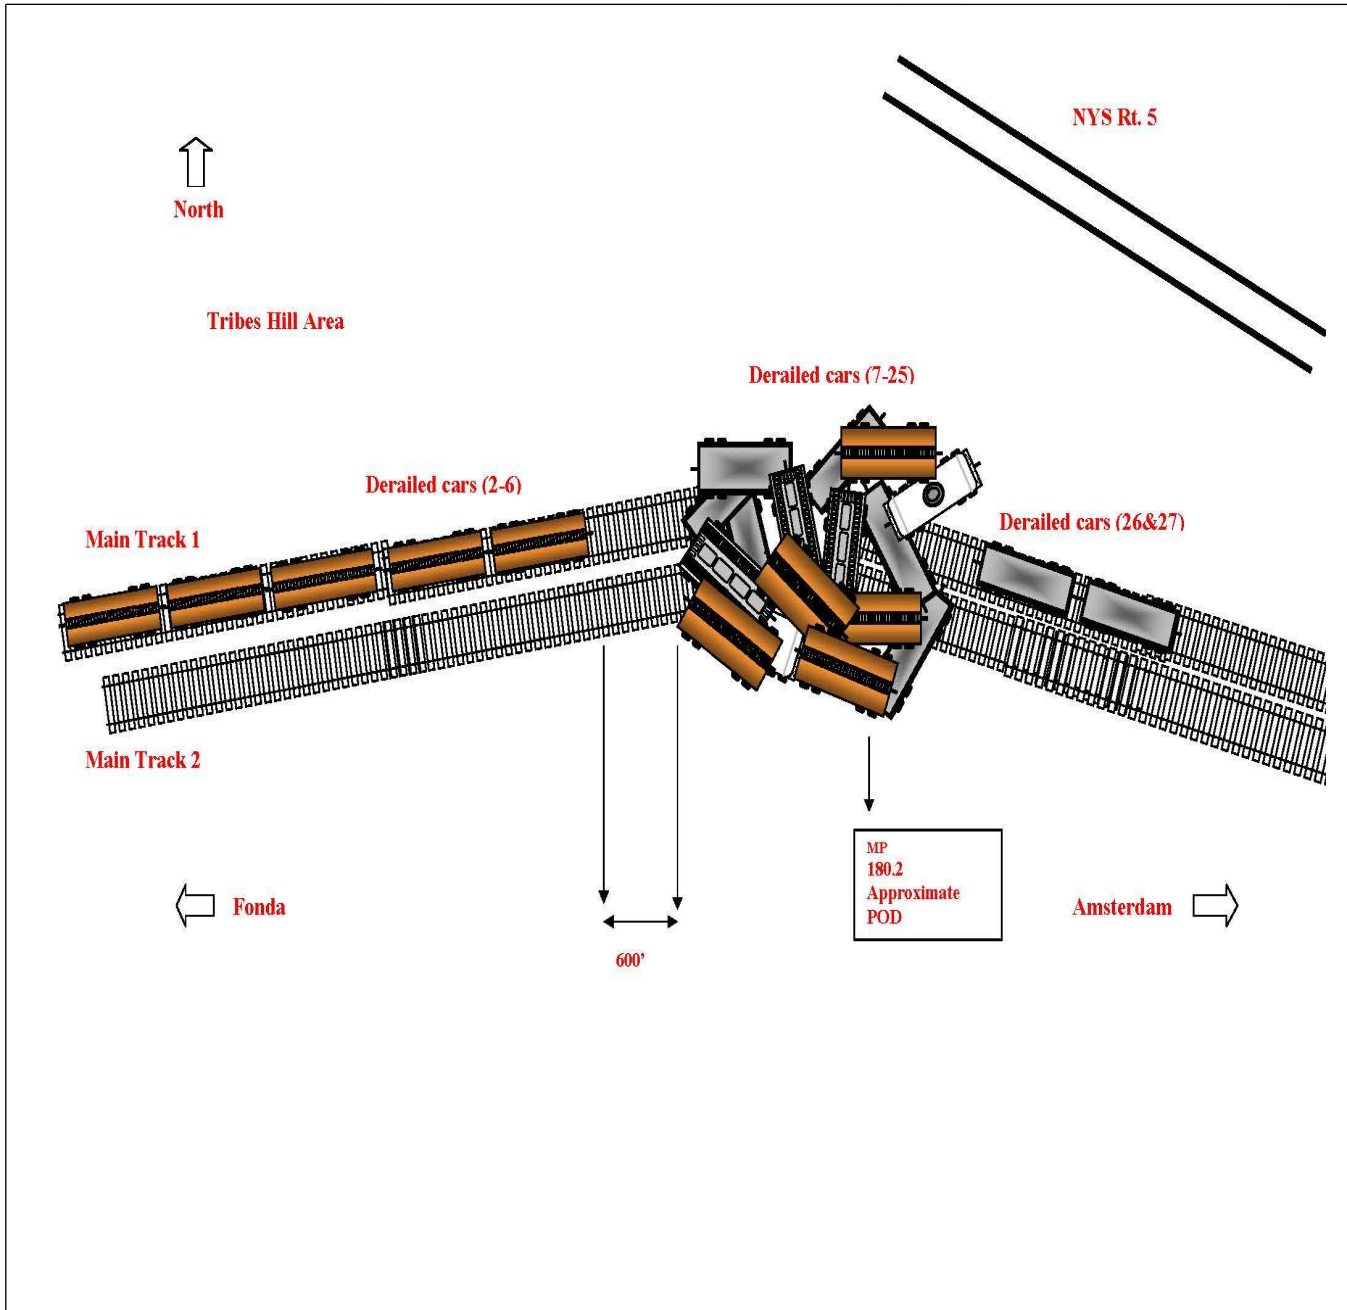
HQ-41-  
2006  
Sketch.jpg

A broken rail approximately 8 feet 2 inches long was found at the suspected point of derailment with an approximate 15% transverse fissure in the gage side of the rail head and there was evidence of batter on the end of the rail head. This piece of rail was from the north or outside rail of the curve.

The investigation revealed that the 1st car (TTPX 806154), an empty bulk head flat, although not derailed, showed a cross sectional impact on the tread of wheel L4 that indicated crossing over a broken rail. The 2nd head car (CSXT 460091), a high side gondola load of scrap metal, was the first to derail to the north side of the rail.

The first 5 derailed cars remained coupled together and were pulled away from the general pile up leaving a separation of 600 feet. The 7th through 25th cars were in the general pile up and the 26th and 27th cars were derailed up right and in line with the track.

Both main tracks were destroyed in the general pile up area.
