***Federal Railroad Administration
Office of Safety
Headquarters Assigned
Accident Investigation Report
HQ-2006-49***

***Amtrak
Bayview, MD
June 14, 2006***

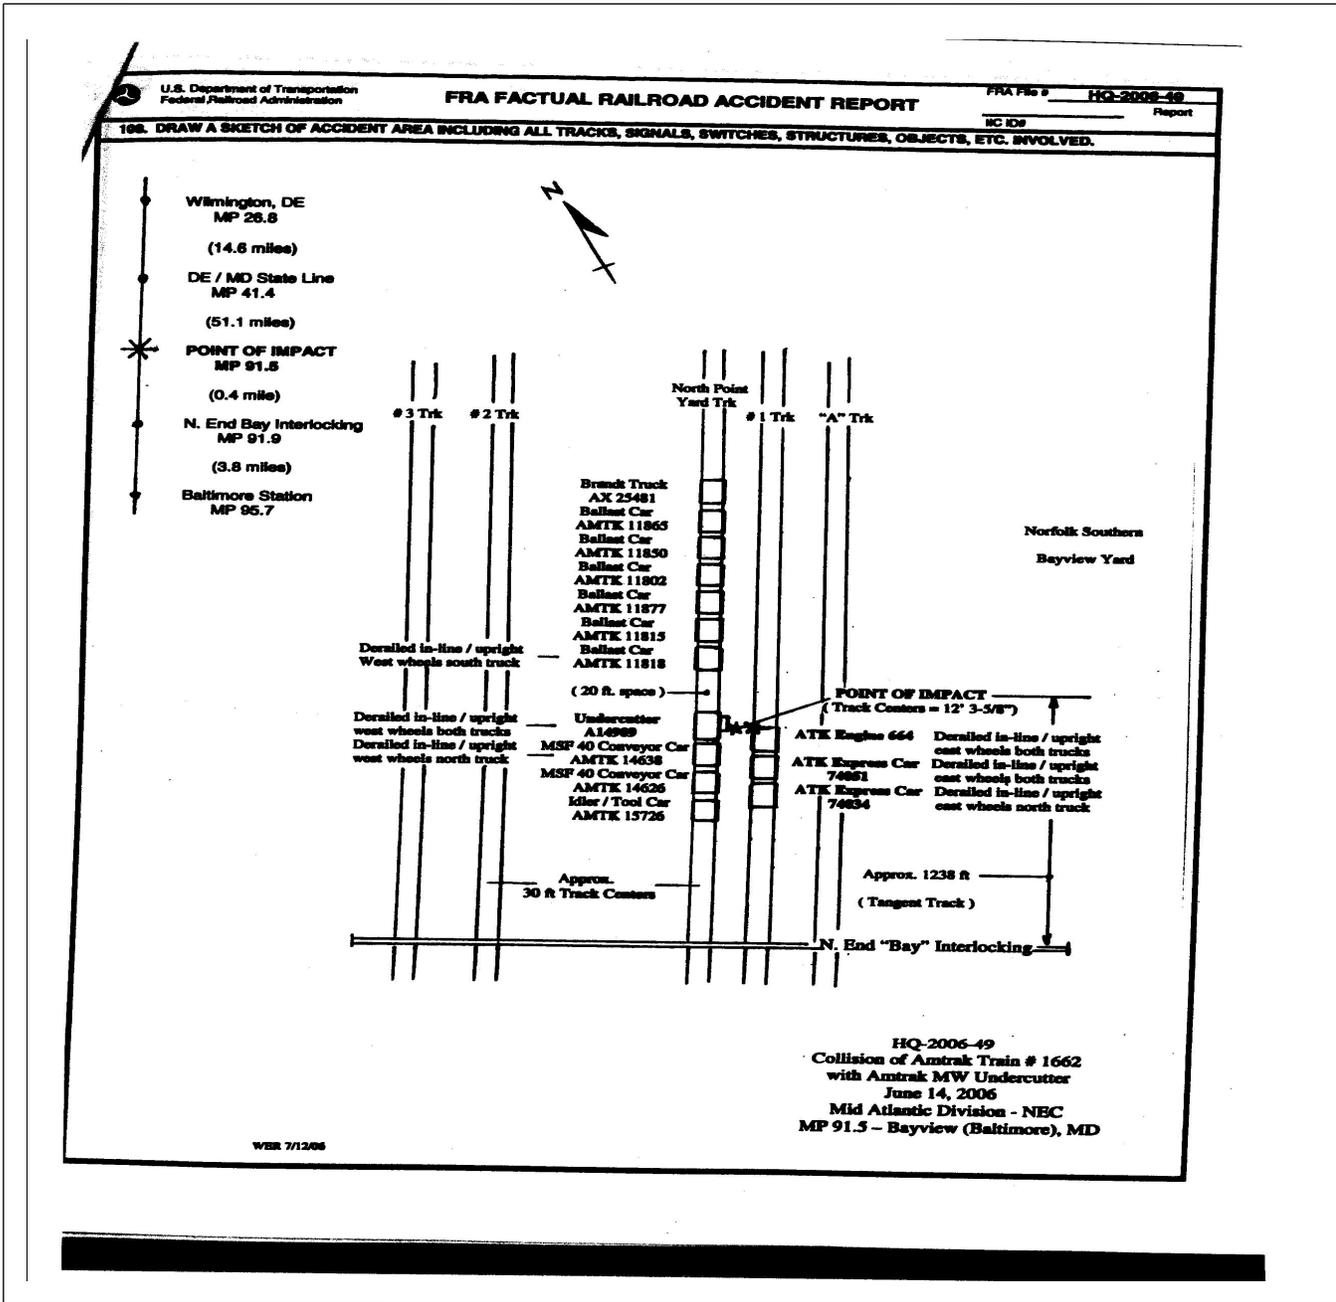
SKETCH
HQ-2006-
49.jpg

The left (west) side of the locomotive, struck the undercutter cutting wheel assembly which is on the east side of the machine, causing the locomotive and the two cars in the train to derail. The train traveled approximately another 250 feet to the north before coming to a stop. Due to the impact, the cutting wheel assembly was torn from it's mounting on the west side of the machine, and was forced to the north and east into the machine, which resulted in extensive damage and derailling of the undercutter, and two adjacent M/W cars.

This investigation revealed that at the point of the collision, the track center between North Point yard track and mainline no.1 track, was 12 feet 3 5/8 inches. When the undercutter wheel assembly is not fully retracted and the locking pins are not engaged properly, the cutting wheel assembly is out of proper lock-up position by 14 inches. The investigation found that when the machine operator retracted the cutting wheel assembly, he used the touch screen to activate the locking pins prematurely. The touch screen does not give an indication of the locking pins being in the proper position, only that they have been activated. When the end of the cutting wheel assembly slide rails came into contact with the extended locking pins, the inward movement of the cutting wheel assembly stopped, giving the machine operator a false indication that the wheel assembly was in a locked position. While this was taking place, other members of the gang were sitting on an Amtrak vehicle waiting for him, so they could return to their headquarters, and were yelling at him to hurry up and get done, and get on the bus. In the machine operators written statement, he states that once the cutting wheel was retracted and locking pins activated, he looked twice from inside the machines cab to see if it had retracted all the way. The machine operator stated that he shut the machine off, locked the cab, dismantled the machine on the west side, which is the opposite side of the machine, from where the cutting wheel is located. He did not look the machine over a second time to make sure everything was in the clear. The machine operator walked away from the machine to the west, crossed 2 sets of tracks and got on the bus.
