***Federal Railroad Administration
Office of Safety
Headquarters Assigned
Accident Investigation Report
HQ-2006-51***

***Norfolk Southern/Union Pacific
Chicago, IL
June 16, 2006***

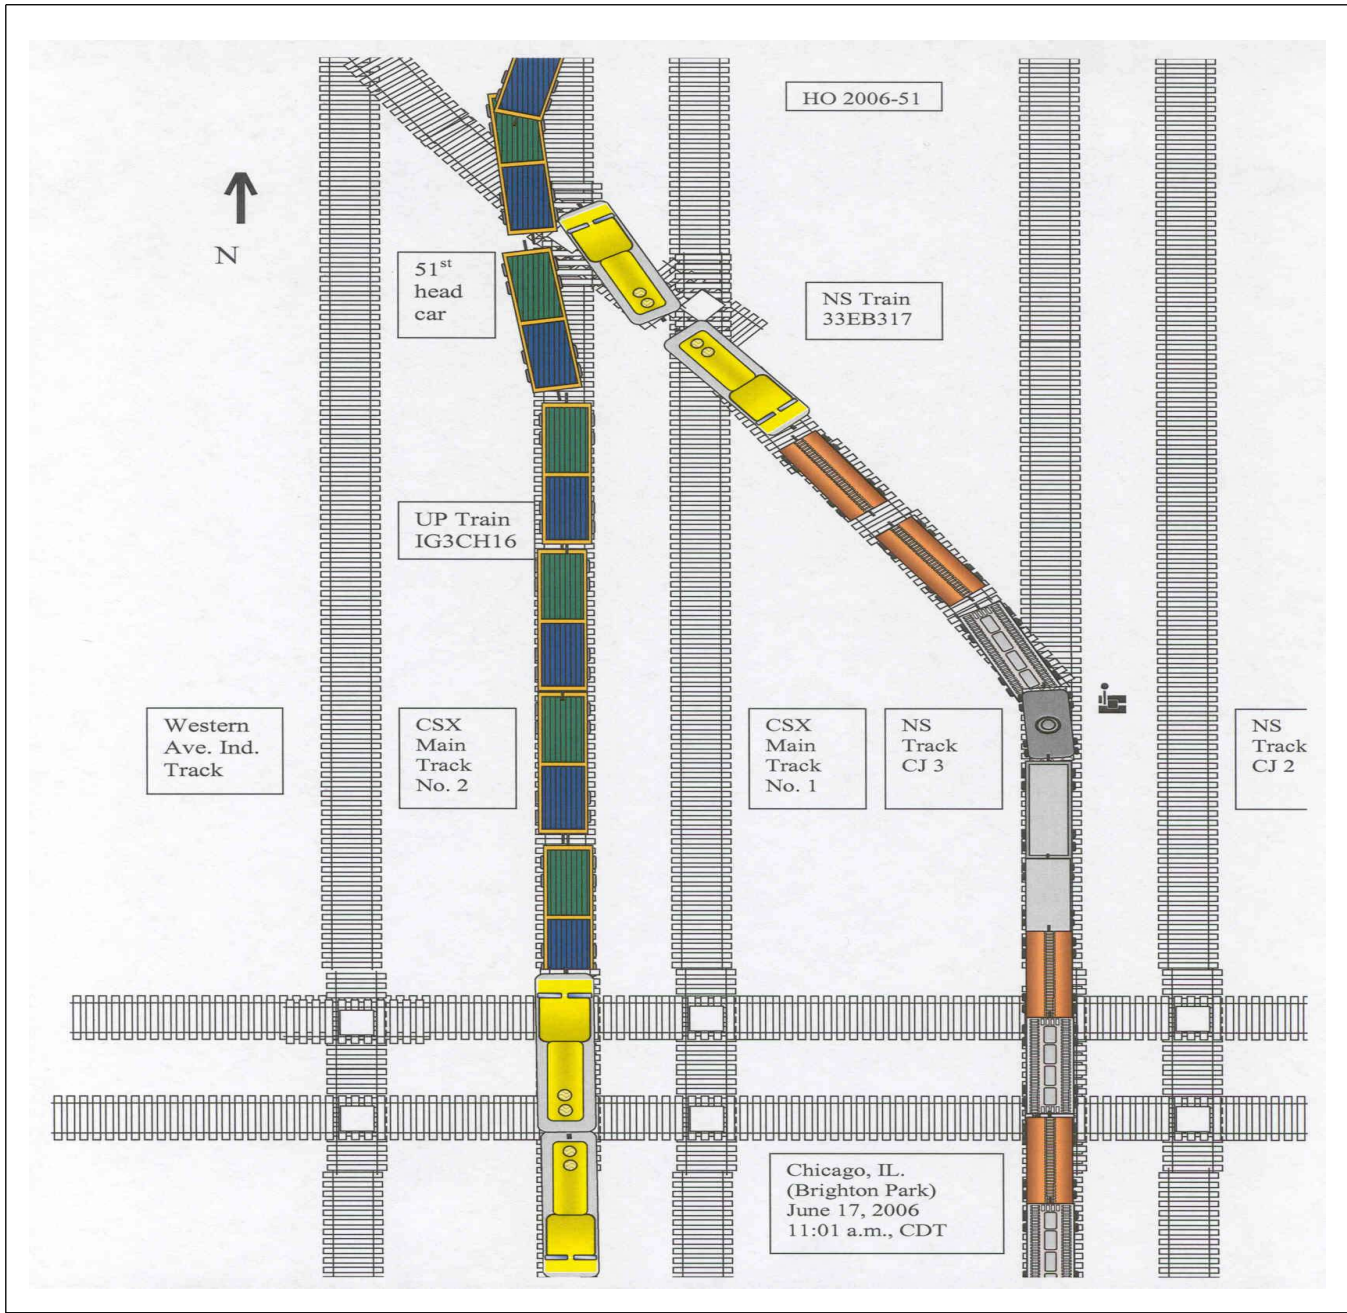
HQ-51-
2006
Accident
Sketch.jpg

There is a hand throw crossover switch located 198 feet north of the northbound STOP board on Track CJ3, which connects Track CJ3 with the Western Avenue Industrial Track. This is a facing-point switch for northbound trains on Track CJ3 and is controlled by the switchtender. The low switch stand, located on the west side of Track CJ3, is equipped with a reflectorized target. The target is green when lined for NS track CJ3 and red when lined for the diverging route. The target can be previewed from the northbound STOP board.

Meanwhile, the locomotive engineer trainee was intently concentrating on the gages to monitor her speed as they approached the next signal. None of the crew members noticed that the crossover switch was lined across the CSX main tracks toward the Western Avenue Industrial Track.

As the locomotive engineer trainee accelerated the train to a recorded speed of eight mph, she suddenly realized that the engine was heading through the crossover toward the side of the eastbound UP train. She immediately made an emergency brake application and shouted a warning to the engineer and conductor. They both leapt to their feet and moved to the right side of the cab, where they braced for the impact. From the point where the locomotive engineer trainee initiated the emergency brake application, the NS train continued 36 feet before the lead locomotive struck the 47th head car of the UP train at 12:01 p.m.

The collision occurred 740 feet from the point where the NS train stopped to wait for permission to proceed. The impact derailed the lead locomotive on the NS train and four intermodal tubs on the UP train. There were no fatalities or injuries, and no hazardous materials were involved. The CN tracks were not damaged. However, they were blocked by both standing trains for a short time.
