***Federal Railroad Administration
Office of Safety
Headquarters Assigned
Accident Investigation Report
HQ-2006-55***

***Amtrak
Arcola, LA
June 26, 2006***

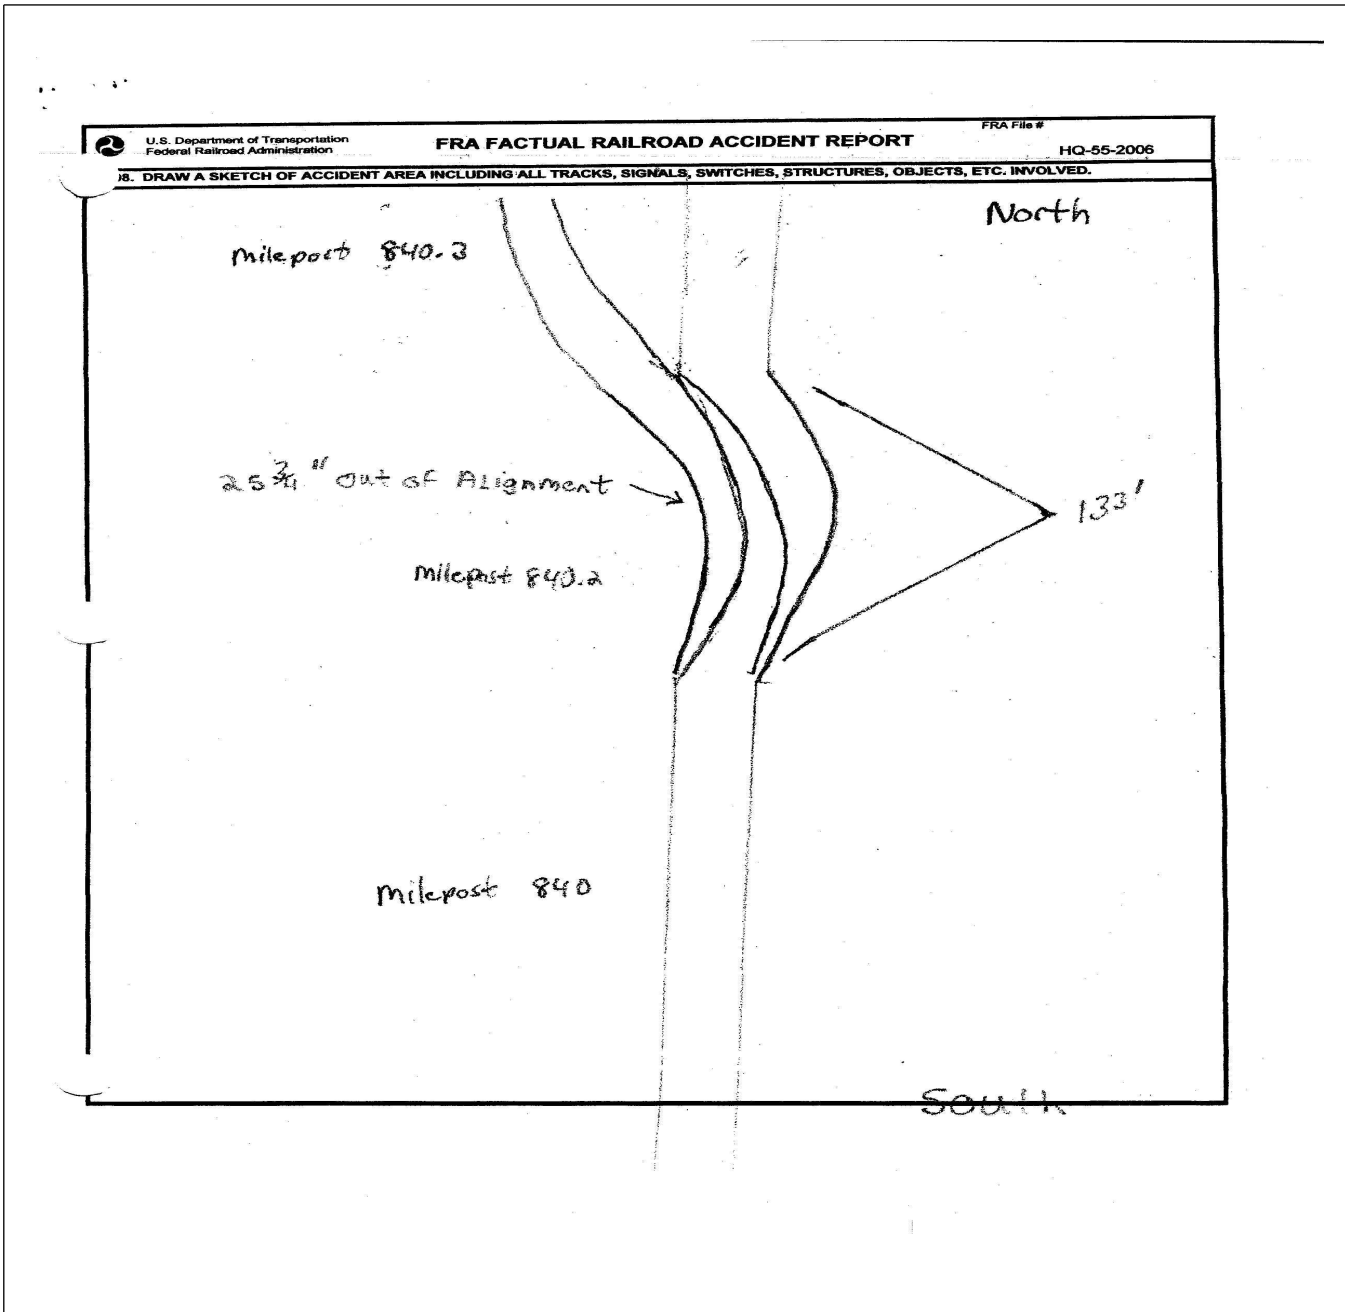
HQ-55-
2006.jpg

108. DRAW A SKETCH OF ACCIDENT AREA INCLUDING ALL TRACKS, SIGNALS, SWITCHES, STRUCTURES, OBJECTS, ETC., INVOLVED.
