***Federal Railroad Administration
Office of Safety
Headquarters Assigned
Accident Investigation Report
HQ-2006-57***

***CSX Transportation
St. Jacobs, IL
June 27, 2006***

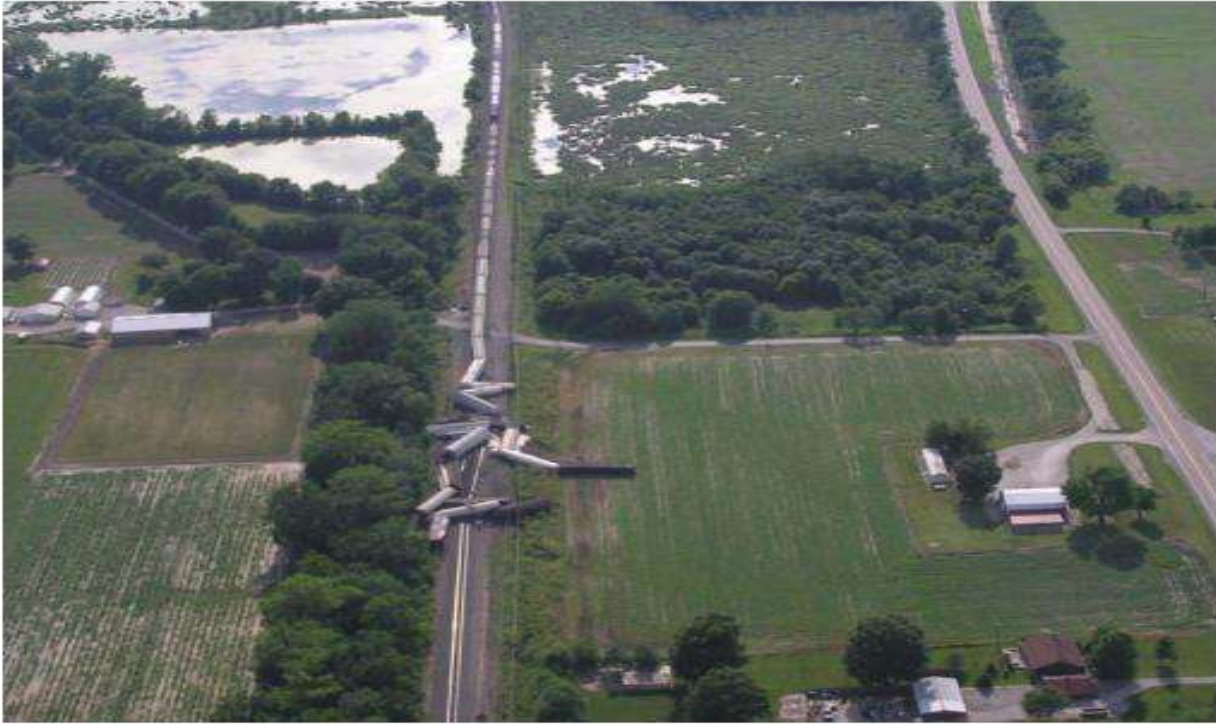
HQ-2006-
57
Sketch.jpg

Double click on the below file to open the photograph. This view is looking west, towards the rear of the train. The head end, or east end of the train is separated from the wreckage and not seen from this photograph. North is to the right as you look at this photograph.

Photo Taken By: Illinois State Trooper - William Skrobul
Taken at: 5 p.m., on June 27, 2006 - Troy Illinois
