***Federal Railroad Administration  
Office of Safety  
Headquarters Assigned  
Accident Investigation Report  
HQ-2006-58***

***Norfolk Southern  
Keating, PA  
June 30, 2006***

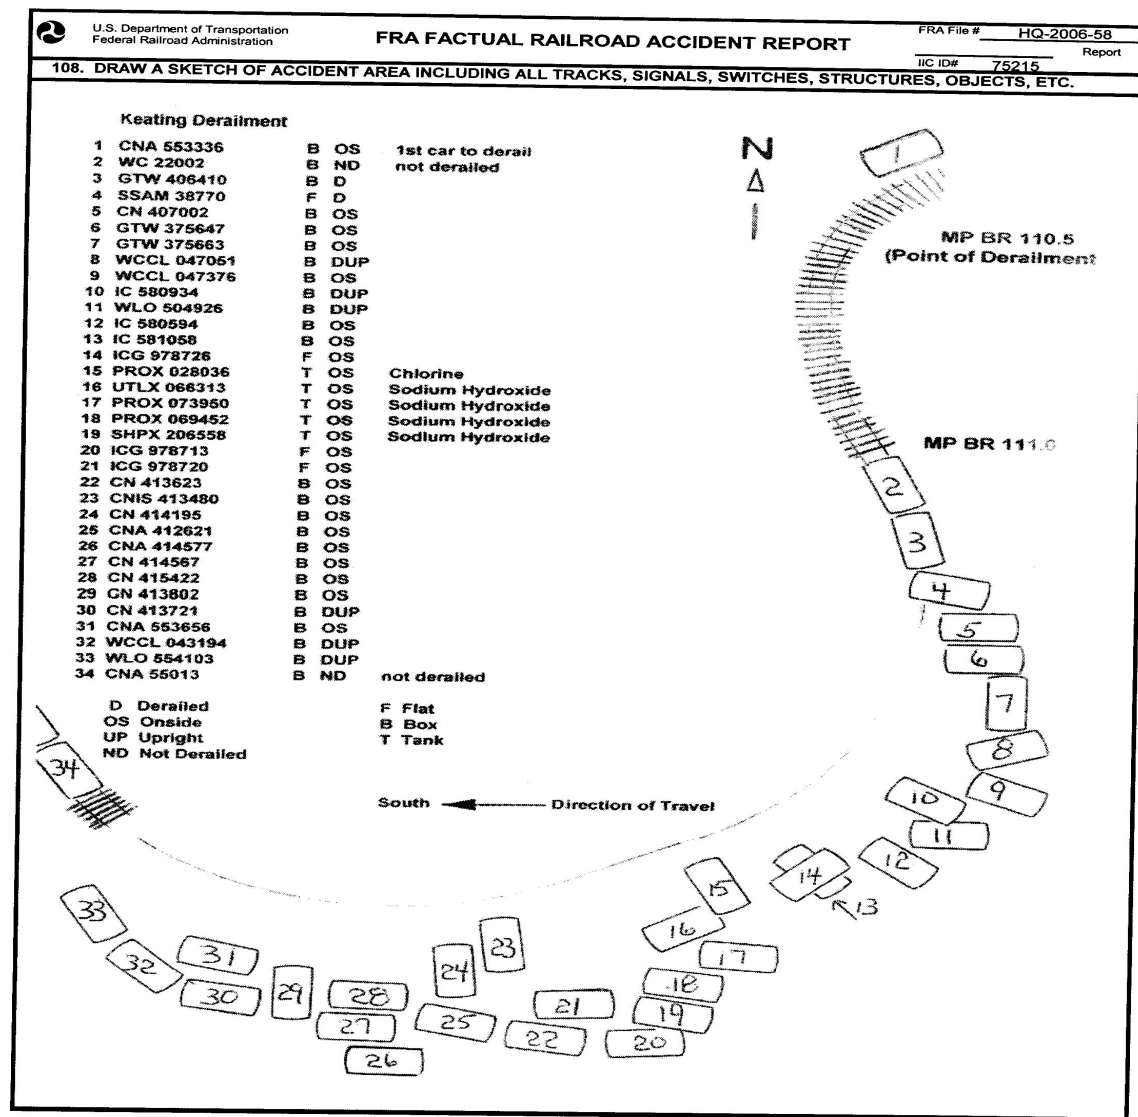
108. DRAW A SKETCH OF ACCIDENT AREA INCLUDING ALL TRACKS, SIGNALS, SWITCHES, STRUCTURES, OBJECTS, ETC., INVOLVED.  
HQ-2006-58.jpg

The Buffalo Line has a series of nine curves ranging from 1-degree 4-minutes to 4-degree with short sections of tangent track between the crest of Keating Summit (milepost BR 107.6) and the location where the first car derailed at milepost BR 110.5. The majority of the train derailed between milepost BR 111 and milepost BR 111.2. Fourteen Hundred feet of track was destroyed.

The first car to derail was CNA 553336 a box car loaded with wall board. As the train was traveling at a recorded speed of 76 MPH the car (CNA 553336) jumped abruptly 21 ½ inches over the high side of the rail and went down a 50 foot embankment landing on its side. There were no marks on the rail or ties and no sign of disturbed track at or prior to the car lifting out of the train.

The majority of the remaining cars, starting with the 15th car, derailed to the east side of the right of way over a steep fill. The tank car load of chlorine, PROX 028036, though heavily damaged by the force of the derailment, did not leak. Two tank car loads of sodium hydroxide, SHPX 206558 and PROX 069452, lost their entire loads while a third tank car load of sodium hydroxide, PROX 073950, leaked all but 800 gallons of its load. A fourth heavily damaged tank car of sodium hydroxide, UTLX 066313, did not leak. 42,000 gallons of sodium hydroxide was lost.
