***Federal Railroad Administration
Office of Safety
Headquarters Assigned
Accident Investigation Report
HQ-2006-59***

***Canadian Pacific Railway Company
Elbow Lake, MN
June 30, 2006***

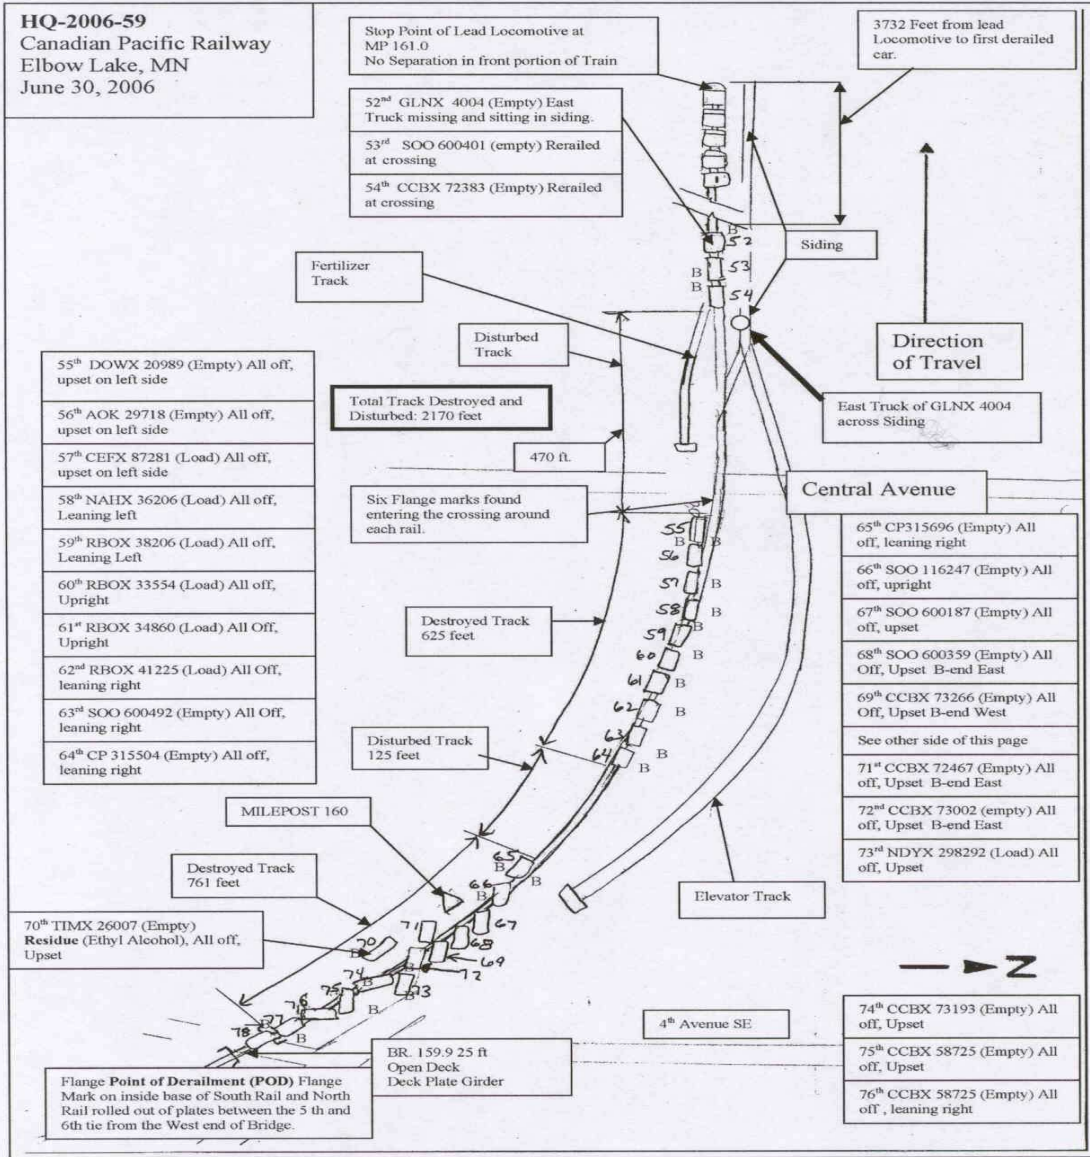
HQ-59-
2006
Accident
Sketch.jpg

The first car derailed was the 52nd car in the consist, GLNX 4004, an empty hopper car. The first mark of a derailment was on the Bridge at milepost 159.9. The high rail was rolled out and a wheel dropped into the gage of the track on the low rail, making one flange mark on the tie plate. The second wheel dropped into the gage of the track just beyond the west end of the bridge. The track was destroyed for 761 feet from the west bridge approach, disturbed for 125 feet, then destroyed for another 625 feet. The derailed GLNX 4004 was observed by a witness, the driver of an automobile stopped at a highway-rail grade crossing 1,429 feet west of the POD. The witness observed a rail car with the east truck derailed. The north wheels were on the field side of the north rail and the south wheels were in the gage of the track.

The train separated between the 54th and 55th cars. It also separated between the 64th and 65th cars. The GLNX 4004 and two cars behind it continued westward re-railing four wheel sets of six that entered the east end of the crossing flangeway. The east truck of the GLNX 4004 began to follow the curved side of a right-hand turnout about 250 feet west of the crossing. The east wheel set climbed over the curved lead rails and was ejected from beneath the car about 450 feet west of the crossing. This wheel set came to rest on the siding on the north side of the main track. The 55th through the 64th car were derailed in a straight line east of the highway-rail grade crossing. There was a 125-foot gap of disturbed track between the 64th and 65th cars. The 65th through the 76th cars were derailed on both
