***Federal Railroad Administration
Office of Safety
Headquarters Assigned
Accident Investigation Report
HQ-2006-60***

***Burlington Northern Santa Fe
Marshal, TX
July 1, 2006***

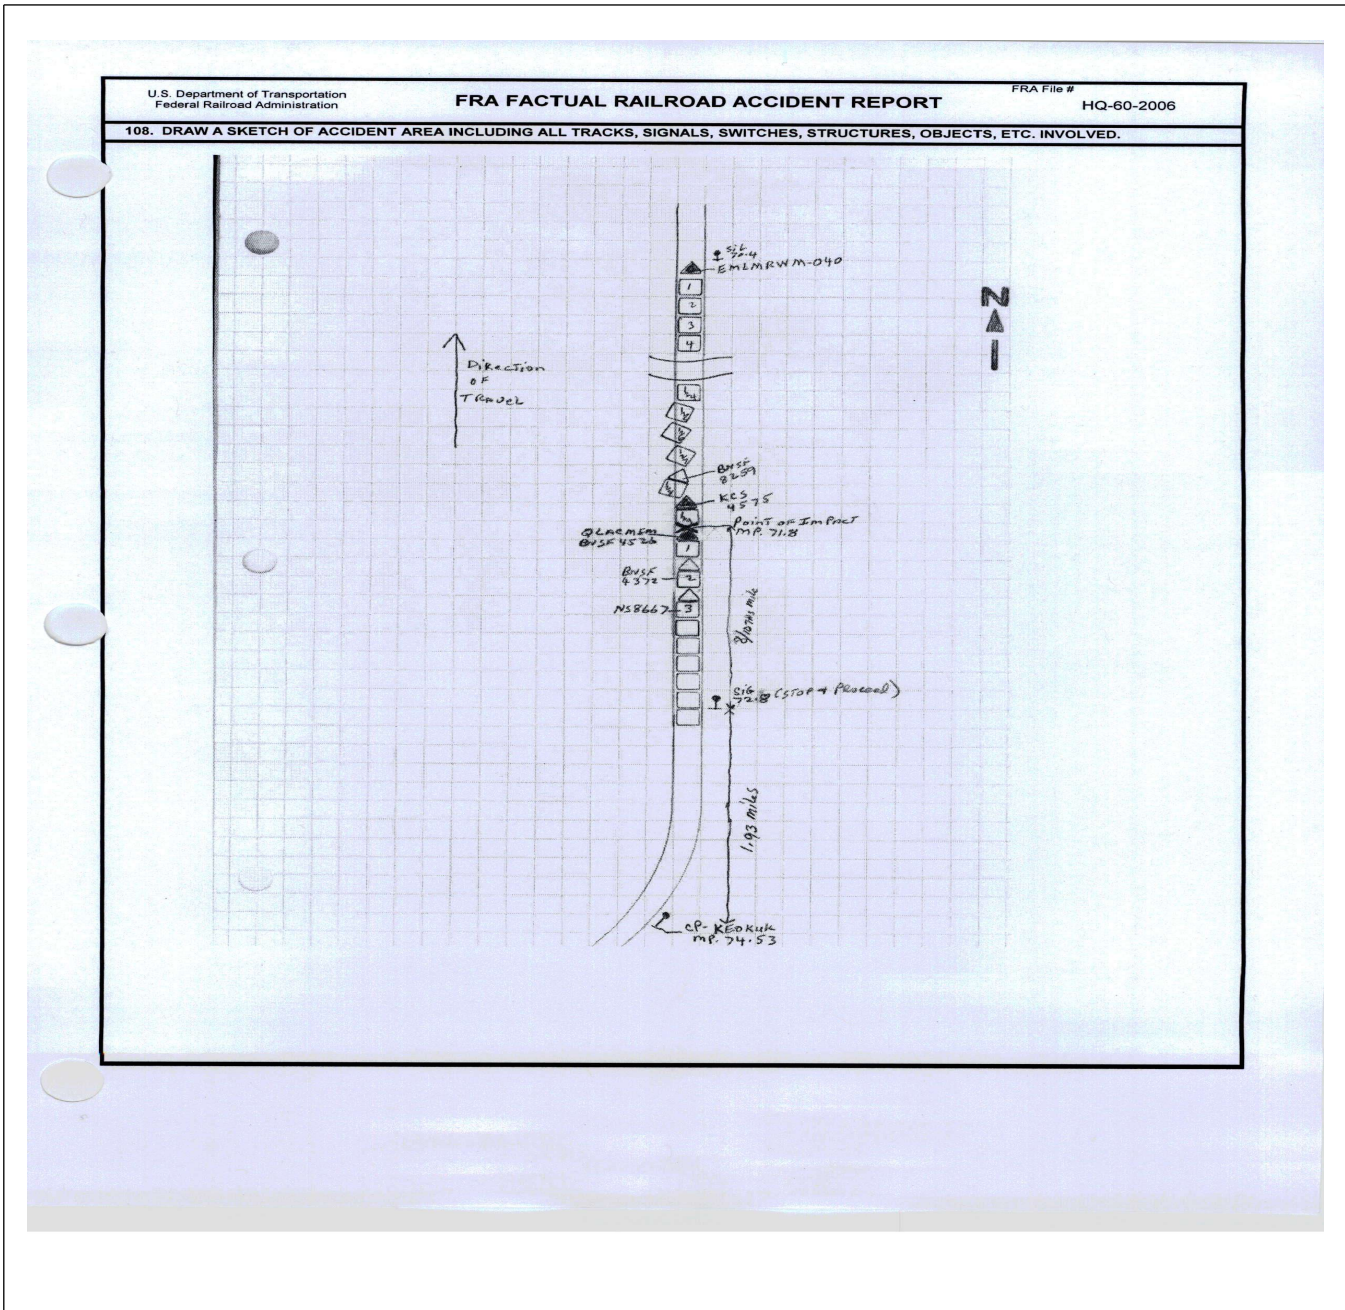
108. DRAW A SKETCH OF ACCIDENT AREA INCLUDING ALL TRACKS, SIGNALS, SWITCHES, STRUCTURES, OBJECTS, ETC., INVOLVED.
HQ-60-
2006.jpg

A northbound BNSF freight train collided with the rear end of a stopped freight train on July 1, 2006 at 12:53 p.m. The accident occurred near Marshall, Texas, at UP milepost 71.8, on the Union Pacific Little Rock Subdivision.

There were no injuries to either train crew. The striking train sustained damage of about \$106,000. The struck train and consist sustained about \$307,194 in damages. There was no track structure damage. Three of the struck train's 125 empty coal cars and one of two distributive power locomotives were derailed as a result of the collision.

The accident was caused by a failure to comply with restricted speed in connection with the restrictive indication of Intermediate Signal 72.8.
