***Federal Railroad Administration
Office of Safety
Headquarters Assigned
Accident Investigation Report
HQ-2006-61***

***Southeastern PA Transportation Authority
Crestmont, PA
July 1, 2006***

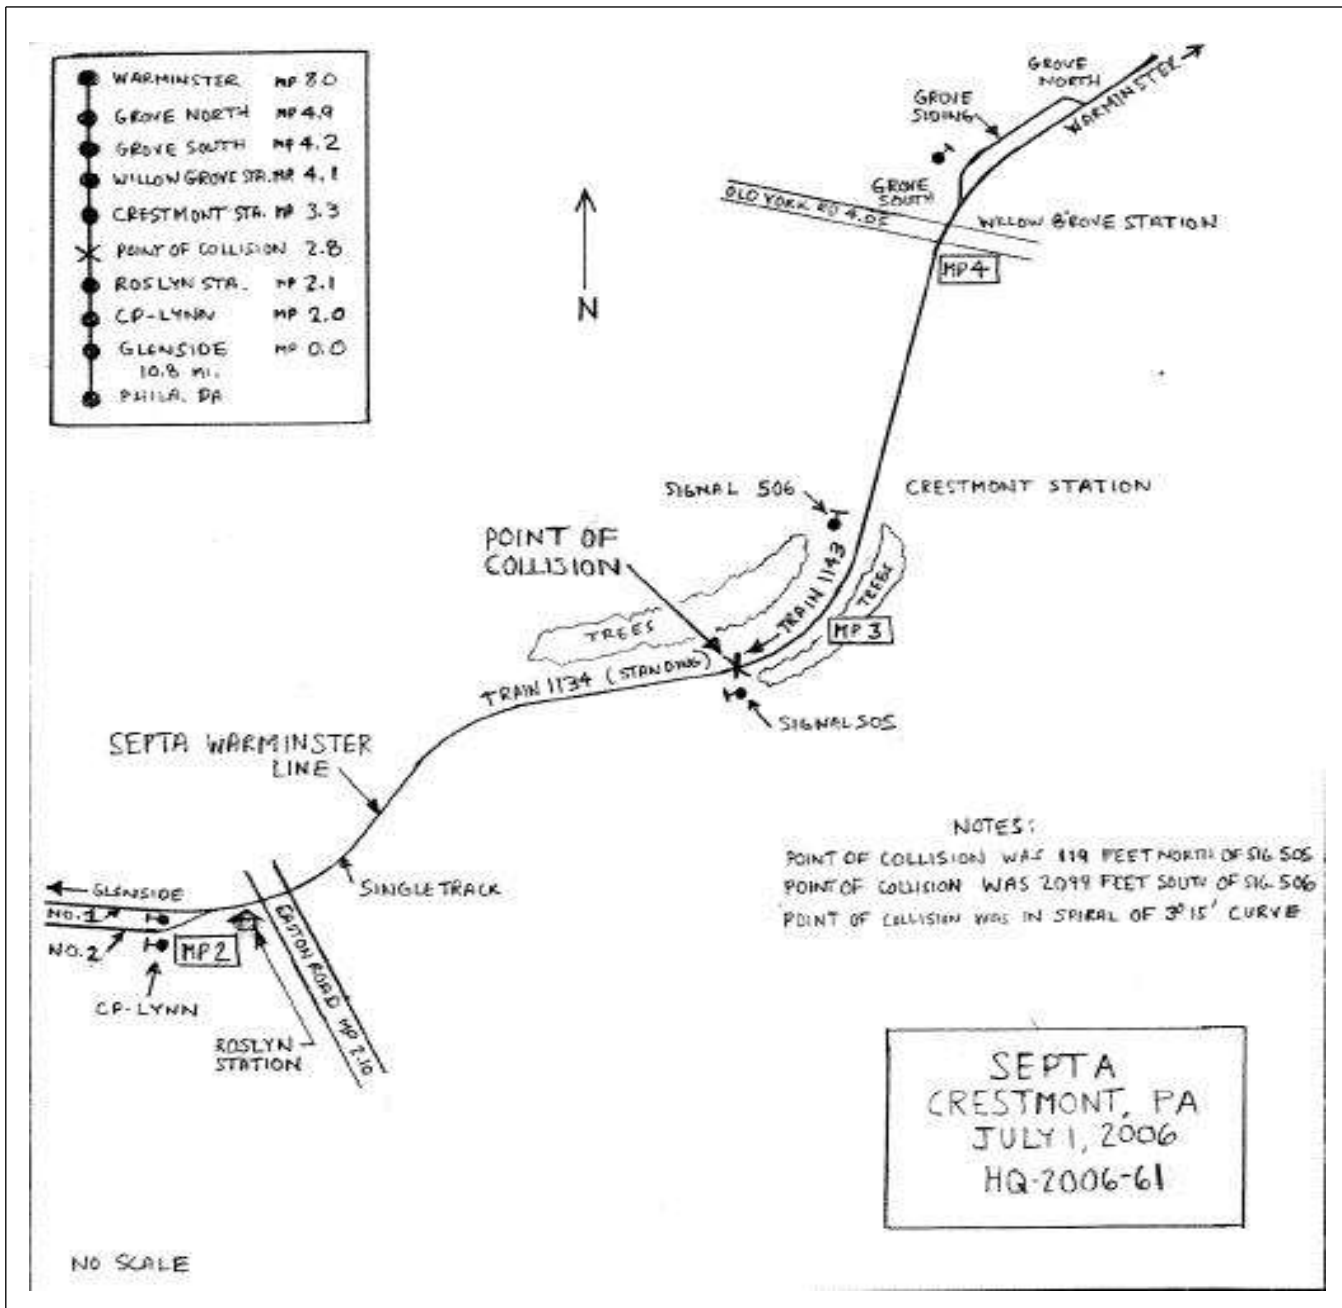
108. DRAW A SKETCH OF ACCIDENT AREA INCLUDING ALL TRACKS, SIGNALS, SWITCHES, STRUCTURES, OBJECTS, ETC., INVOLVED.
hq-2006-61.JPG

Southbound SEPTA Train 1143 collided head-on with a standing northbound SEPTA Train 1134 on single main track. The accident occurred near Crestmont, Pennsylvania on July 1, 2006 at 2:54 p.m. EDT. Trains were operating on SEPTA's, single Main Track, at milepost 2.8 on the Warminster Line.

The primary cause of the accident is attributed to the engineer of the southbound train failing to comply with a displayed stop signal indication. The stop signal, an absolute/home signal, is located at Grove South Interlocking, at milepost 4.2 on single Main Track.
