***Federal Railroad Administration
Office of Safety
Headquarters Assigned
Accident Investigation Report
HQ-2006-82***

***Burlington Northern Santa Fe
St. Genevieve
October 21, 2006***

A southbound Amtrak passenger train collided with an automobile at a private highway-rail crossing on July 3, 2006, at 4:45 p.m. The accident occurred near Castle Rock, Washington, 49 miles north of Vancouver, at BNSF Milepost 83.8, on the BNSF Railway Company Seattle Subdivision.

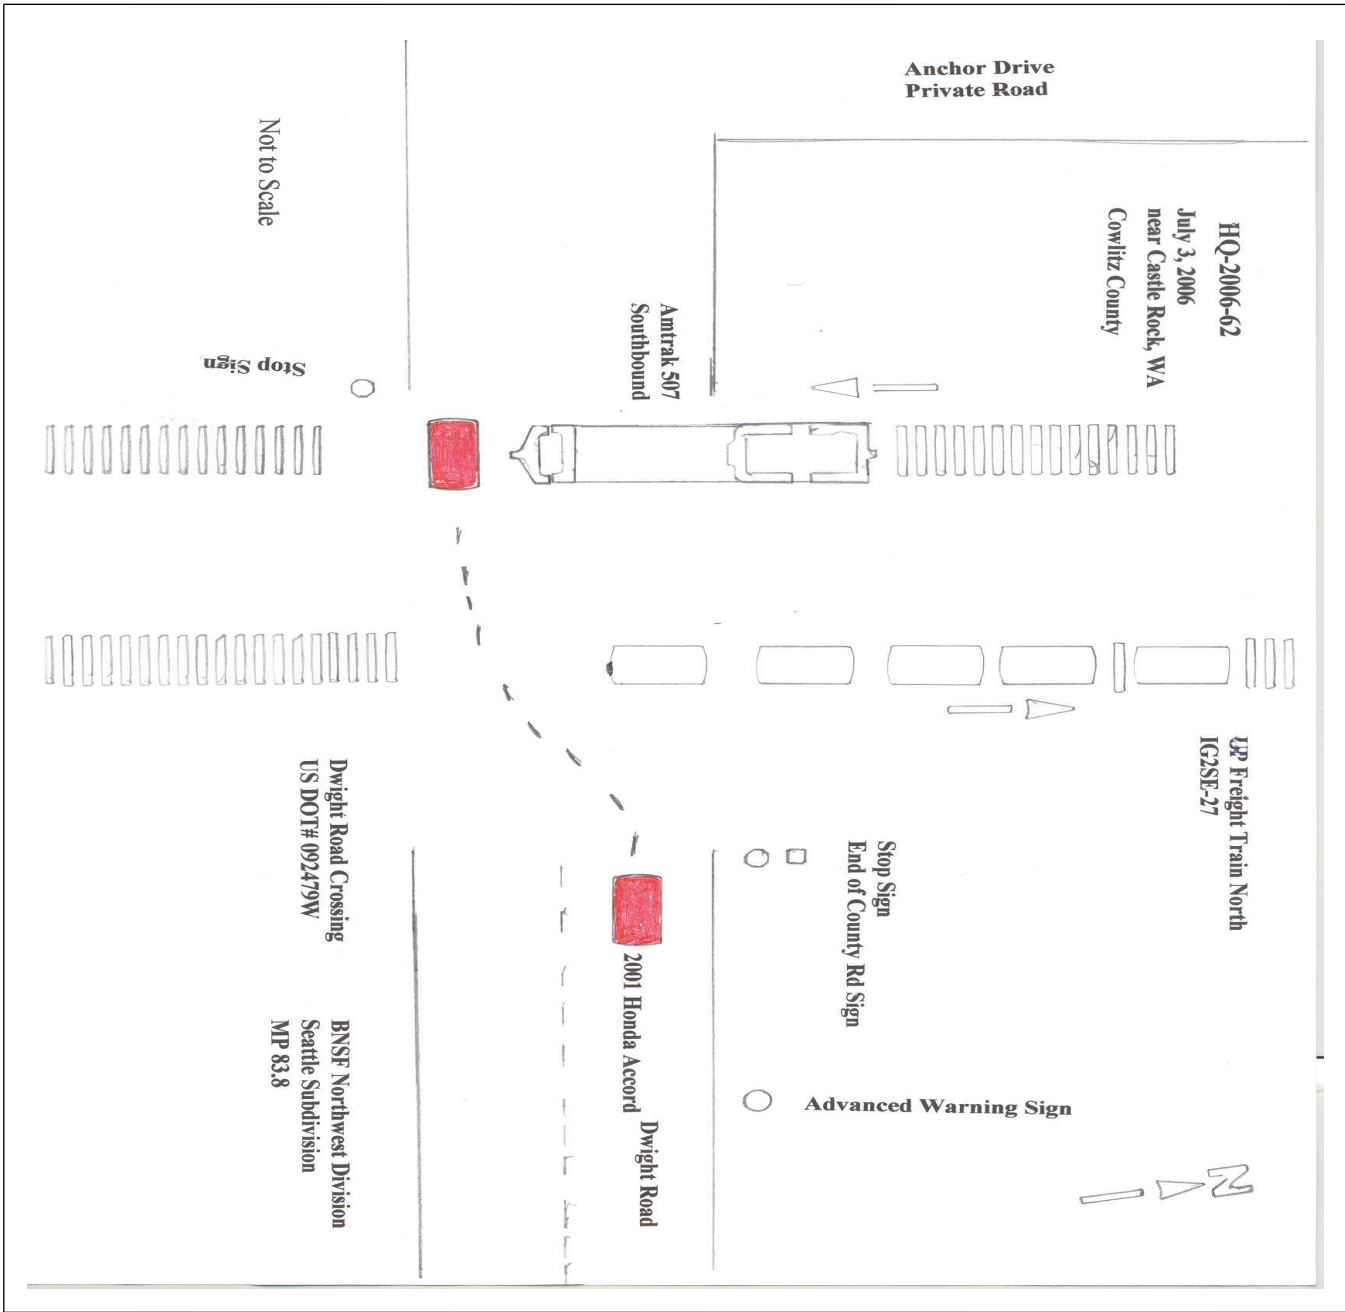
HQ-62-
2006
Sketch.jpg

The automobile was traveling east to west on Dwight Road. According to the Amtrak engineer, the automobile entered the crossing as soon as the northbound freight train cleared the Dwight Road highway-rail crossing. There was no way to estimate the speed of the automobile prior to the collision, but the posted speed limit in this area is 25 mph. The train struck the passenger side of the automobile, a 2001 Honda Accord, midpoint. The automobile was split in two pieces. The train
