***Federal Railroad Administration  
Office of Safety  
Headquarters Assigned  
Accident Investigation Report  
HQ-2006-63***

***Union Pacific  
Klamath Falls, OR  
July 14, 2006***

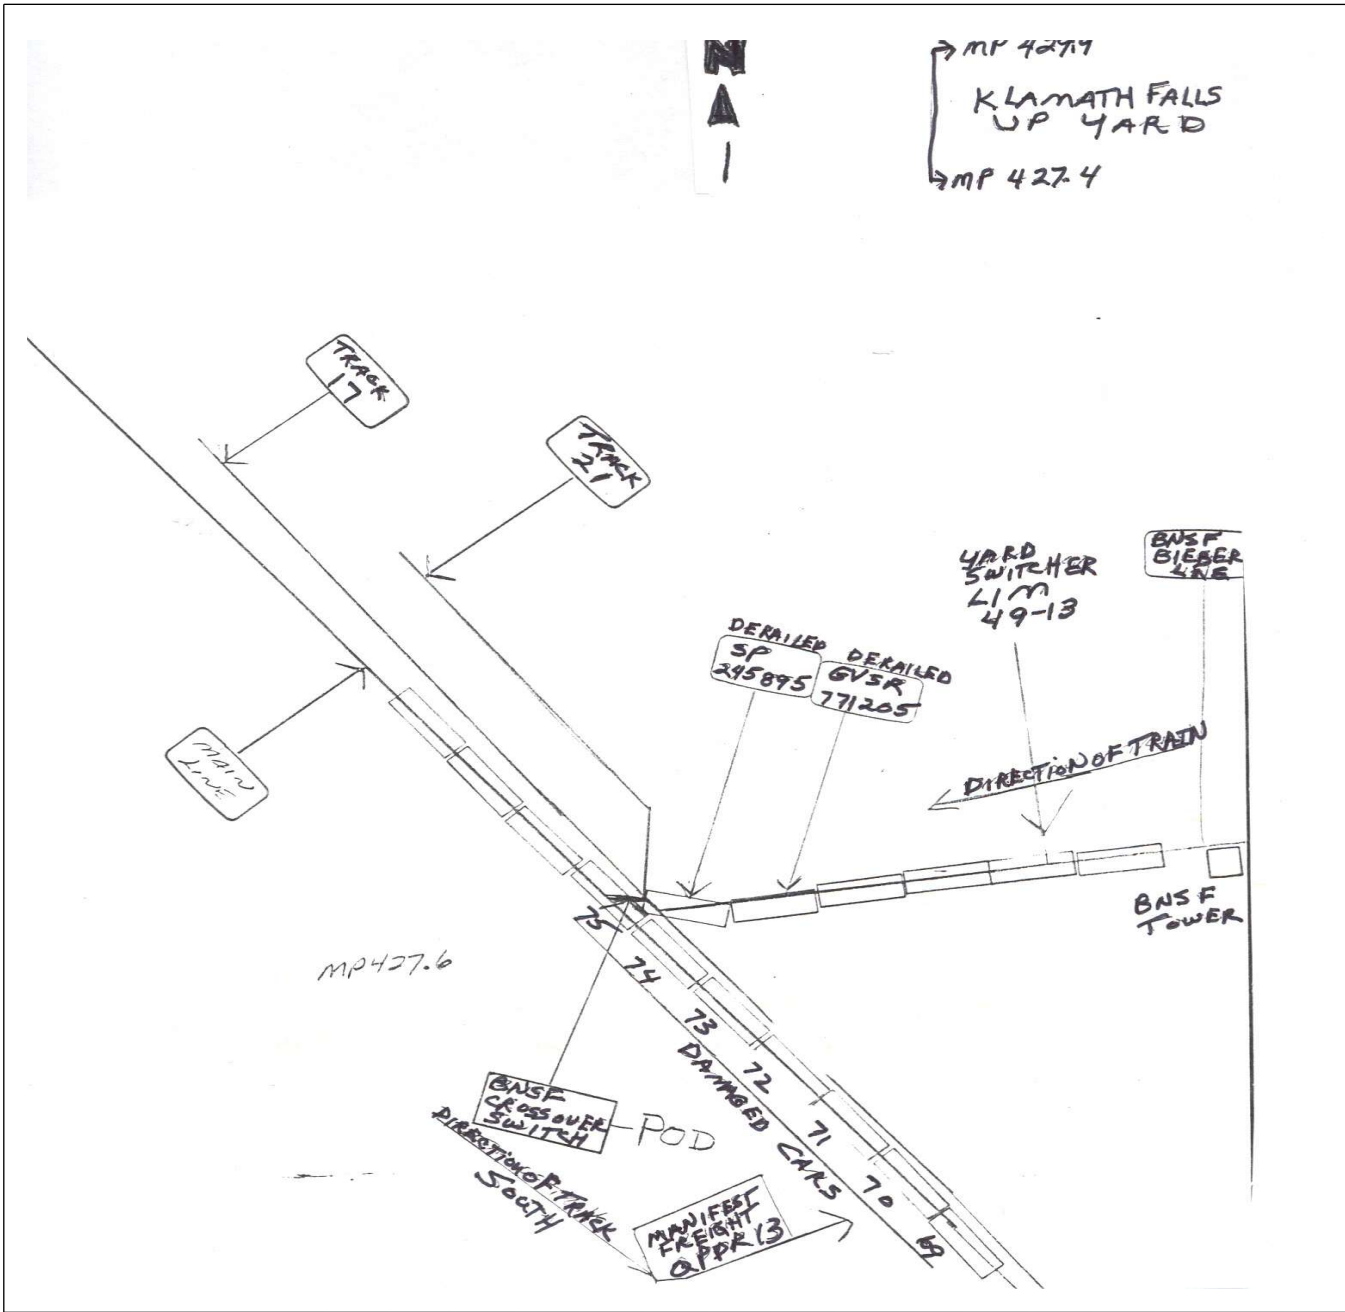
HQ-  
63Sketch.  
jpg

108. DRAW A SKETCH OF ACCIDENT AREA INCLUDING ALL TRACKS, SIGNALS, SWITCHES, STRUCTURES, OBJECTS, ETC., INVOLVED.

The yard switch train crew was transferring the 13 cars (shoving ahead of the locomotive) from the BNSF yard to the UP yard when the train entered the crossover switch which was improperly lined for their intended movement. The cars were shoved onto the UP main track and collided with the 69th car of the southbound freight train.

Upon investigation, the conductor of the yard switch train observed the crossover switch from track 17 to the main track was lined and locked toward the main track and that the yard switch train had collided with the freight train, derailling the lead two cars they were shoving. The conductor also determined that no cars on the southbound freight had derailed.

The investigation also revealed that prior to the accident the brakeman on the yard switch train drove past the crossover switch, parked the vehicle he was driving, then walked back past the crossover switch and lined the track 17 switch for movement. The brakeman then observed the train enter the crossover and strike the southbound freight train that was traveling on the main track. The brakeman told investigating officers that he did not notice that the crossover switch was improperly lined.
