***Federal Railroad Administration  
Office of Safety  
Headquarters Assigned  
Accident Investigation Report  
HQ-2006-64***

***Burlington Northern Santa Fe  
McKenzie, ND  
July 16, 2006***

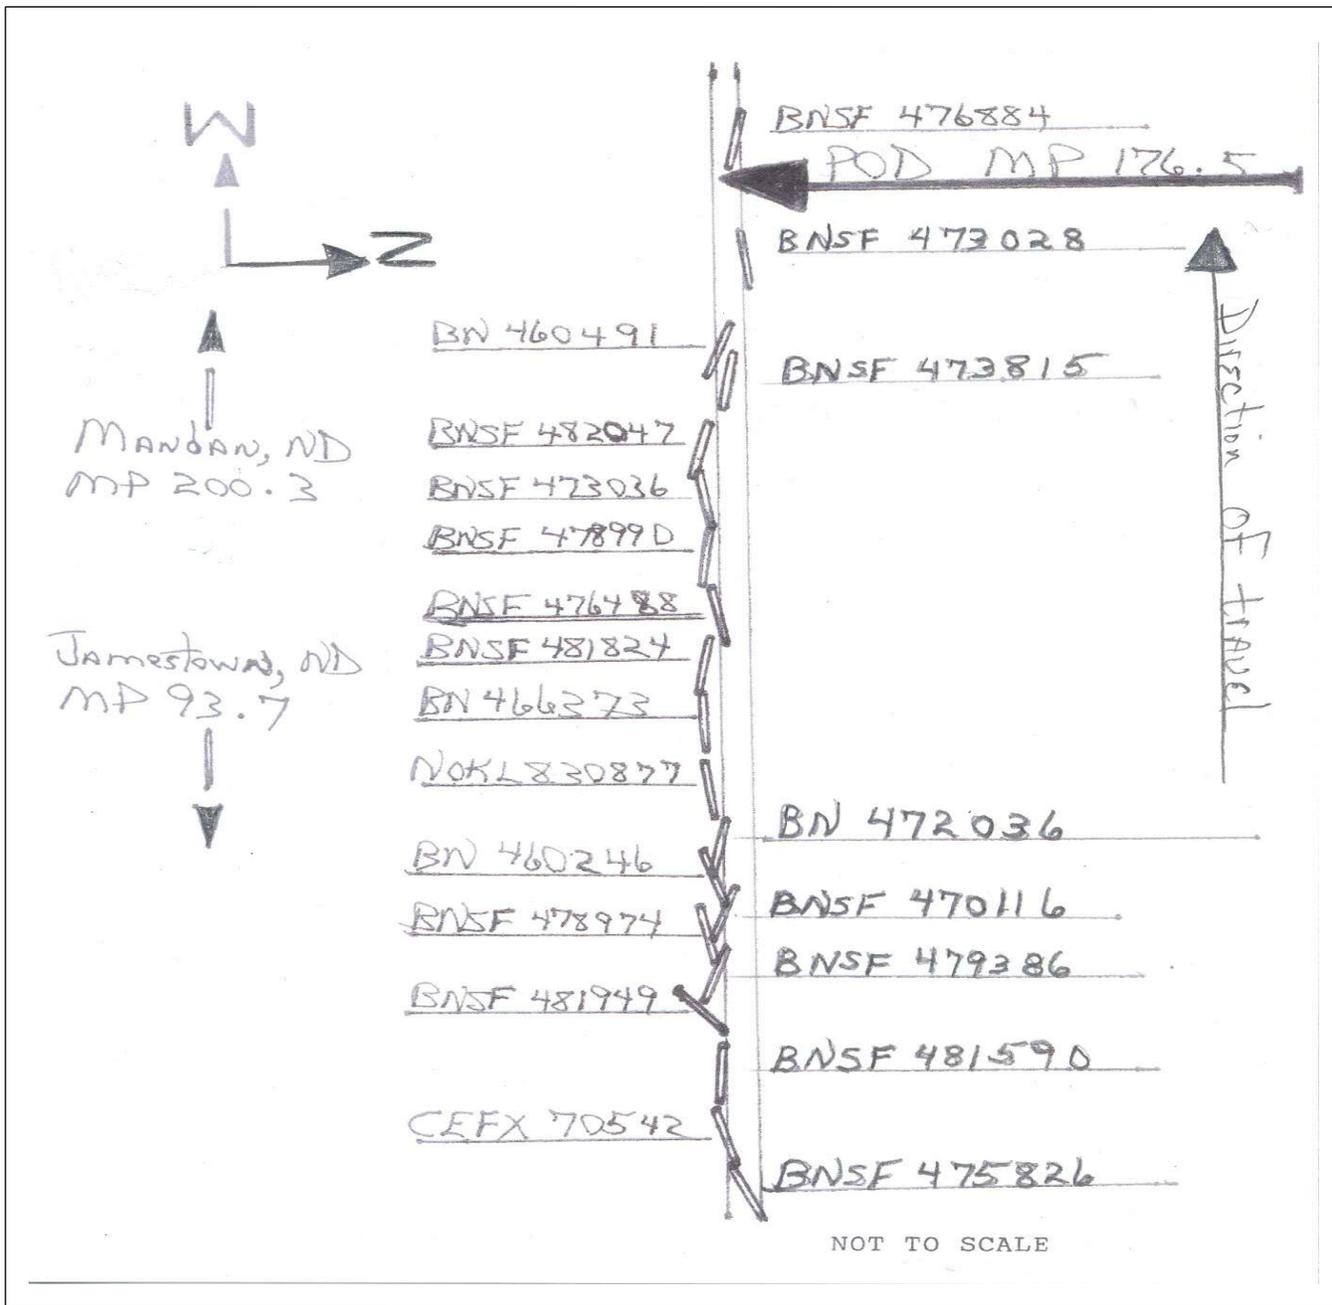
HQ-64-  
2006  
Sketch.jpg

Approaching the accident site from east to west starting at about mile 174.7, there is a tangent for 7,392 feet, and then a left hand 1-degree 4-minute curve for 2,112 feet to the point of derailment and 1,848 feet beyond. The grade approaching the derailment is a 0.40 percent descending grade from mile 174.7 to 176.0, and a 0.22 percent descending grade from mile 176.0 to 176.1, and a 0.0 percent grade from mile 176.1 to the point of derailment and 8,448 feet beyond.

The investigation revealed the train derailed due to a thermal track buckle at mile 176.5.
