***Federal Railroad Administration
Office of Safety
Headquarters Assigned
Accident Investigation Report
HQ-2006-65***

***Union Pacific
St. Mary's, KS
July 17, 2006***

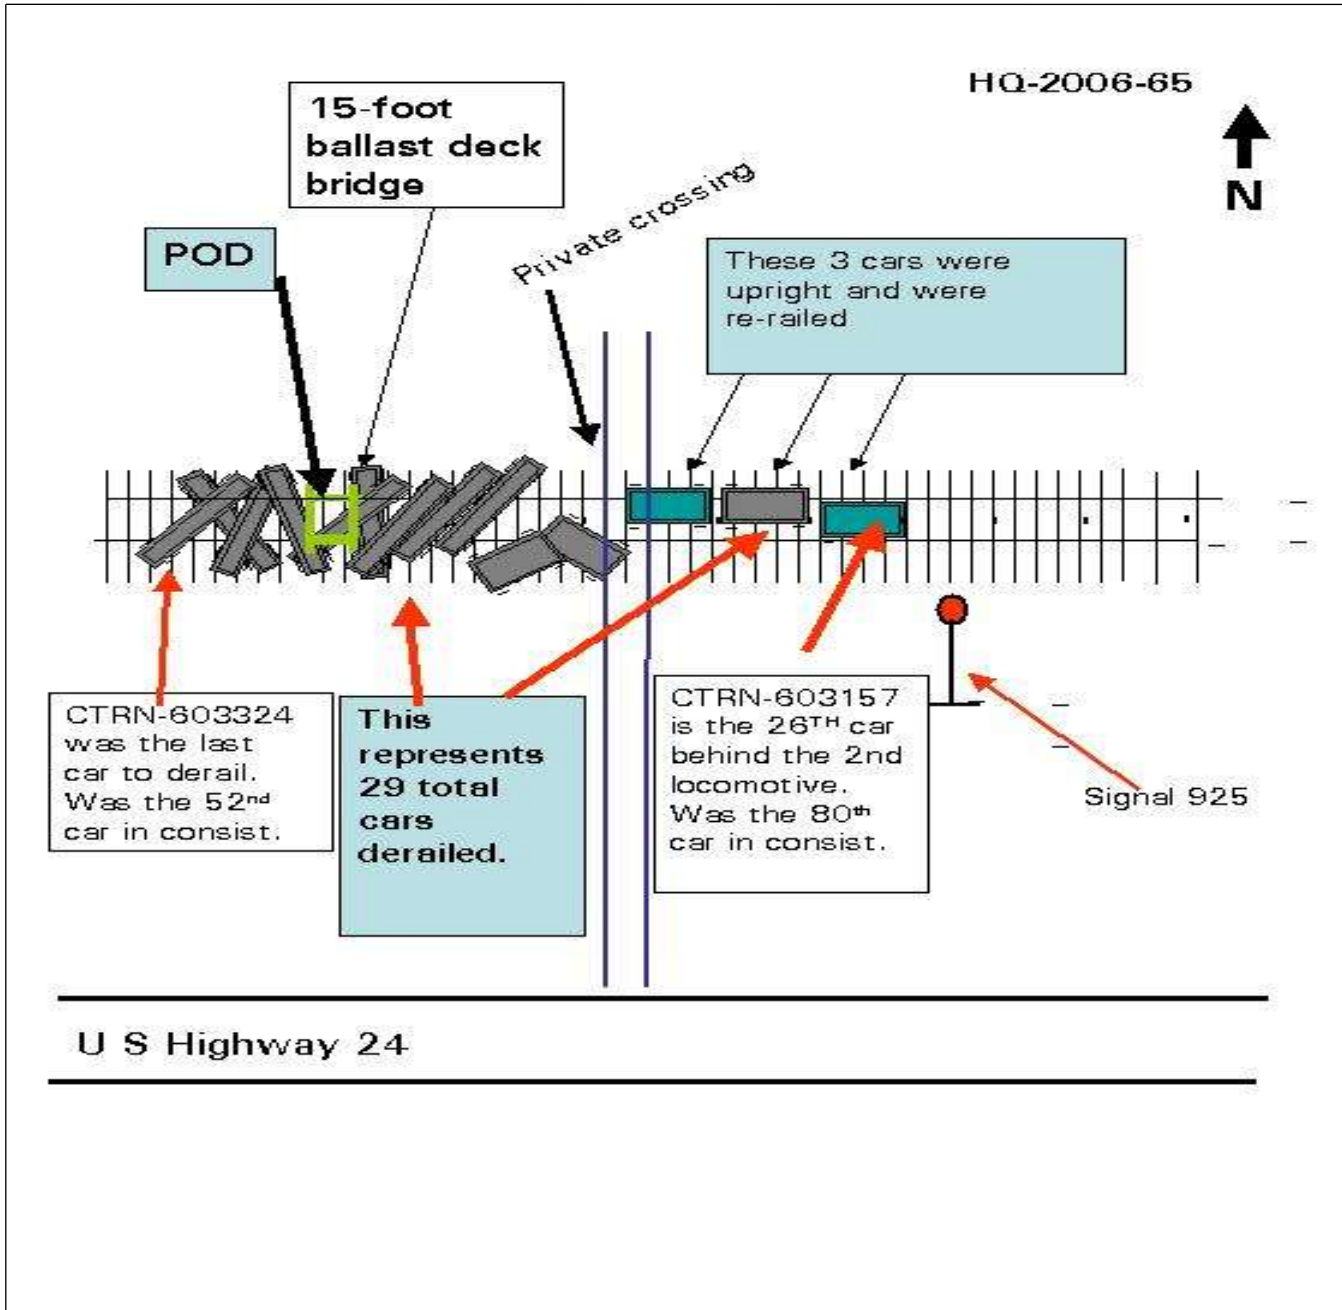
HQ-2006-65
sketch.jpg

At 11:05 a.m. CDT, July 17, 2006, eastbound Union Pacific (UP) loaded coal Train Symbol CWECOSH-12 operating at a recorded speed of 40 mph, derailed 29 cars near St. Marys, Kansas. The derailed cars were the 26th thru 54th from the head-end locomotive consist. The estimated damages were \$1,464,440 to equipment and \$99,095 to track. There was no hazmat release and no injuries. The weather was clear and hot, with a temperature of 100 F.

Thermal misalignment of the track caused the derailment. This location was lined earlier in the day by UP track maintenance forces but the appropriate speed restriction/track compaction measures were not effective at preventing the derailment.
