***Federal Railroad Administration
Office of Safety
Headquarters Assigned
Accident Investigation Report
HQ-2006-66***

***CSX Transportation
Valdosta, GA
July 17, 2006***

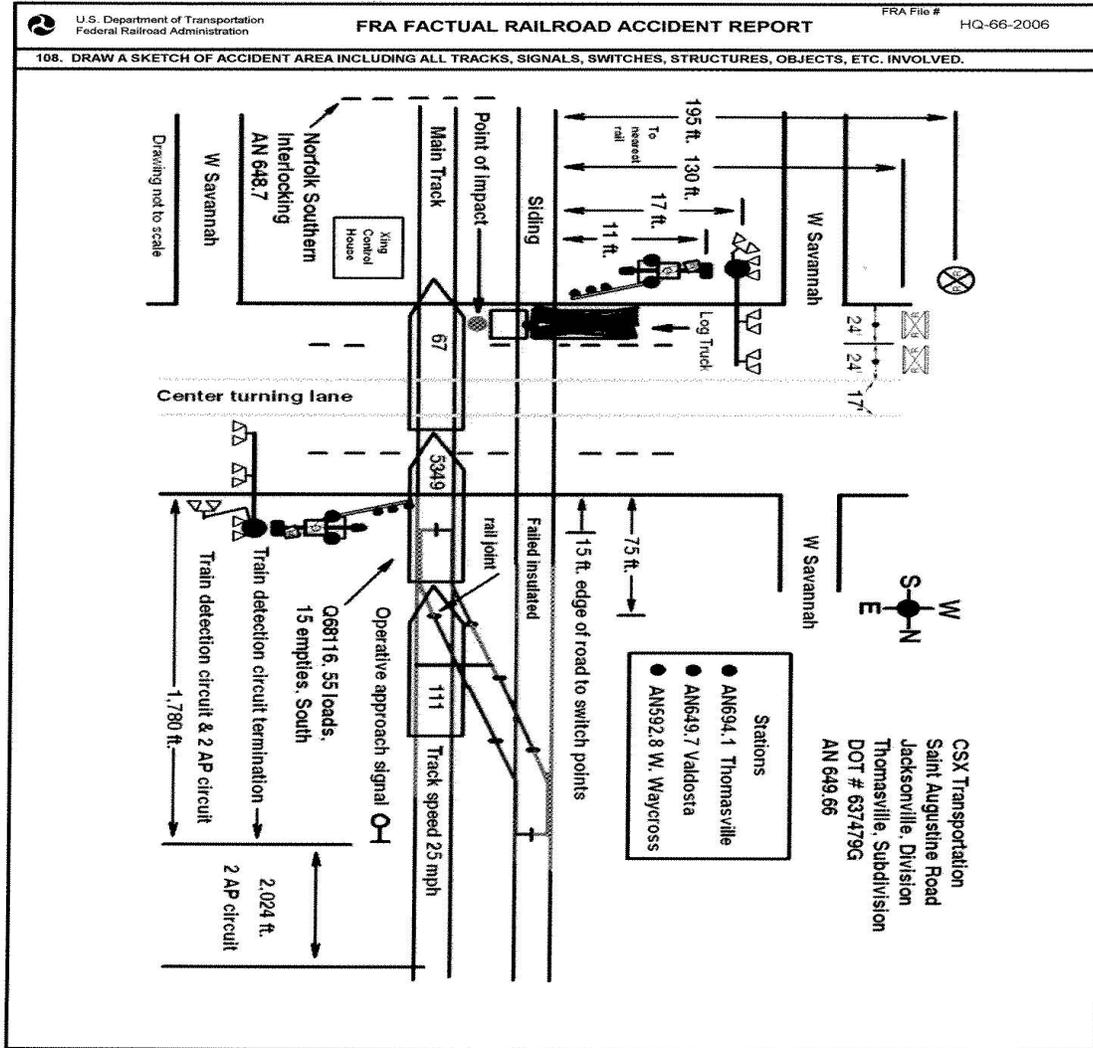
HQ-2006-66
sketch.jpg

The log truck struck the lead locomotive on the engineer's side at the front stairs and beneath the engineer's window. The driver and passenger remained in the cab. At impact the log truck was forced south and parallel with the tracks and train. The trailer struck the signal mast located on the south west quadrant. The train came to a stop about 400 feet south of Saint Augustine Road.
