***Federal Railroad Administration
Office of Safety
Headquarters Assigned
Accident Investigation Report
HQ-2006-67***

***Union Pacific
Champlin, UT
July 27, 2006***

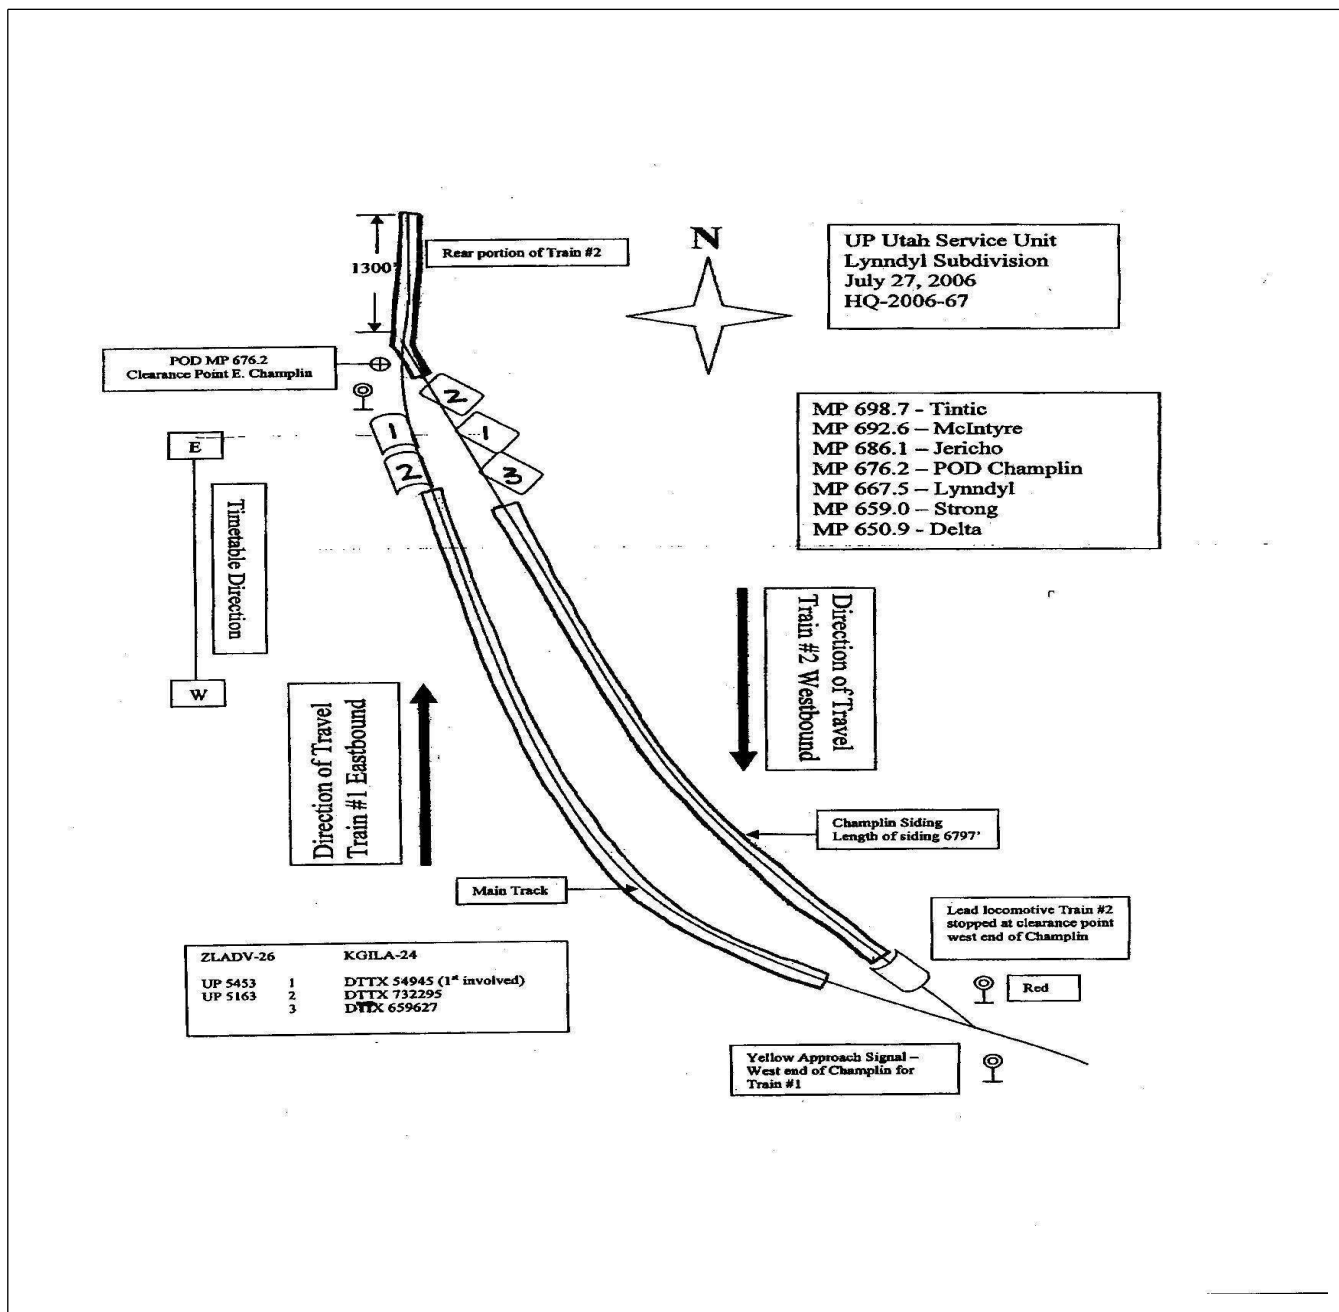
Champlin
 Accident.
 jpg

Train #1 struck the west side of Train #2 standing to foul both the siding and the main track at the east clearance point of Champlin at about 12:45 a.m. The side collision was in a glancing blow between the lead locomotive of Train #1 (UP 5453) and line 32 car DTTX 54945 of Train #2. After train #1 came to rest, both crewmen escaped from the cab of the lead locomotive. The lead locomotive was derailed and upright and listing to the west at about 15 degrees; the second locomotive was derailed and upright with little to no degree of list.

Train #2 traveled under normal operating conditions with no outstanding delay and without incident from Salt Lake City to the clearance point at the west end of the siding at Station Champlin. The purpose of Train #2 taking the siding at Champlin was to complete a meet with Train #1. Train #2 was unable to clear in the siding at Champlin due to the length available for clearance; which was 6797 feet clearance point (west) to clearance point (east). When Train #2 stopped at the west end of the siding at Champlin, approximately 1300 feet of the rear portion of the train extended past the clearance point at the east end of the siding and out onto the single main track. Train #2's crew were all properly positioned and seated on the lead locomotive standing at the clearance point at the west end of Champlin siding. Three cars of Train #2 were damaged and derailed due to the collision.
